# Exhibit D

Property Name: June Foster Haas House

### **62** Yankee Point Drive-Carmel Highlands

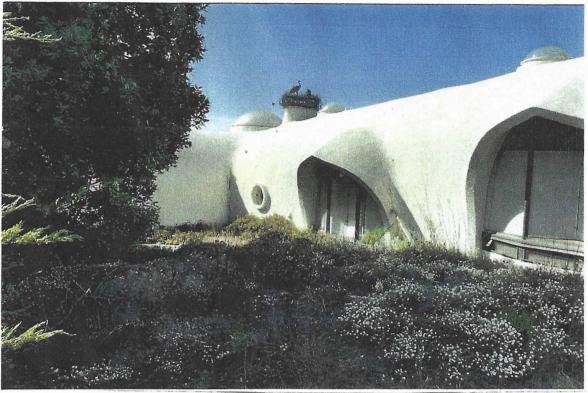
Photograph #1. Looking NW at the South side-elevation, new door is proposed at location of porthole window, Tai Tang, September, 2021.

The owner proposes to enclose the walled open courtyard of the South arm of the cruciform plan with a glazed dome, for bathroom use, and replace the exterior porthole window in an adjacent bathroom space with a door, accessing an outdoor sitting space. The door will either be an existing feature, or one of matching design. All new work will be undertaken in conformance with the *The Secretary of the Interior's Standards for the Treatment of Historic Properties, under the Standard for Rehabilitation.*

Add a glazed dome above the existing enclosed patio wall for a bathroom, and replace the exterior porthole window to the East, in an adjacent bathroom, with a door accessing an outdoor sitting area.

All exterior work outlined in the evaluation above will take place on the South elevation. It includes construction of a steel-framed domelike window connecting an enclosed patio space with the main building envelope & replacement of a single adjacent porthole window with an exterior door. The door will either be a repurposed original feature of the house, or a new door matching, in kind, others found on the building envelope.

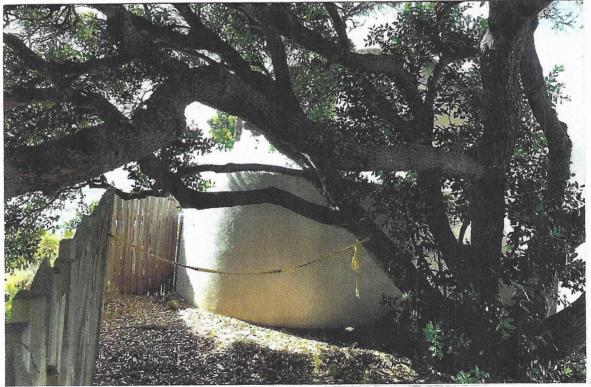
Photograph #2. Looking West at patio wall, SW corner of South side-elevation, note mature tree screening feature, Tai Tang, September, 2021.

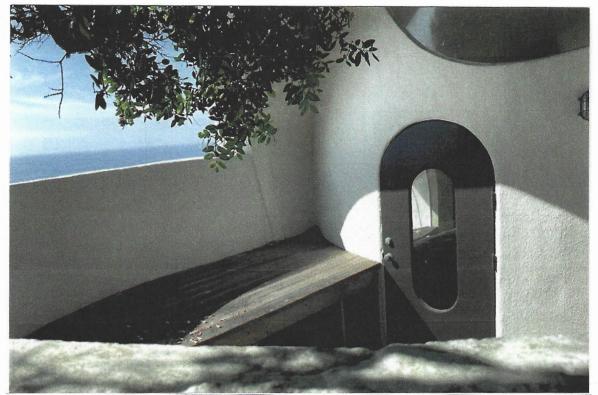
Photograph #3. Looking NW at patio space proposed for new bathroom, note original door. This door type, to be used as replacement for porthole window access to outdoor seating area, Tai Tang, September, 2021.
