PROJECT DESCRIPTION

The Porter Vallejo mansion also known as the Pajaro Library underwent severe storm damage and this past year. The majority of the damage was due to water infiltration from a lack of weatherproofing per the original building construction of the late 1800's.

PAJARO BRANCH LIBRARY

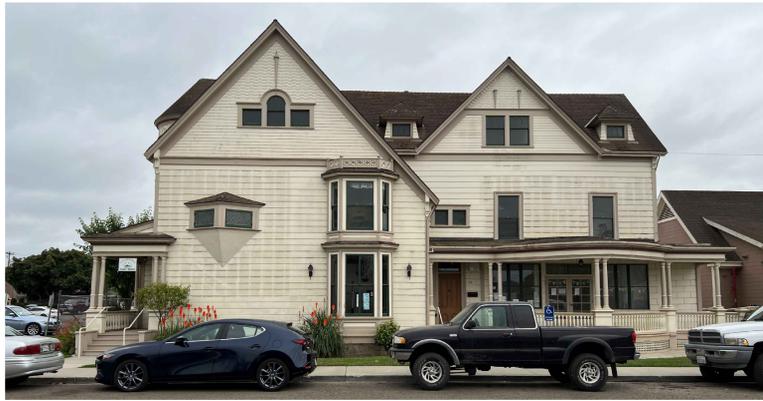
(A)

NORTH OVERALL VIEW

TO SALVAGE 90% OF THE NORTH FACADE SHIP LAP SIDING

TO REPLACE WITH 100% SALVAGED SIDING BY UTILIZING 10% FROM THE SOUTH FACADE

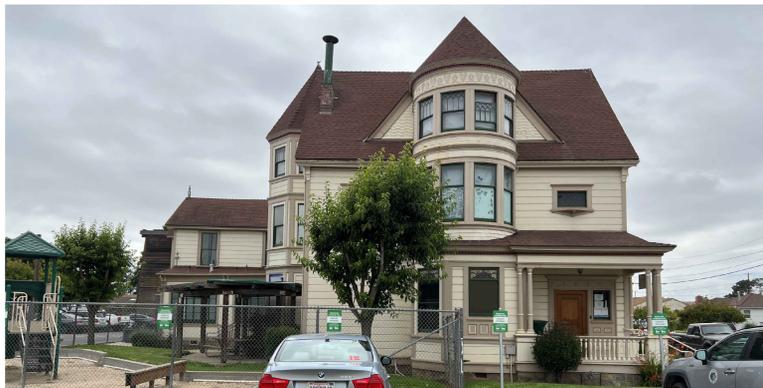
(B)

EAST OVERALL VIEW

TO SALVAGE 90% OF THE EAST FACADE SHIP LAP SIDING

TO REPLACE WITH 100% SALVAGED SIDING BY UTILIZING 10% FROM THE SOUTH FACADE

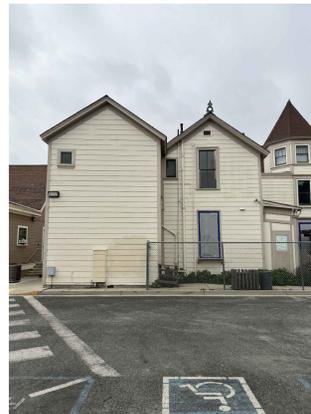
(D)

SOUTH VIEWS

INTENT TO SALVAGE 50% OF THE SOUTH FACADE SHIP LAP SIDING TO BE RE-PURPOSED FOR THE NORTH AND EAST ELEVATIONS.

PROPOSE TO REPLACE 100% OF SOUTH FACING SIDING WITH AMERICANA WOOD PRODUCTS SEE DETAIL 3 PAGE-14 - NOTE: THIS IS THE ONLY FACADE PROPOSING REPLACEMENT

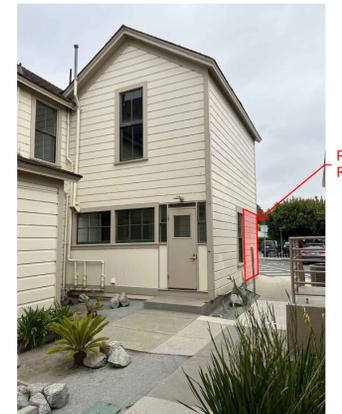
(H)

WEST VIEWS

TO SALVAGE 75% OF THE ORIGINAL WEST FACADE SHIP LAP SIDING

FOR THE NORTH PORTION OF WEST FACADE TO BE REPLACE WITH 100% SALVAGED SIDING. THE SOUTH PORTION OF THE WEST FACADE TO BE REPLACED WITH THE NEW AMERICANNA WOOD PRODUCT. AS A PORTION OF THE STORAGE BDLG. HAS ALREADY BEEN PREVIOUSLY REPLACED.

SEE WEST ELEVATION ON SHEET 10 FOR INDIATION OF AREA TO BE SALVAGED & REPLACED

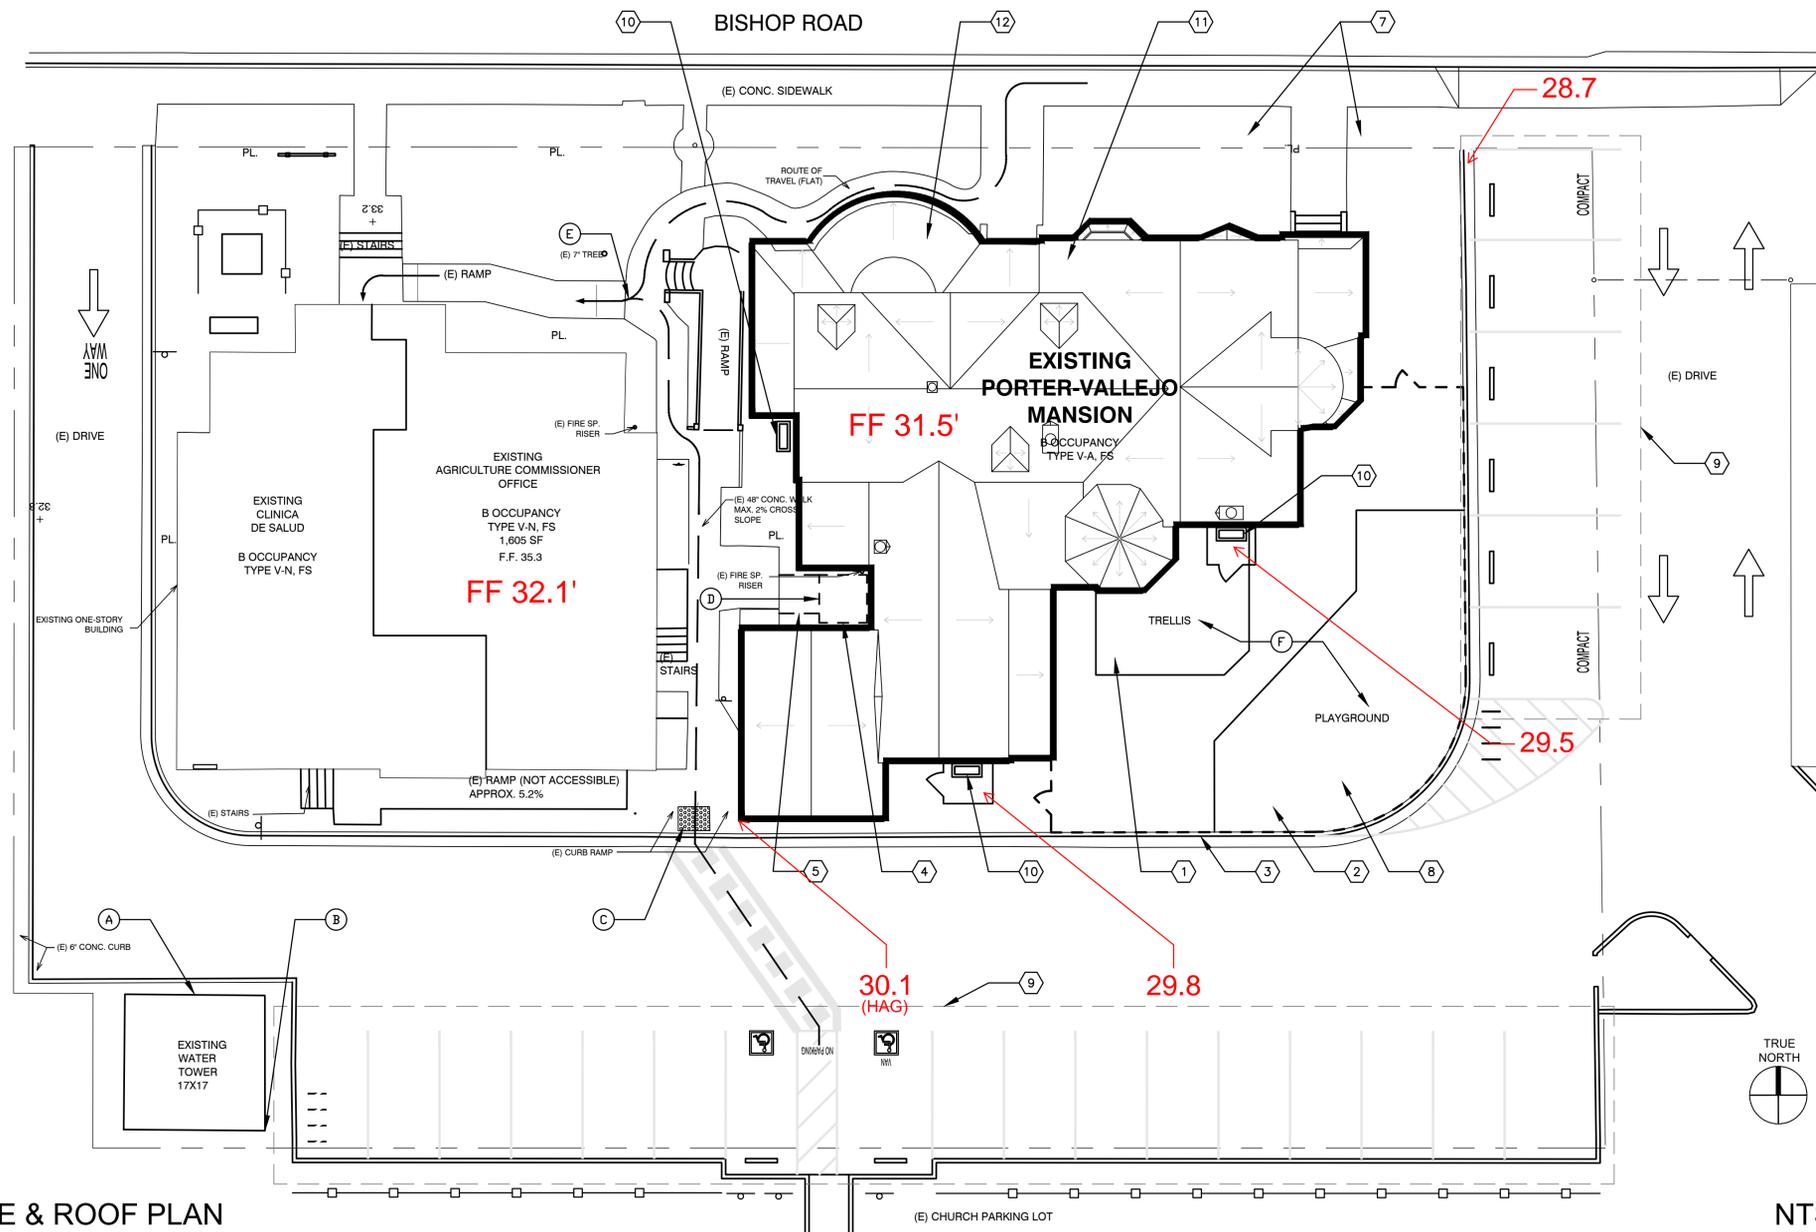
SITE & ROOF PLAN

- ① REMOVE EXISTING TRELLIS. CONTRACTOR TO LEVEL CONCRETE SLAB.
- ② EXISTING PLAYGROUND STRUCTURE, SAND, AND CONCRETE CURB TO BE REMOVED. TO BE REPLACED WITH NEW COMMUNITY SPACE - SEE PAGE 4.
- ③ EXISTING 6'-0" HIGH CYCLONE FENCE TO BE REMOVED AND REPLACED WITH 3'-0" HIGH WHITE PICKET FENCE.
- ④ PROPOSED FUTURE ELEVATOR LOCATION
- ⑤ PROPOSED PATH EXTENSION TO FUTURE ELEVATOR.
- ⑥ EXISTING WATER TOWER TO REMAIN IN PLACE AND BE MOTHBALLED.
- ⑦ EXISTING GRASS TO REMAIN
- ⑧ PROPOSED SITTING AREA (LAYOUT TBD).
- ⑨ EXISTING PARKING TO REMAIN
- ⑩ NEW HEAT PUMP - SEE MECHANICAL PLAN PAGE 10
- ⑪ REPLACEMENT OF ASPHALT SHINGLES ON PRIMARY ROOF, TURRETS AND DORMERS TO MATCH EXISTING. ALL NEW VALLEY FLASHING AND GUTTERS OVER NEW PAPER AND SUBSTRATE AS NEEDED.
- ⑫ NEW CAP SHEET / TPO ROOFING OVER WOOD FRAMING TO MATCH EXISTING SHAPE AND SLOPE. CARLISLE COLOR PALETTE - TERRA COTTA

BASE FLOOD ELEVATION (BFE) FOR REFERENCE ONLY:
ELEVATIONS NOTED IN RED ARE PER CONVERSATION WITH COUNTY OF MONTEREY LAND SURVEYOR ON 10.11.23.

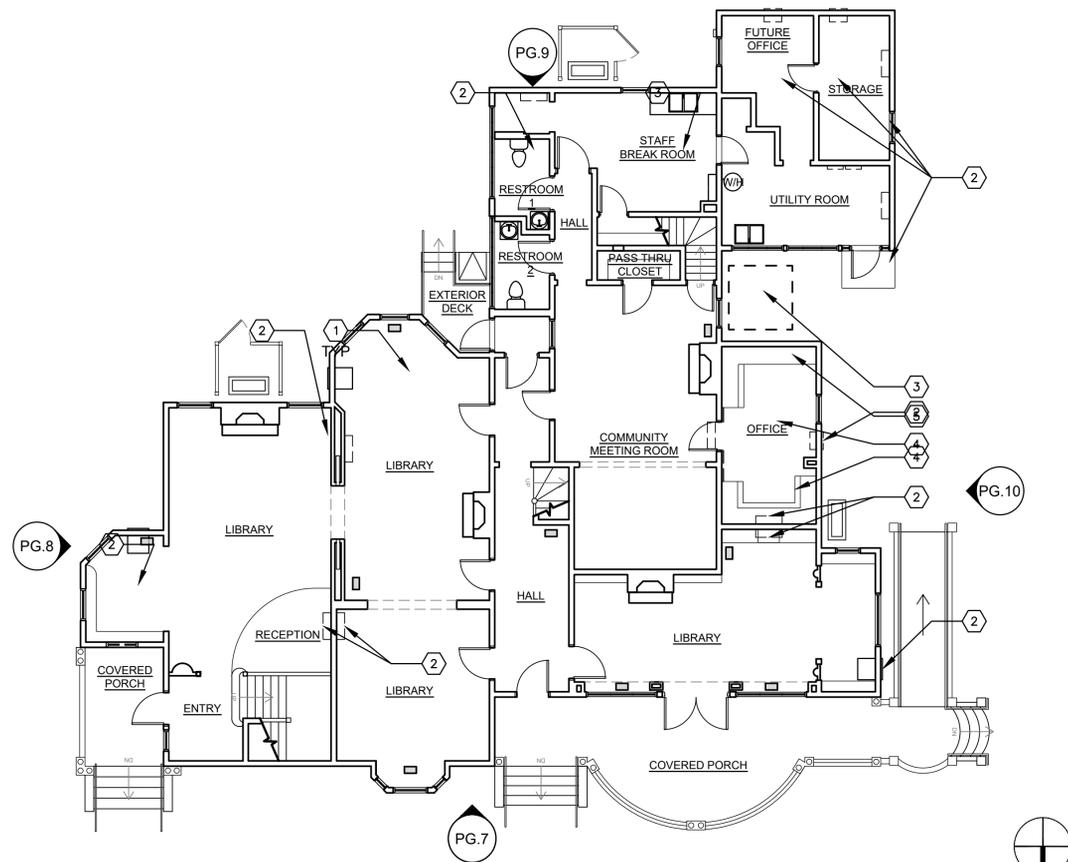
FIRST FLOOR PLAN

1. ALL CHIMNEYS ARE PLACEHOLDERS.
2. CONTRACTOR TO PROTECT ANY EXISTING FOUNDATION VENTS OR OPENINGS WITH 1/4" WIRE MESH MINIMUM.
3. SIDING TO BE REMOVED AND SALVAGED.
4. TRIM TO BE REMOVED AND SALVAGED.
5. ALL WINDOWS WHERE SHIP LAP SIDING IS REMOVED TO RECEIVE FLASHING ON ALL 4 SIDES.
6. 2ND AND 3RD FLOOR SCOPE OF WORK FOR FUTURE SUBMITTAL.
7. LATH AND PLASTER HAS BEEN REMOVED IN SEVERAL ROOMS. PRIMARILY ON THE SOUTH SIDE DUE TO WATER INFILTRATION AND DAMAGE.
8. MITIGATION MEASURES AND CONTAINMENT ARE ONGOING TO REMOVE THE WATER DAMAGED AREAS, MOLD, AND DRY ROT.
9. FLOORING HAS BEEN REMOVED DOWN TO THE SUB FLOOR AND FRAMING IN SOME CASES TO DRY OUT THE WOOD MEMBERS AS NEEDED.
10. NEW HVAC FOR 2ND AND 3RD FLOORS TO BE SUBMITTED UNDER SEPARATE PROPOSAL FOR FUTURE WORK.

- ① EXISTING WOOD RAILINGS AND TURNED PICKETS TO BE REPAIRED AS NEEDED WASH WITH GENTLE BRUSH AND REPAINTED TO MATCH EXISTING.
- ② WOOD DECKING TO BE REPLACED AND PAINTED TO MATCH EXISTING COLOR. STRUCTURAL ENGINEER TO DESIGN NEW STRUCTURAL SUPPORT SYSTEM FOR DECKING. PAINT ENTIRE DECK - COLOR TO MATCH EXISTING.
- ③ EXISTING STONE AT BASE TO REMAIN. CONTRACTOR TO VERIFY CONDITION OF ROPE STYLE MORTAR, REPAIR AS NEEDED.
- ④ REPLACE FOUNDATION FASCIA BASEBOARDS WITH NEW TO MATCH EXISTING SIZING AND PAINTED COLOR.
- ⑤ FUTURE ELEVATOR PROPOSED LOCATION. TO SECOND FLOOR ONLY.
- ⑥ SHADED AREA OF BASEMENT REPRESENTS AREA FOR PROPOSED, NON-STRUCTURAL RAT SLAB

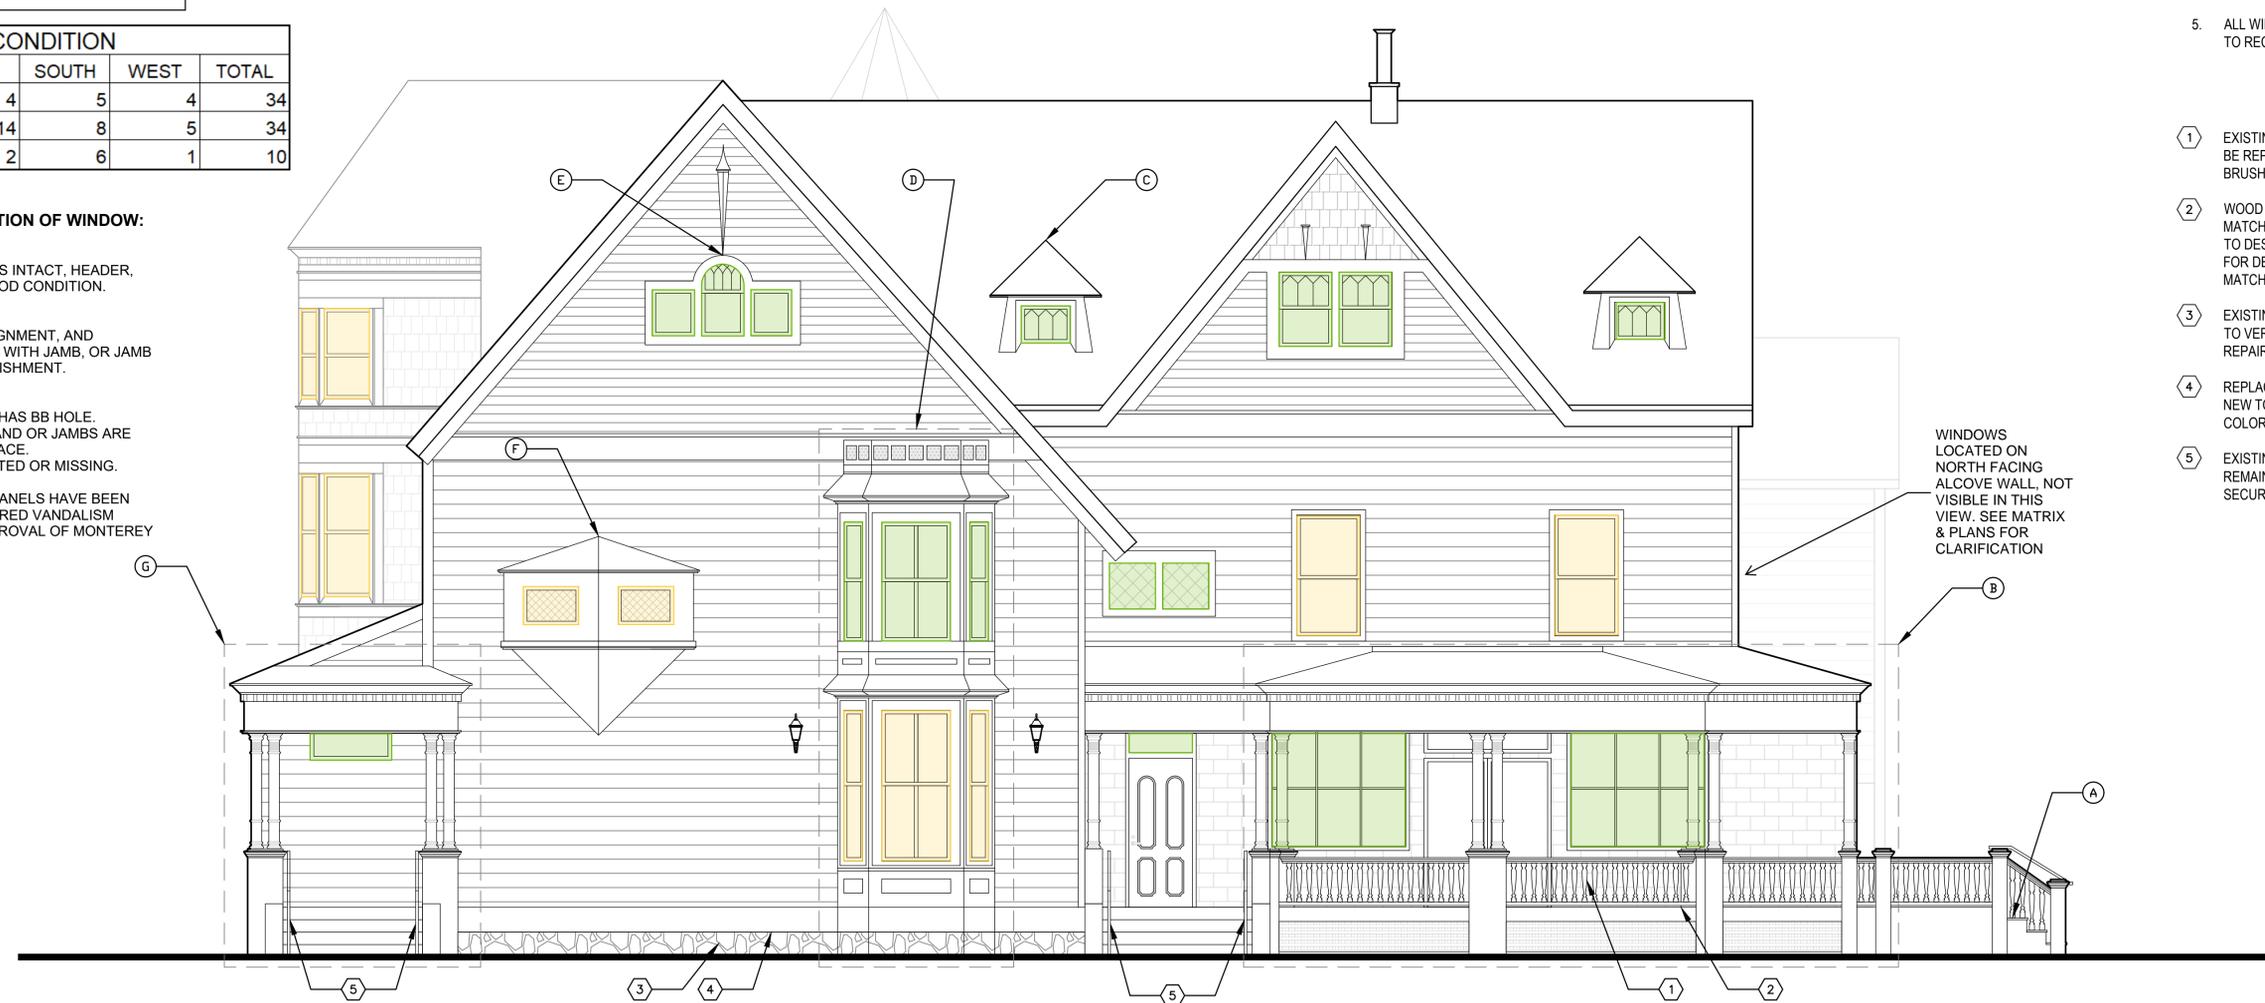
THE NORTH ELEVATION IS TO BE REPLACED WITH 100% SALVAGED HORIZONTAL SHIPLAP SIDING.

1. ALL CHIMNEYS ARE PLACEHOLDERS.
2. CONTRACTOR TO PROTECT ANY EXISTING FOUNDATION VENTS OR OPENINGS WITH 1/4" WIRE MESH MINIMUM.
3. SIDING TO BE REMOVED AND SALVAGED.
4. TRIM TO BE REMOVED AND SALVAGED.
5. ALL WINDOWS WHERE SHIP LAP SIDING IS REMOVED TO RECEIVE FLASHING ON ALL 4 SIDES.

1. EXISTING WOOD RAILINGS AND TURNED PICKETS TO BE REPAIRED AS NEEDED WASH WITH GENTLE BRUSH AND REPAINTED TO MATCH EXISTING.
2. WOOD DECKING TO BE REPLACED AND PAINTED TO MATCH EXISTING COLOR. STRUCTURAL ENGINEER TO DESIGN NEW STRUCTURAL SUPPORT SYSTEM FOR DECKING. PAINT ENTIRE DECK - COLOR TO MATCH EXISTING.
3. EXISTING STONE AT BASE TO REMAIN. CONTRACTOR TO VERIFY CONDITION OF ROPE STYLE MORTAR, REPAIR AS NEEDED.
4. REPLACE FOUNDATION FASCIA BASEBOARDS WITH NEW TO MATCH EXISTING SIZING AND PAINTED COLOR.
5. EXISTING GALVANIZED STEP PIPE RAILINGS TO REMAIN. STRUCTURAL TO VERIFY IF RAILINGS ARE SECURE.

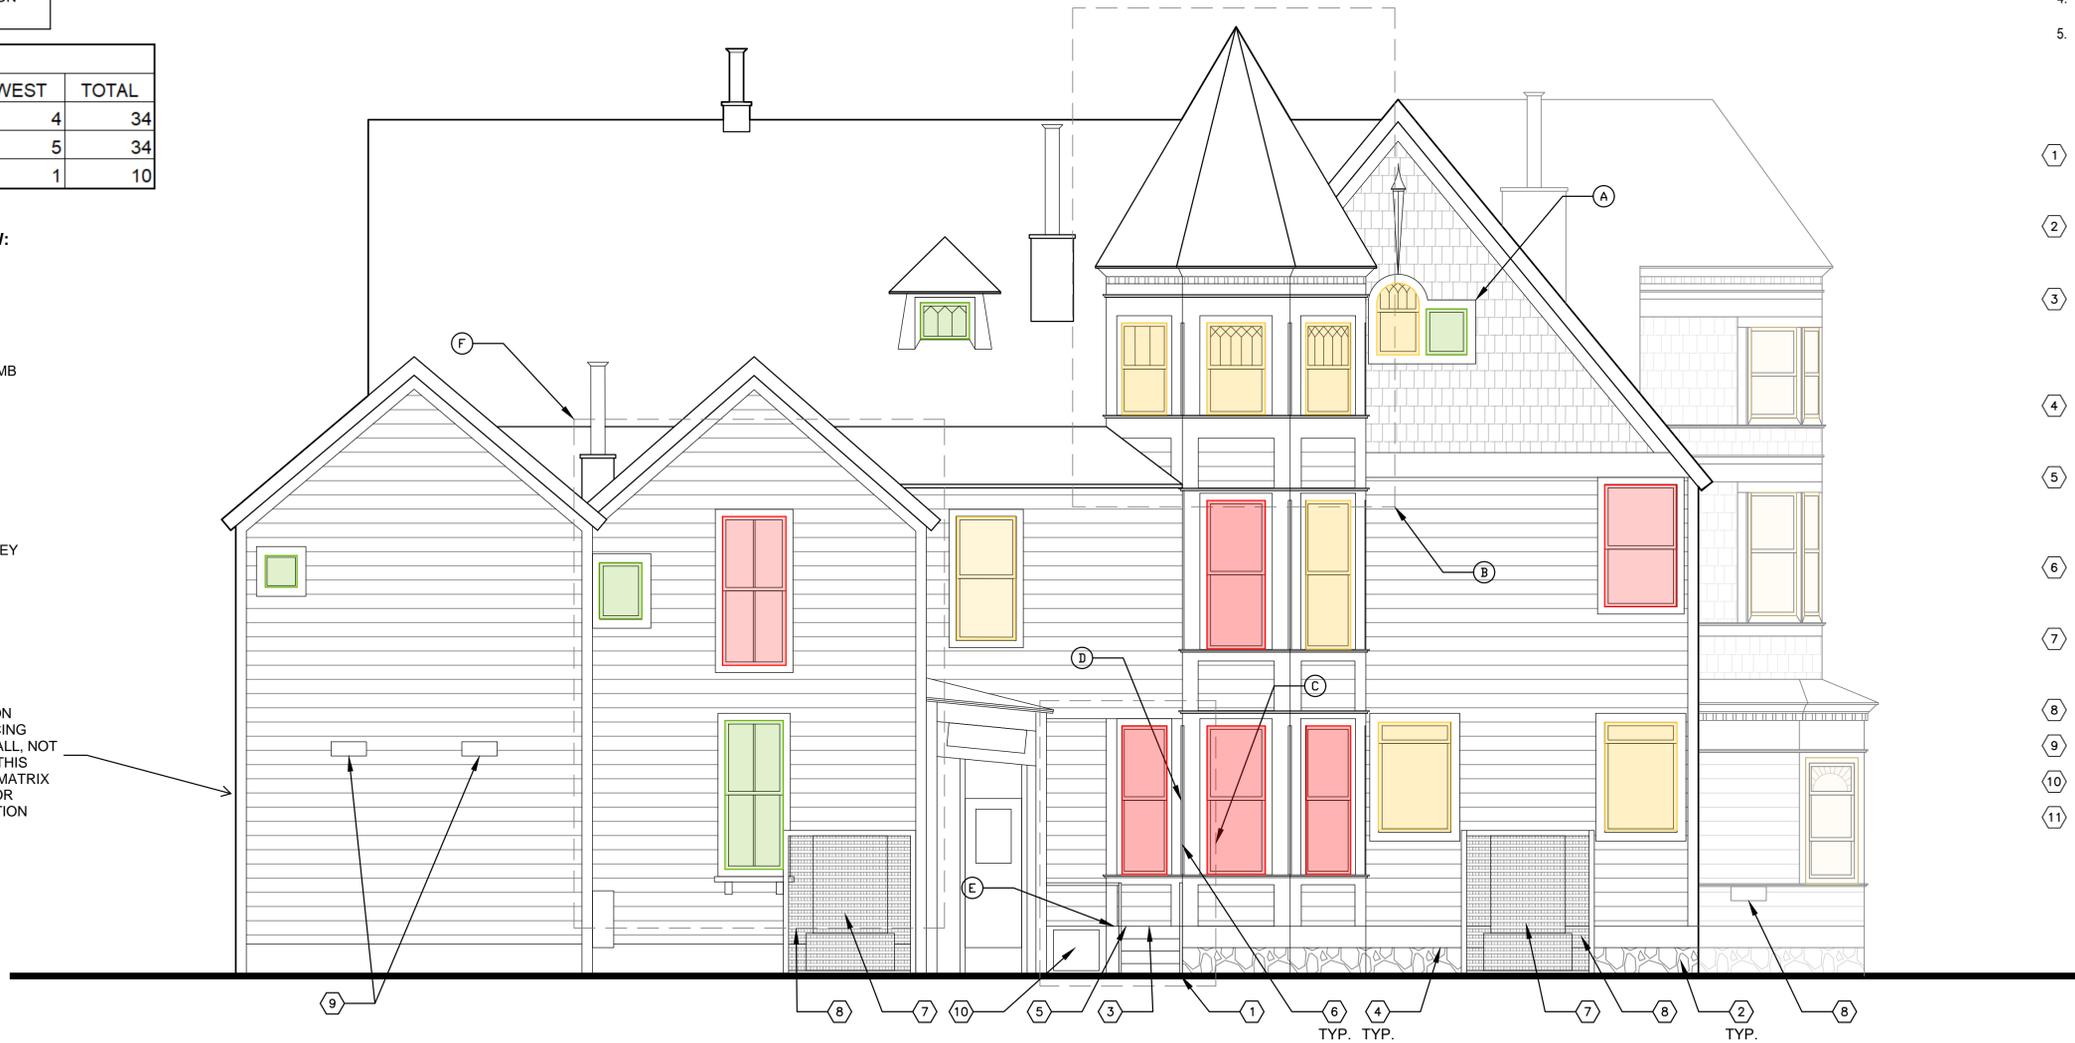
SOUTH ELEVATION

1. ALL CHIMNEYS ARE PLACEHOLDERS. CHIMNEYS DO NOT KNOW THE EXTENT OF HOW FAR THEY FOLLOW THROUGH.
2. CONTRACTOR TO PROTECT ANY EXISTING FOUNDATION VENTS OR OPENINGS WITH 1/4" WIRE MESH MINIMUM.
3. SIDING TO BE REMOVED AND SALVAGED.
4. TRIM TO BE REMOVED AND SALVAGED.
5. ALL WINDOWS WHERE SHIP LAP SIDING IS REMOVED TO RECEIVE FLASHING ON ALL 4 SIDES.

1. EXISTING GALVANIZE STEEL PIPE RAILINGS TO REMAIN. STRUCTURAL TO VERIFY BRACKETS ARE SECURE.
2. EXISTING STONE AT BASE TO REMAIN. CONTRACTOR TO VERIFY CONDITION OF ROPE STYLE MORTAR, REPAIR AS NEEDED.

3. WOOD DECKING TO BE REPLACED AND PAINTED TO MATCH EXISTING COLOR. STRUCTURAL ENGINEER TO DESIGN NEW STRUCTURAL SUPPORT SYSTEM FOR DECKING. PAINT ENTIRE DECK - COLOR TO MATCH EXISTING.

4. REPLACE FOUNDATION FASCIA BASEBOARDS WITH NEW TO MATCH EXISTING SIZING AND PAINTED COLOR.
5. EXTERIOR DECKING AT REAR ENTRANCE. REPLACE ALL BOARDS THAT ARE DAMAGED OR HAVE DRY ROT. ENTIRE DECK AT REAR ENTRANCE TO BE REPAINTED.

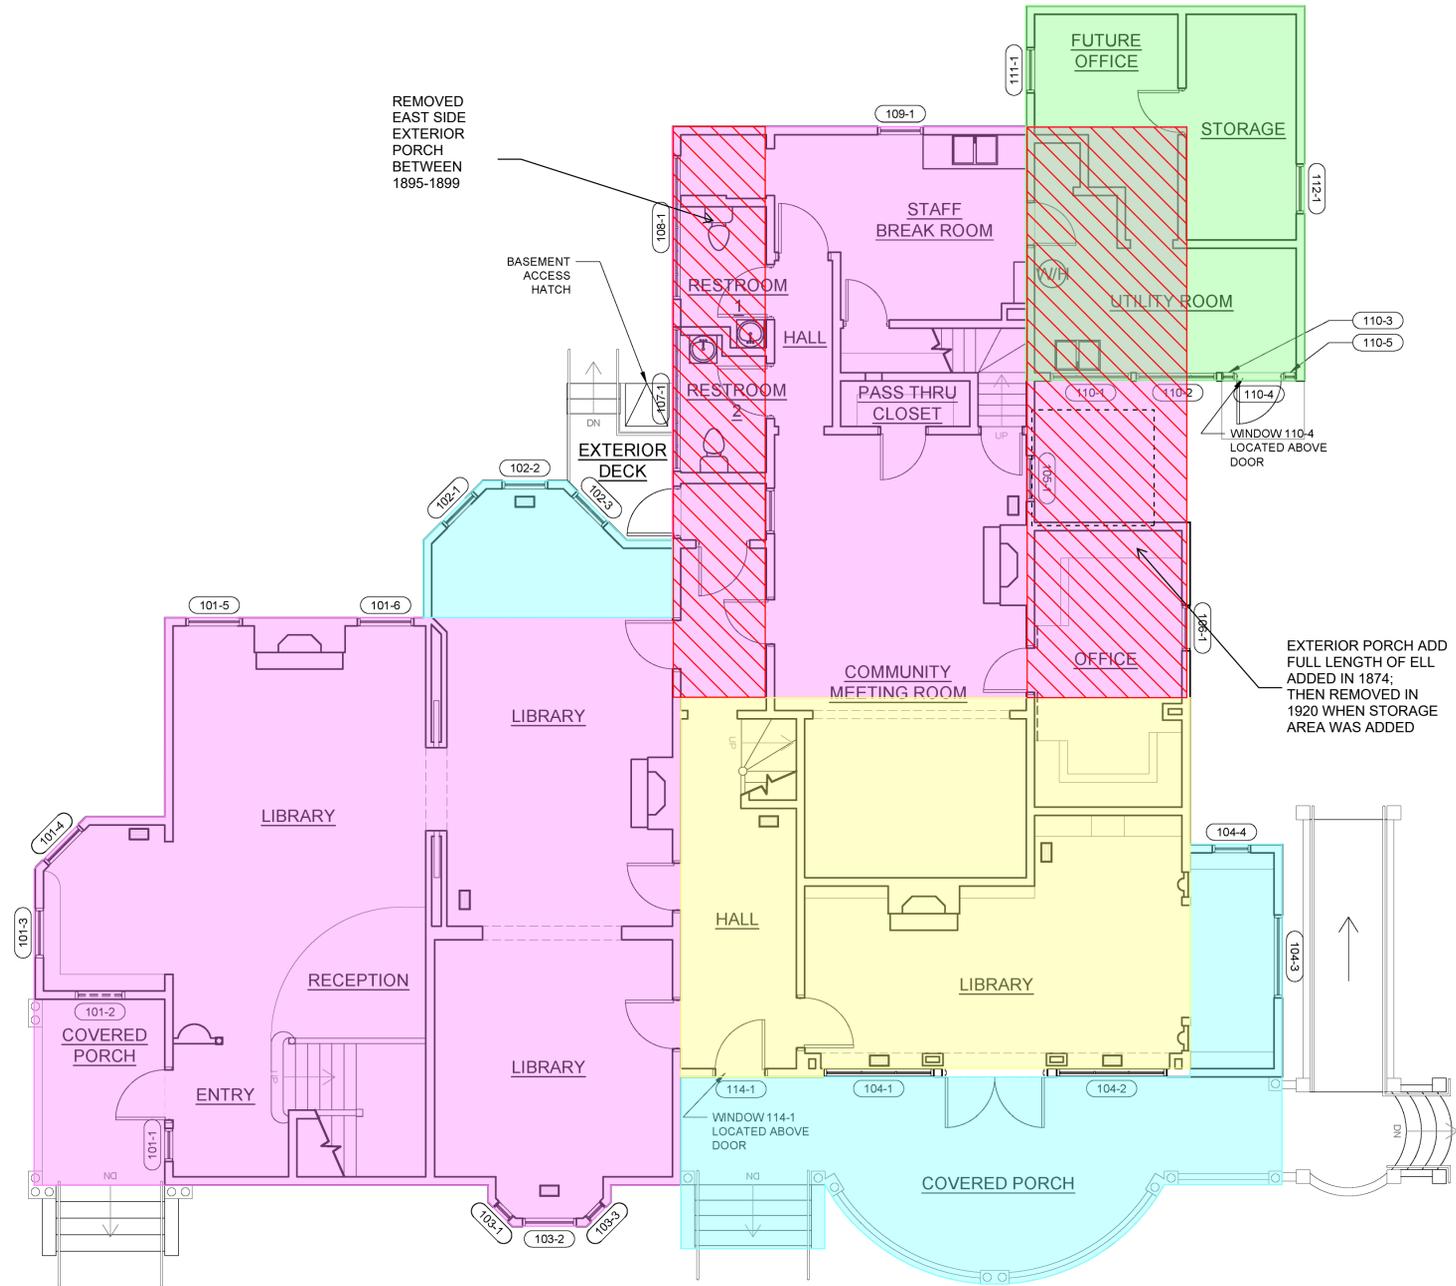
FIRST FLOOR PLAN CONSTRUCTION HISTORY

The north porch was lengthened and configured into a shallow curve. A spindle work balustrade defined the porch edge, and the slender Gothic columns were replaced by paired columns, supported by peers. The front parlor was expanded by pushing out the walls of the west elevation, with the addition of a bay.

On the front elevation some of the ground floor 1870s windows were removed and replaced. French doors were added between the new windows. These additions were poorly constructed in deterred from the buildings designed and therefore not considered to be significant character to the defining features.

The north porch was lengthened and configured into a shallow curve. A spindle work balustrade defined the porch edge, and the slender Gothic columns were replaced by paired columns, supported by peers. The front parlor was expanded by pushing out the walls of the west elevation, with the addition of a bay.

On the front elevation some of the ground floor 1870s windows were removed and replaced. French doors were added between the new windows. These additions were poorly constructed in deterred from the buildings designed and therefore not considered to be significant character to the defining features.

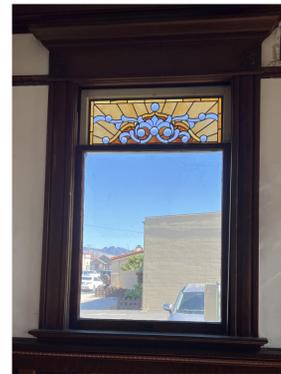
GOOD
WINDOW GLAZING/ SASH IS INTACT, HEADER, JAMB AND SILL ARE IN GOOD CONDITION.

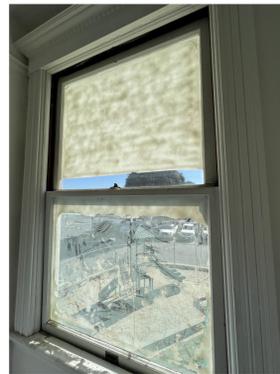
POOR
WINDOW IS CRACKED OR HAS BB HOLE. SASH IS COMPROMISED, AND OR JAMBS ARE NOT HOLDING SASH IN PLACE. JAMB AND/OR SILL IS ROTTED OR MISSING.

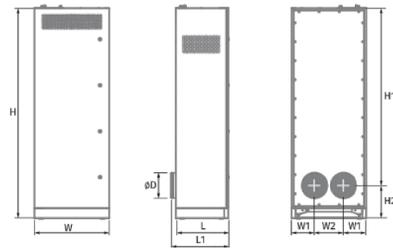
Overall dimensions [in] **HRV-2**

The unit is rated for indoor application with the ambient temperature ranging from +34 °F to +104 °F and relative humidity up to 80%.

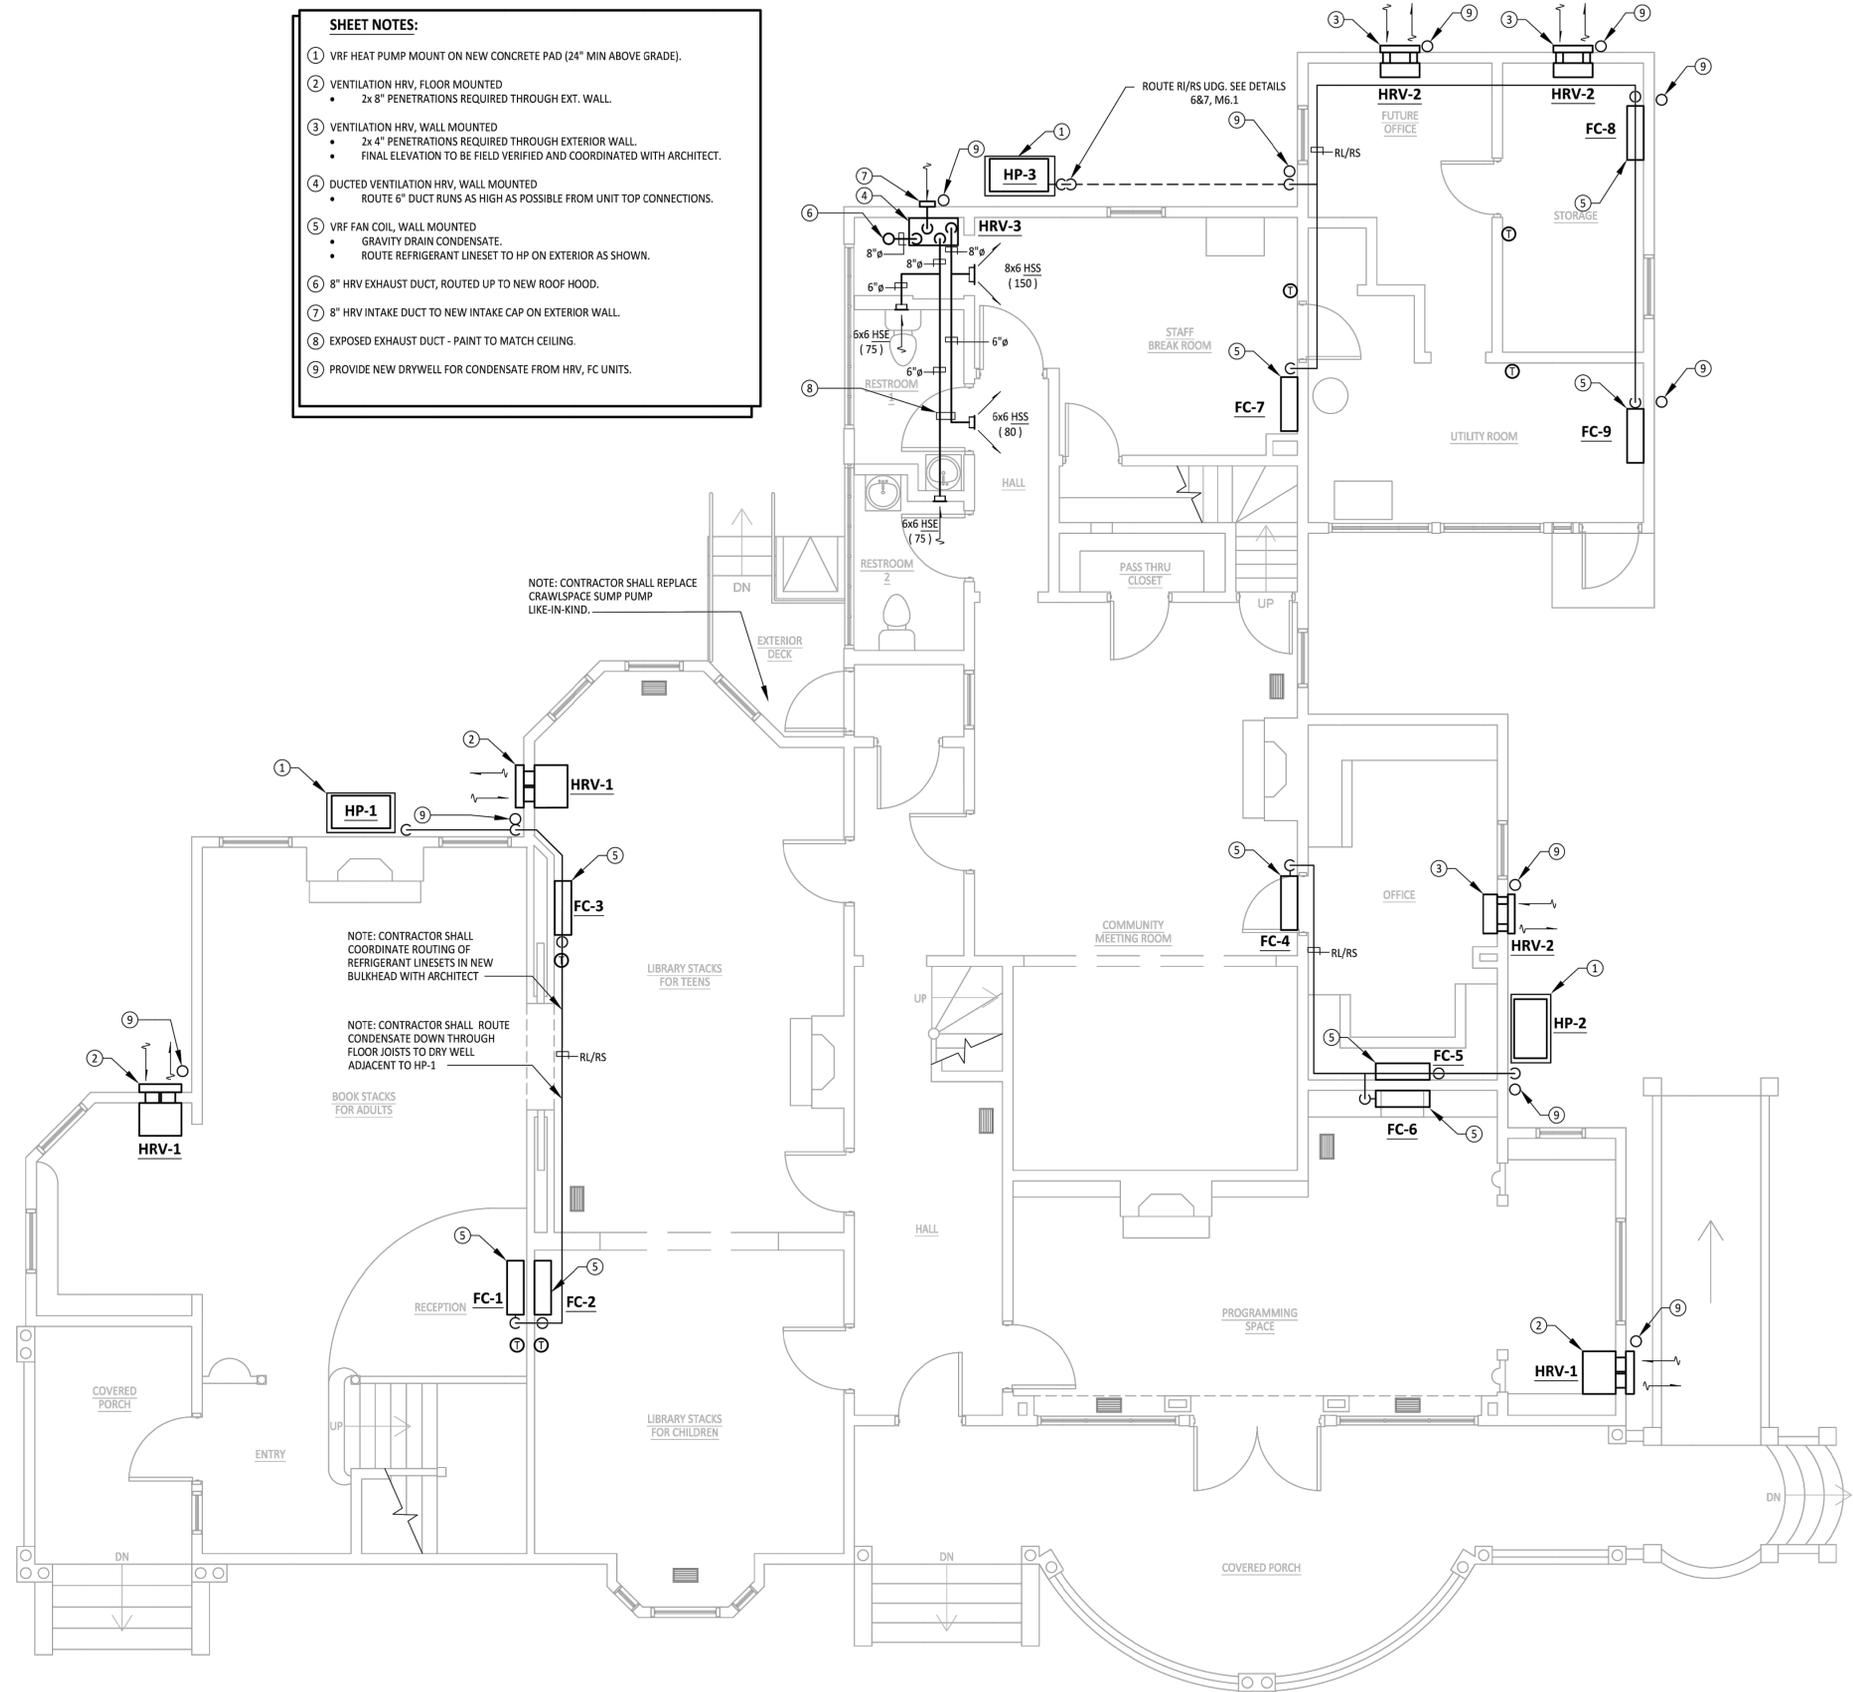
LIBRARY - FLOOR PLAN - MECHANICAL

- VRF HEAT PUMP MOUNT ON NEW CONCRETE PAD (24" MIN ABOVE GRADE).
- VENTILATION HRV, FLOOR MOUNTED
 - 2x 8" PENETRATIONS REQUIRED THROUGH EXT. WALL.
- VENTILATION HRV, WALL MOUNTED
 - 2x 4" PENETRATIONS REQUIRED THROUGH EXTERIOR WALL.
 - FINAL ELEVATION TO BE FIELD VERIFIED AND COORDINATED WITH ARCHITECT.
- DUCTED VENTILATION HRV, WALL MOUNTED
 - ROUTE 6" DUCT RUNS AS HIGH AS POSSIBLE FROM UNIT TOP CONNECTIONS.
- VRF FAN COIL, WALL MOUNTED
 - GRAVITY DRAIN CONDENSATE.
 - ROUTE REFRIGERANT LINESET TO HP ON EXTERIOR AS SHOWN.
- 8" HRV EXHAUST DUCT, ROUTED UP TO NEW ROOF HOOD.
- 8" HRV INTAKE DUCT TO NEW INTAKE CAP ON EXTERIOR WALL.
- EXPOSED EXHAUST DUCT - PAINT TO MATCH CEILING.
- PROVIDE NEW DRYWELL FOR CONDENSATE FROM HRV, FC UNITS.
