FINAL
ENVIRONMENTAL IMPACT REPORT
GENERAL PLAN AMENDMENT
FOR THE
LAGUNA SBCA OFFICE PARK
DEVELOPMENT
BASE MAP #17

MARCH 1983

County of Monterey Planning Department

Scott Lefaver, A.I.-C.P.

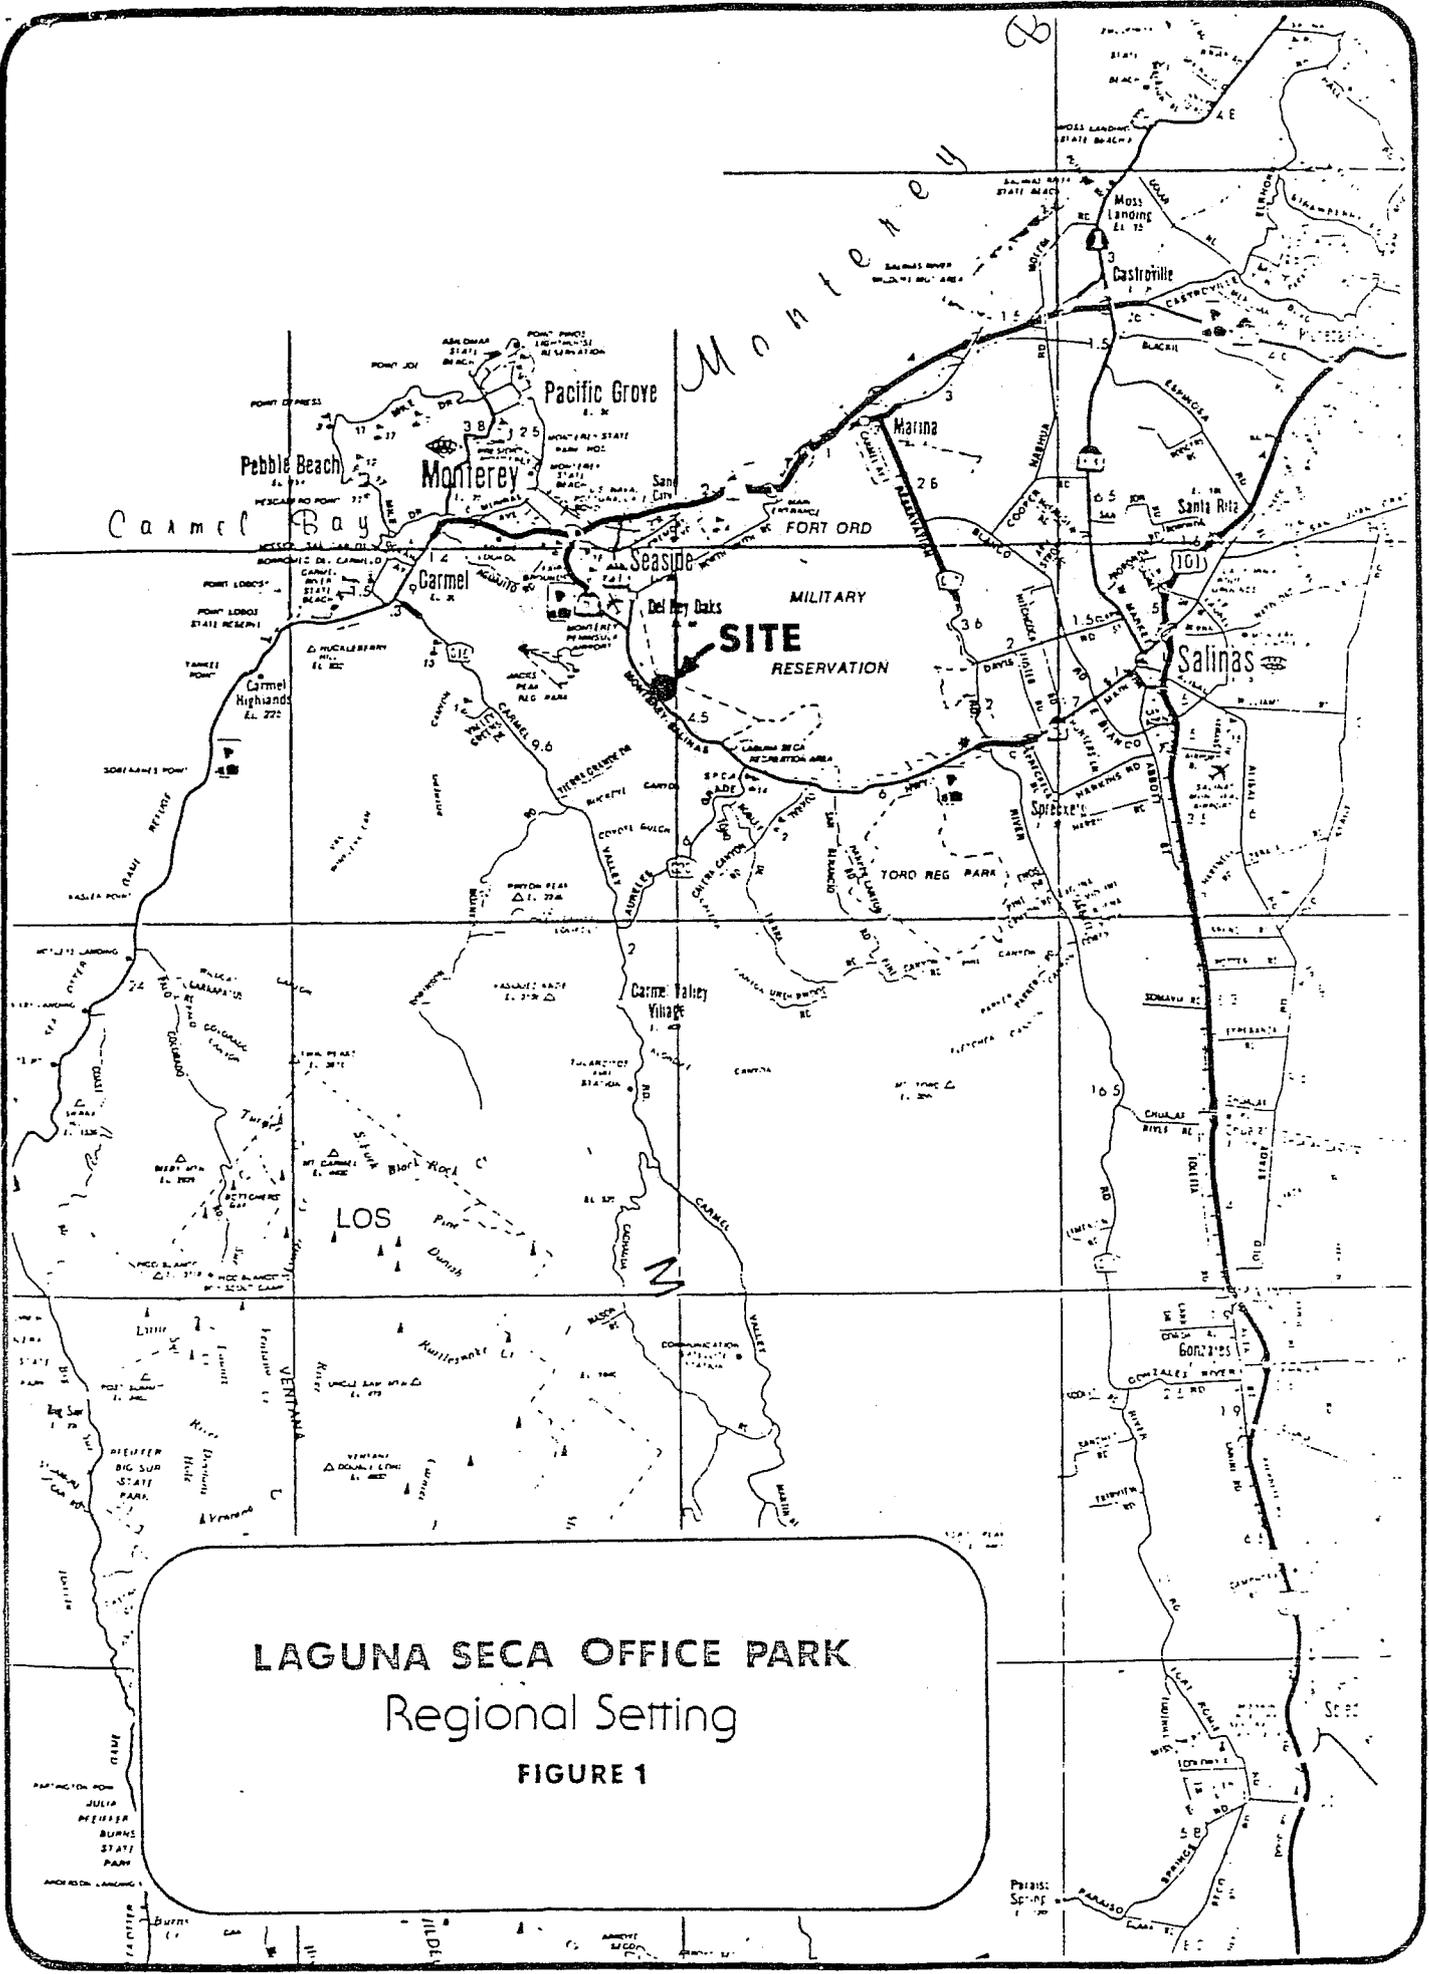
LAGUNA SECA OFFICE PARK
 Regional Setting
FIGURE 1

The proposed Office Park is adjacent to the Laguna Seca Ranch. The regional location is illustrated in Figure 1.

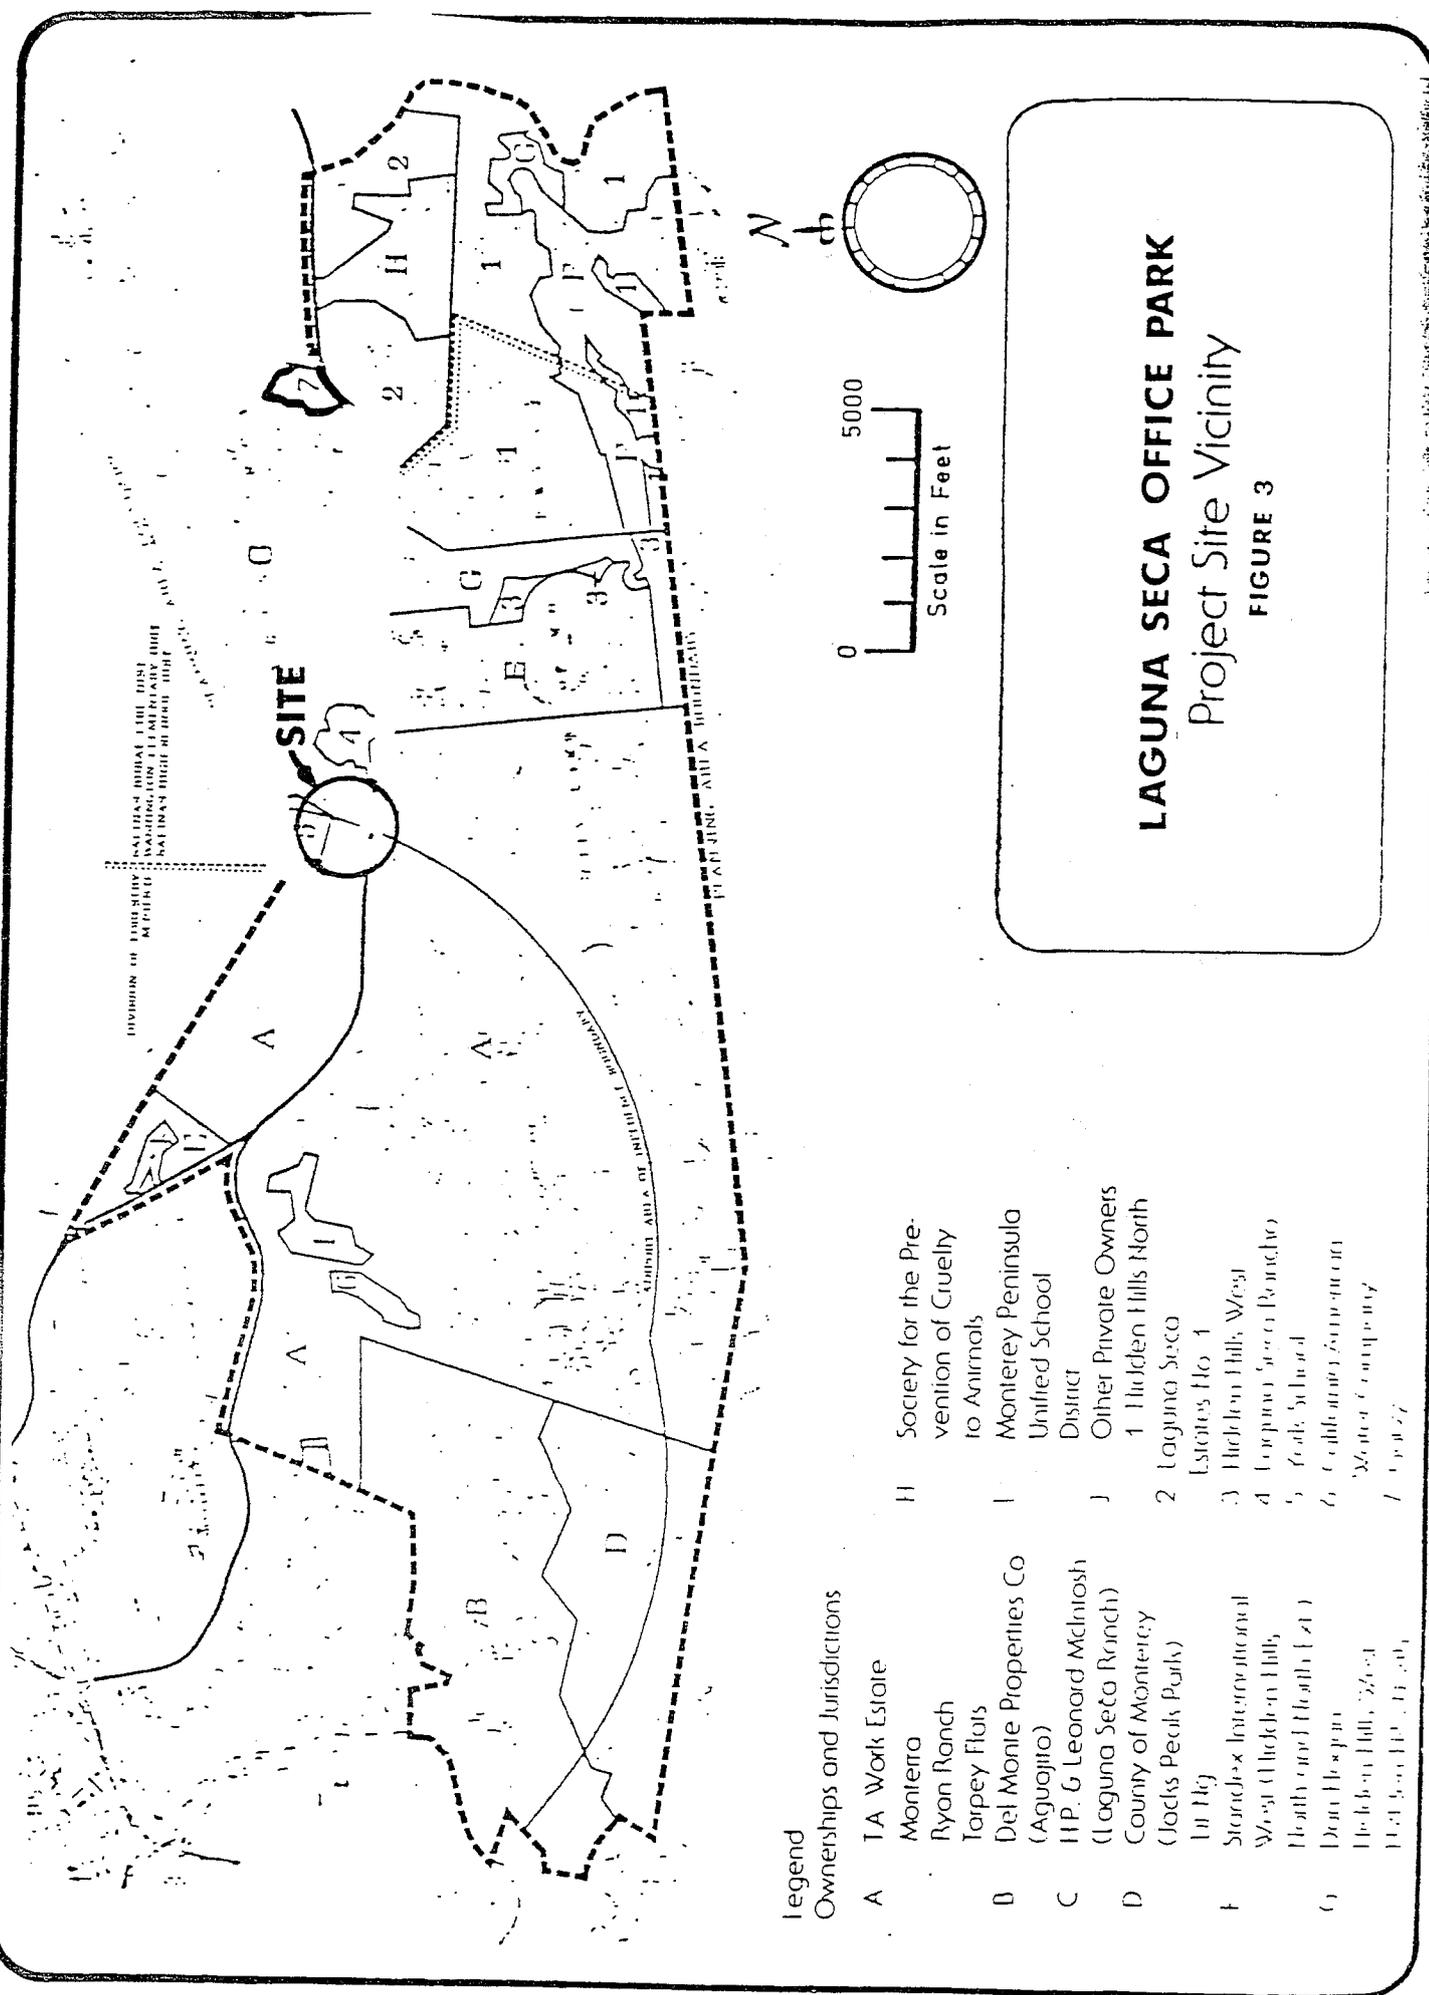
LAGUNA SECA OFFICE PARK
 Project Site Vicinity
FIGURE 3

- Legend**
Ownerships and Jurisdictions
- A T.A. Work Estate
 Monterro
 Ryan Ranch
 Tarpey Flats
 - B Del Monte Properties Co
 (Aguajito)
 - C H.P. G. Leonard McIntosh
 (Laguna Seca Ranch)
 County of Monterey
 (Locks Pecels Park)
 Hill Hig
 - D Strachan International
 West (Hidden Hills)
 Health and Health East
 - E Don Hespan
 Hidden Hills West
 Hill Top (Hill Top)
 - F Society for the Prevention of Cruelty to Animals
 - G Monterey Peninsula Unified School District
 - H Other Private Owners
 1 Hidden Hills North
 2 Laguna Seca Estates Ho. 1
 3 Hidden Hills West
 4 Laguna Seca Rancho
 5 Oak School
 6 California Company
 7 West

place within the County at the present. The land holdings and neighborhood vicinity are illustrated in Figure 3 and are discussed below in Section 3, Cumulative Impacts of this Report.

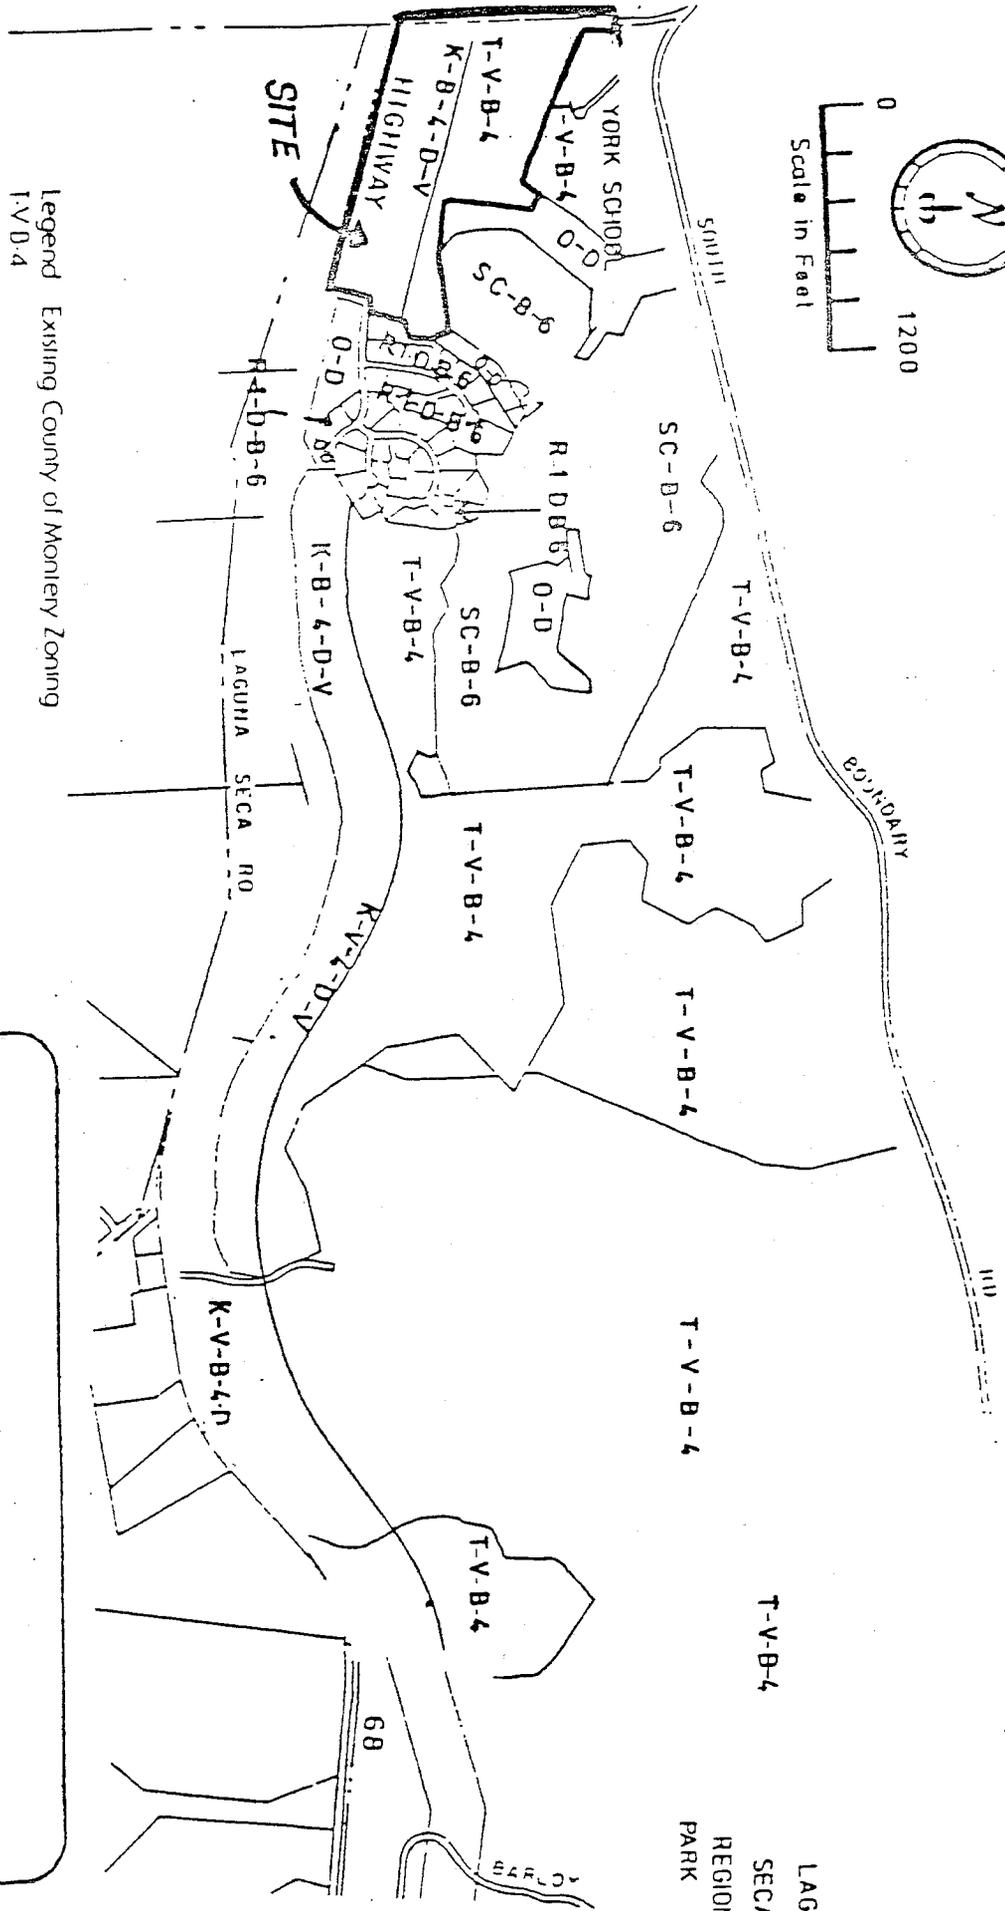
FIGURE 4

Legend Existing County of Monterey Zoning

- TVD.4
- K.VD.4D
- OD.
- SC.D.6
- R1D.D.6

LAGUNA SECA OFFICE PARK
Existing Zoning

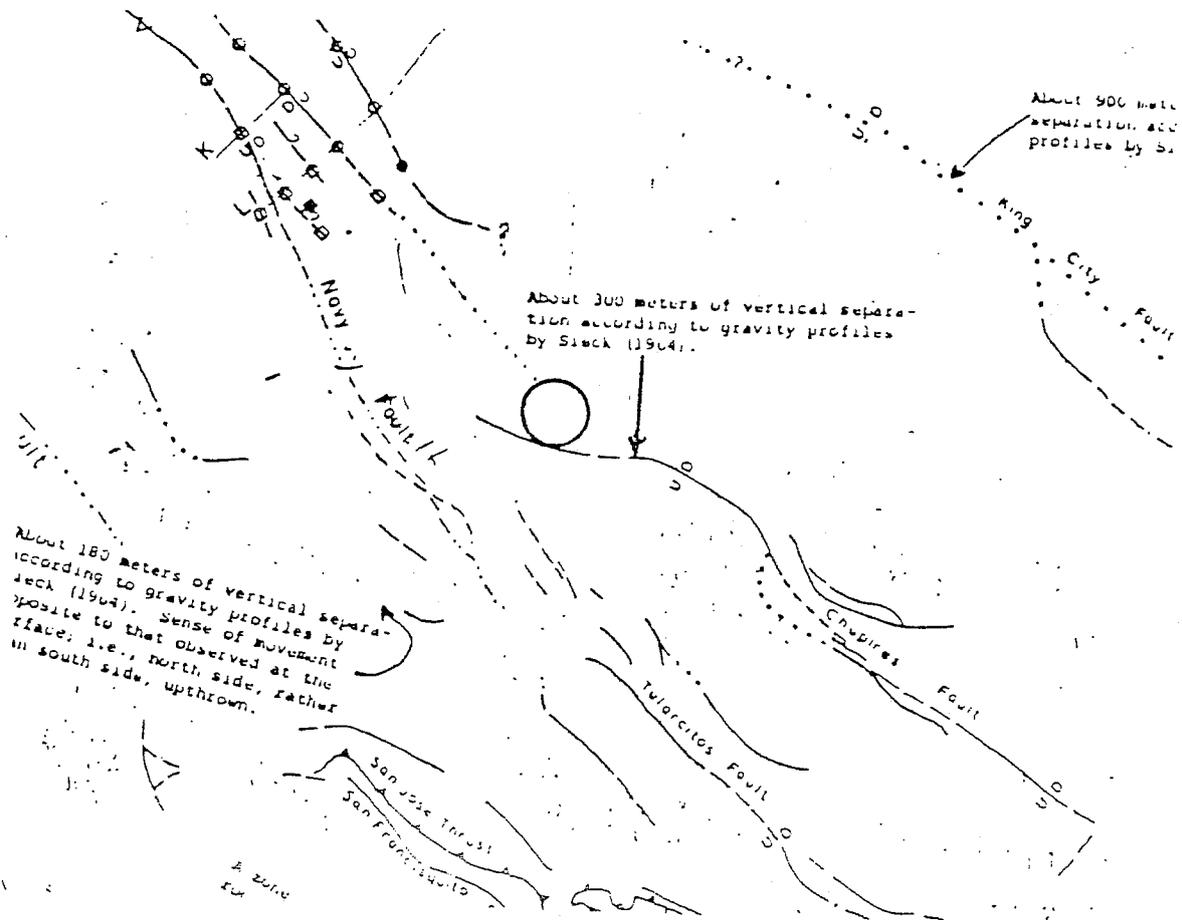
LAGUNA SECA OFFICE PARK
Local Faulting
FIGURE 6

Modified after Greene and others (1973)

Local Faulting. Many small, inactive faults lie wholly within Miocene shales and form a secondary network of faults whose orientation is nearly at right angles to the northwest/southeast trend of the larger faults. Figure 6 illustrates the local area faulting.

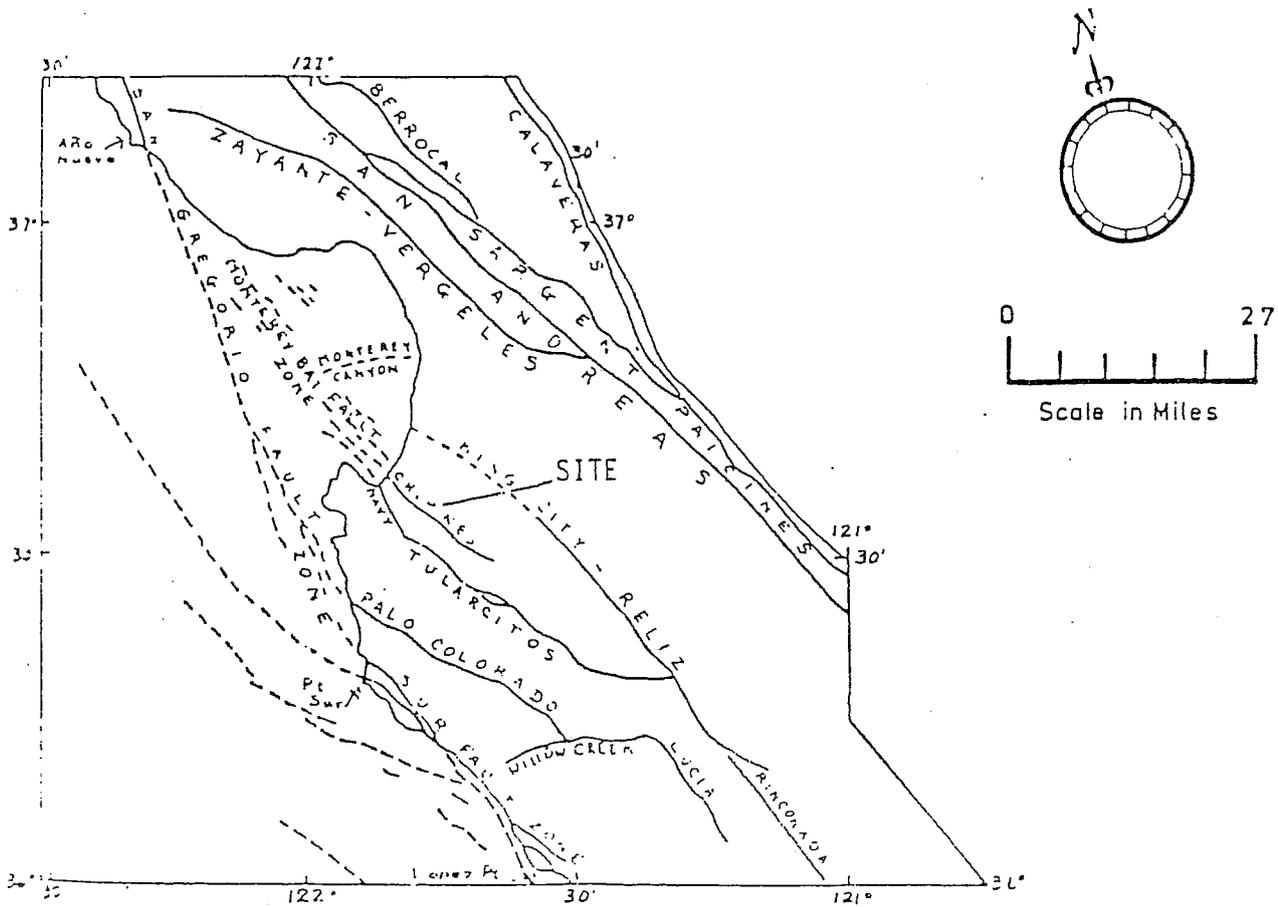
Map of Fault Zones
 Monterey Bay and Vicinity
 Modified after Buchanan Banks et al 1978

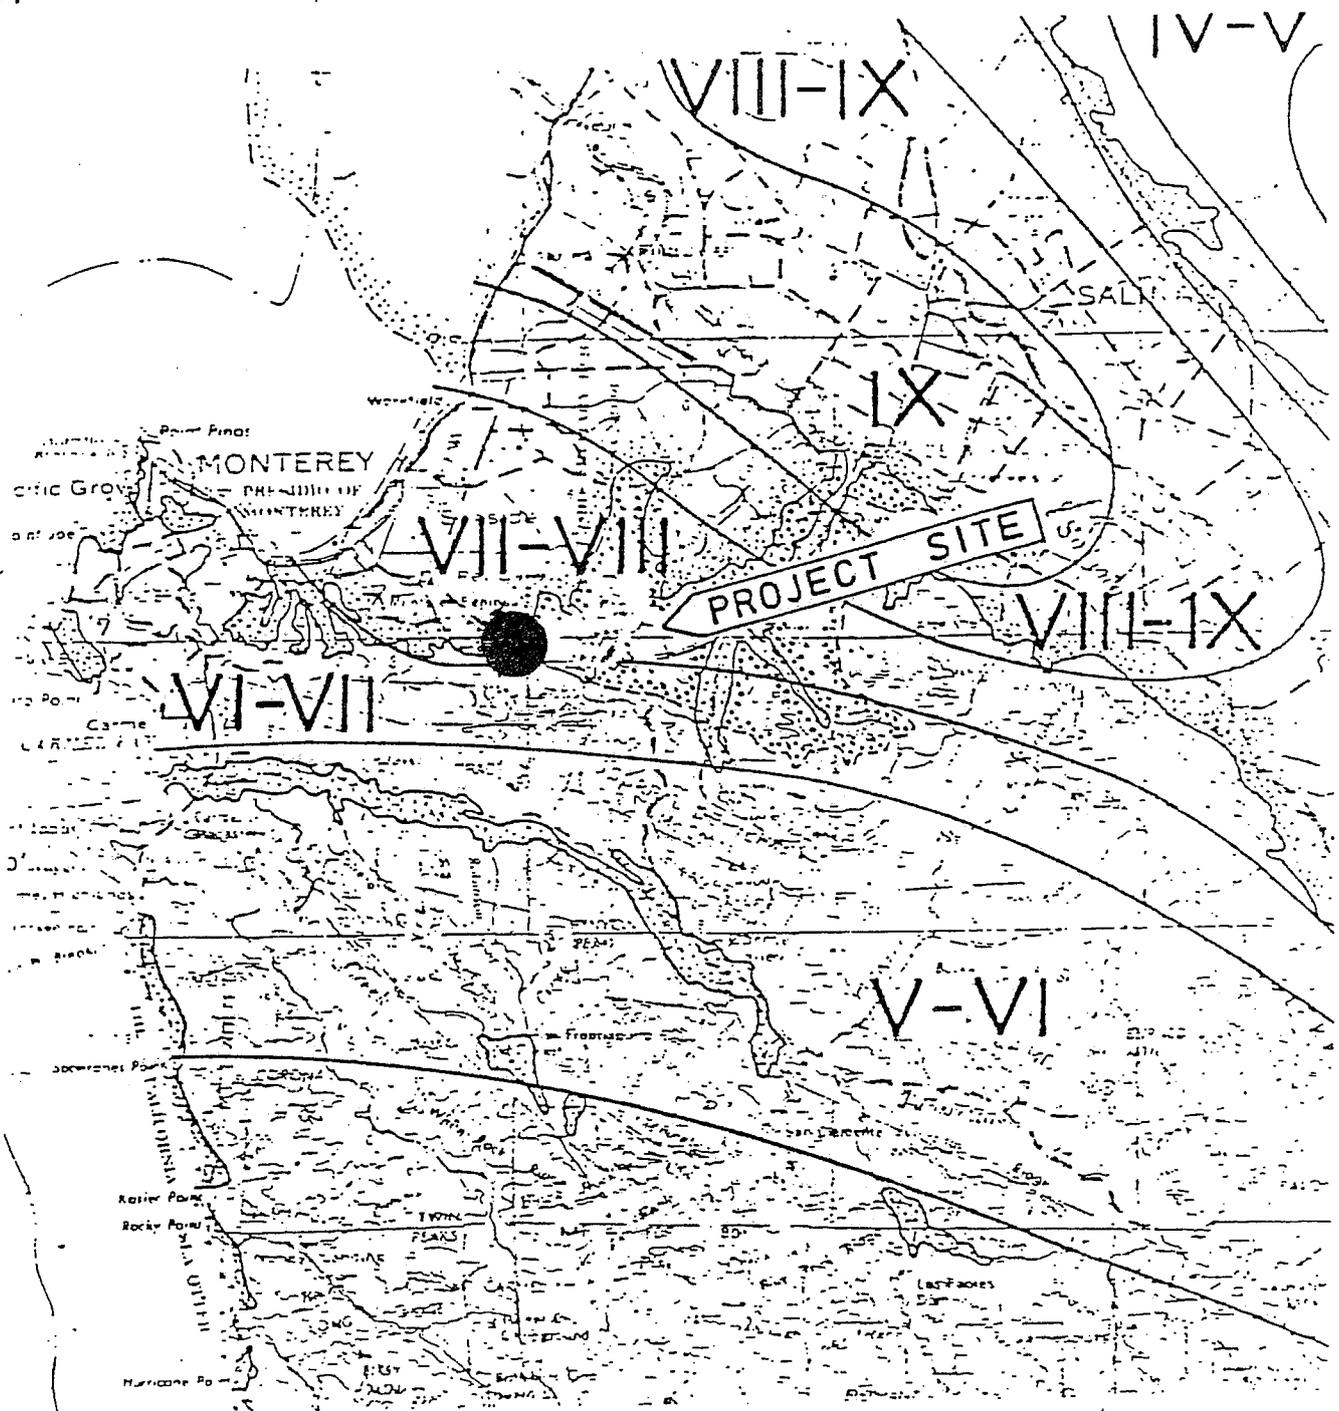
FIGURE 10

Seismic Hazard Zone VII-VIII

LAGUNA SECA OFFICE PARK
 Earthquake Intensity Zones

The proposed subdivision is located within earthquake intensity zones VI-VII on the Rossi-Forel scale. (Refer to Appendix B.) The zones are plotted, from historical ground failure, on USGS Map MF-903 (McCroery et al., 1977) and are illustrated in Figure 10.

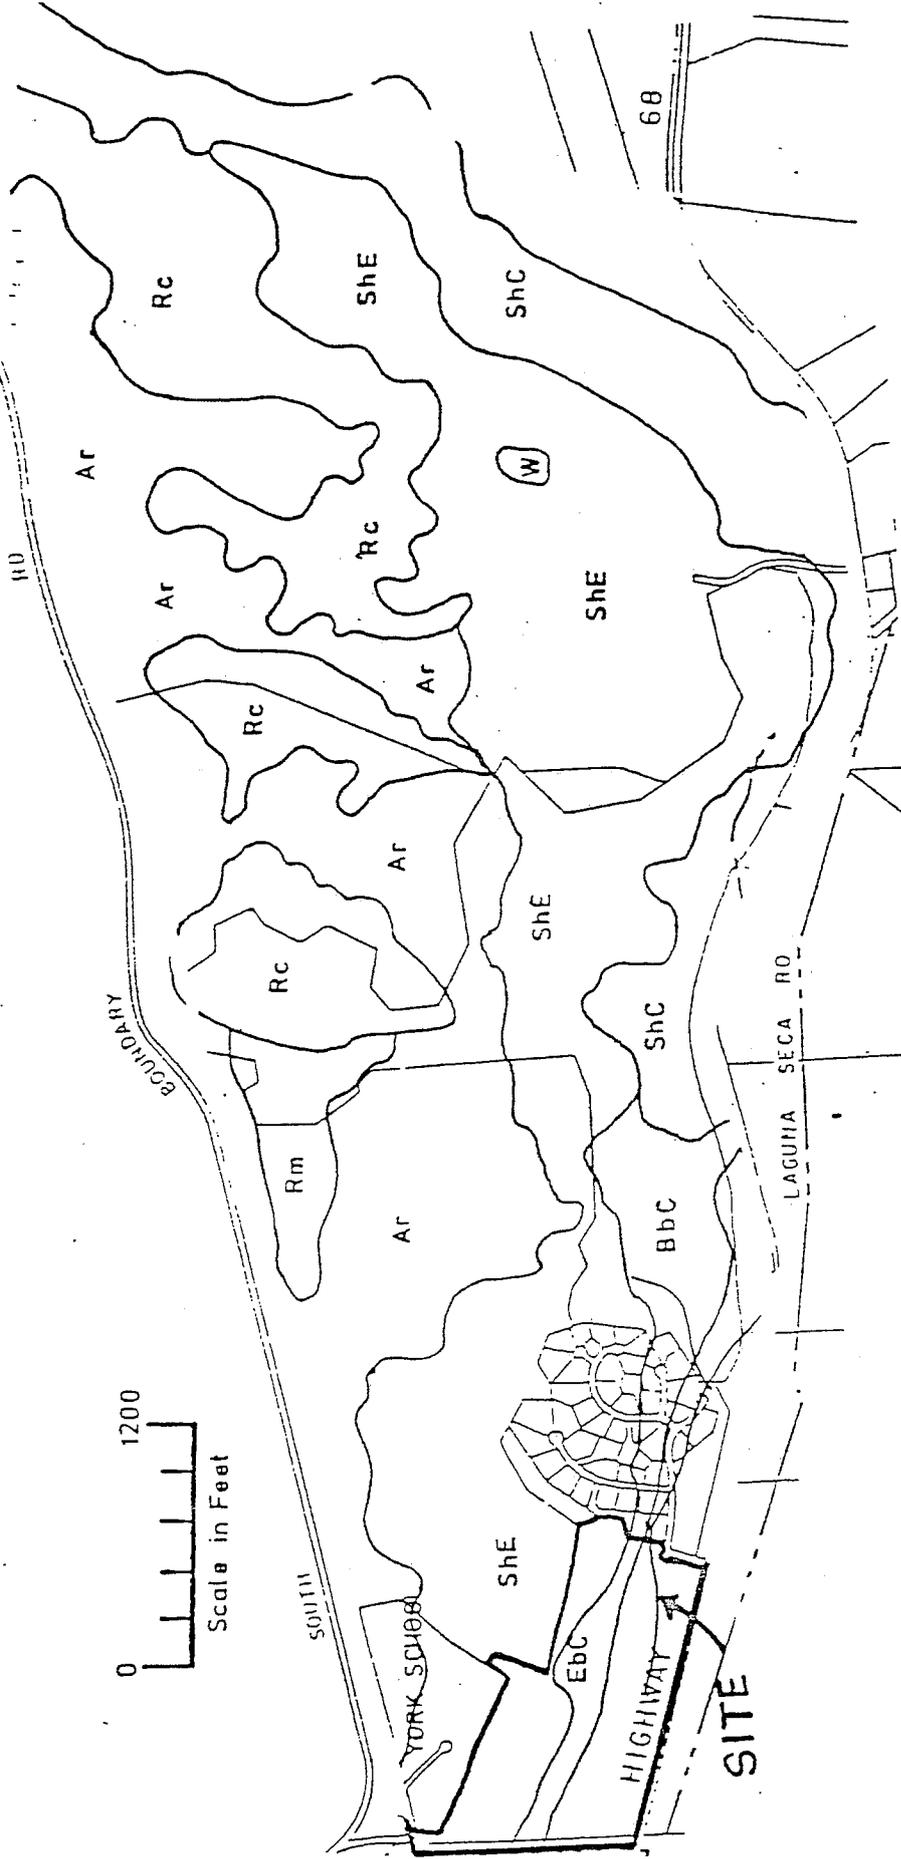
- ShC Santa Ynez fine sandy loam (2.9% slopes)
- ShE Santa Ynez fine sandy loam (15-30% slopes)
- Ebc Elder fine sandy loam
- BbC Baywood Sand
- Rc Rock outcrop Xerorthents association
- Ar Arnold Santa Ynez Complex
- Rm Pits and dumps

The soils at or near the Site are classified into the following categories according to the Soil Survey of Monterey County.

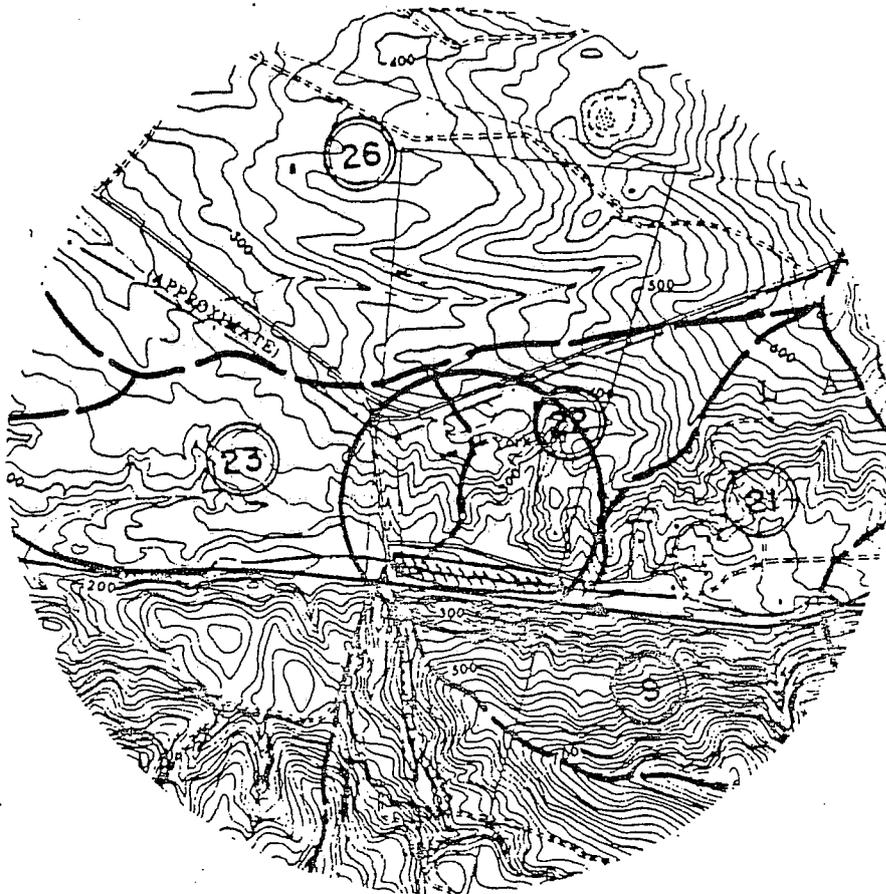
Source: Monterey County Master Drainage Plan 1977

- ① sub watershed
- ▨ flood hazard area, 100-year flood plain

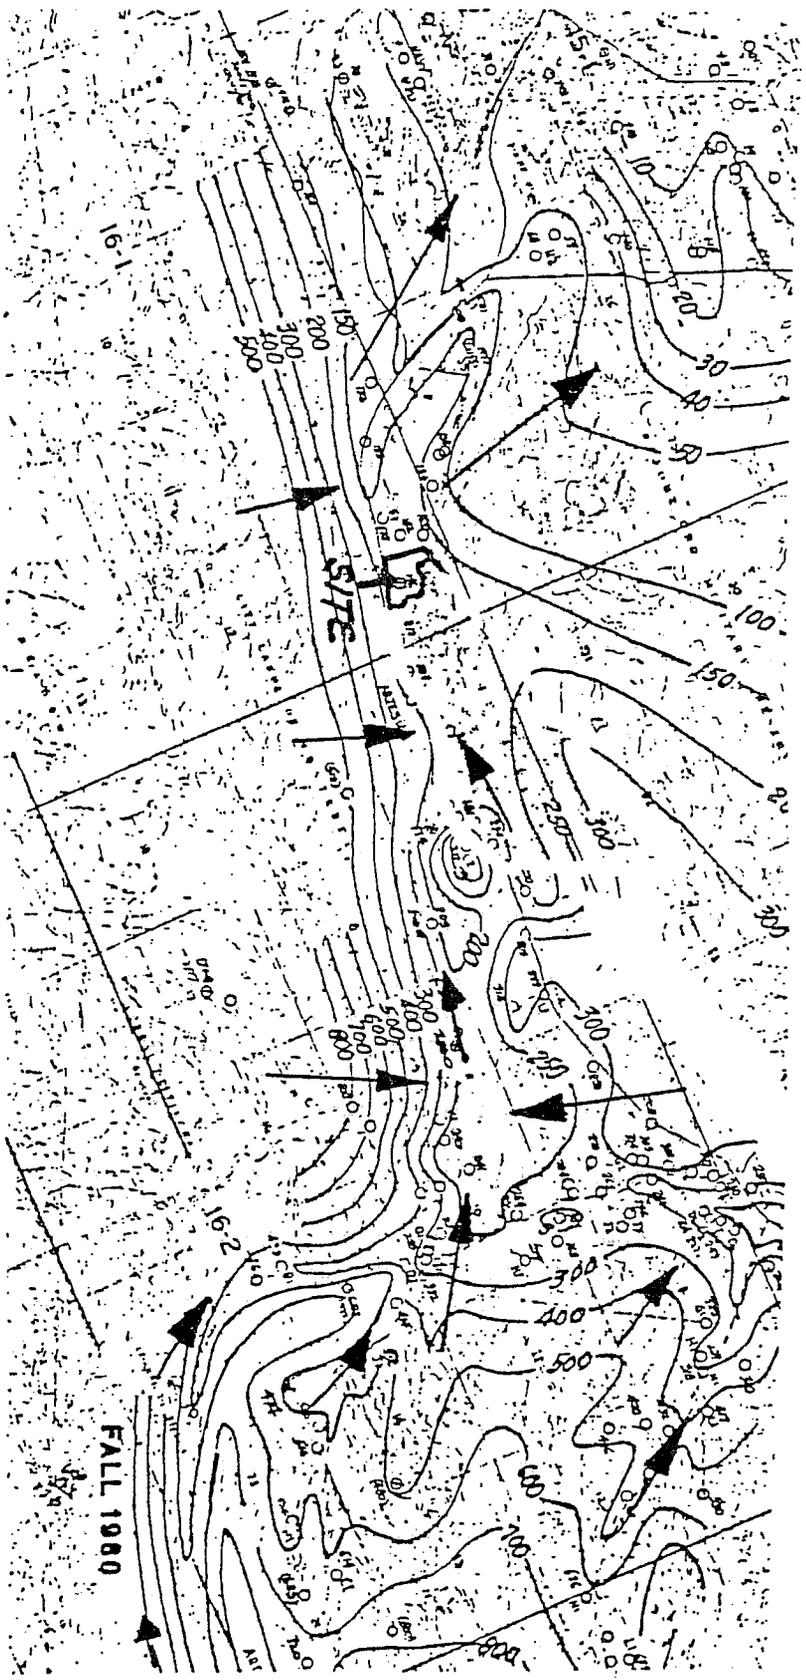
← Groundwater
 200 Groundwater Level
 20 Well Water Level

LAGUNA SECA OFFICE PARK
 Waterable Map
 FIGURE 13

Source: Richard R. Thorup, Consulting Geologist

Figure 13 is a revised water table map for Fall 1980. Covering the area from San Benancio Canyon to Seaside, the map gives well water measurements. Sources for well measurements are as follow:

Figure 13 illustrates the Water Table for Fall 1980. The contour lines are derived from the water surface elevations, which are shown plotted at the well locations. A summary of the groundwater flow is discussed below.

The 1980 Fall Water Table Map (Figure 13) contains approximately 150 measured water levels covering the entire sedimentary trough from San Benancio Canyon to Seaside and Fort Ord. This map shows that Upper Corral de Tierra and Calera Canyon water is percolating into the Laguna Seca-Hidden Hills area. The consulting groundwater geologist feels that the 1980 data, which includes additional wells located east of, but in proximity to, the Divide, confirms his interpretation of the direction of flow of the groundwater into this area.

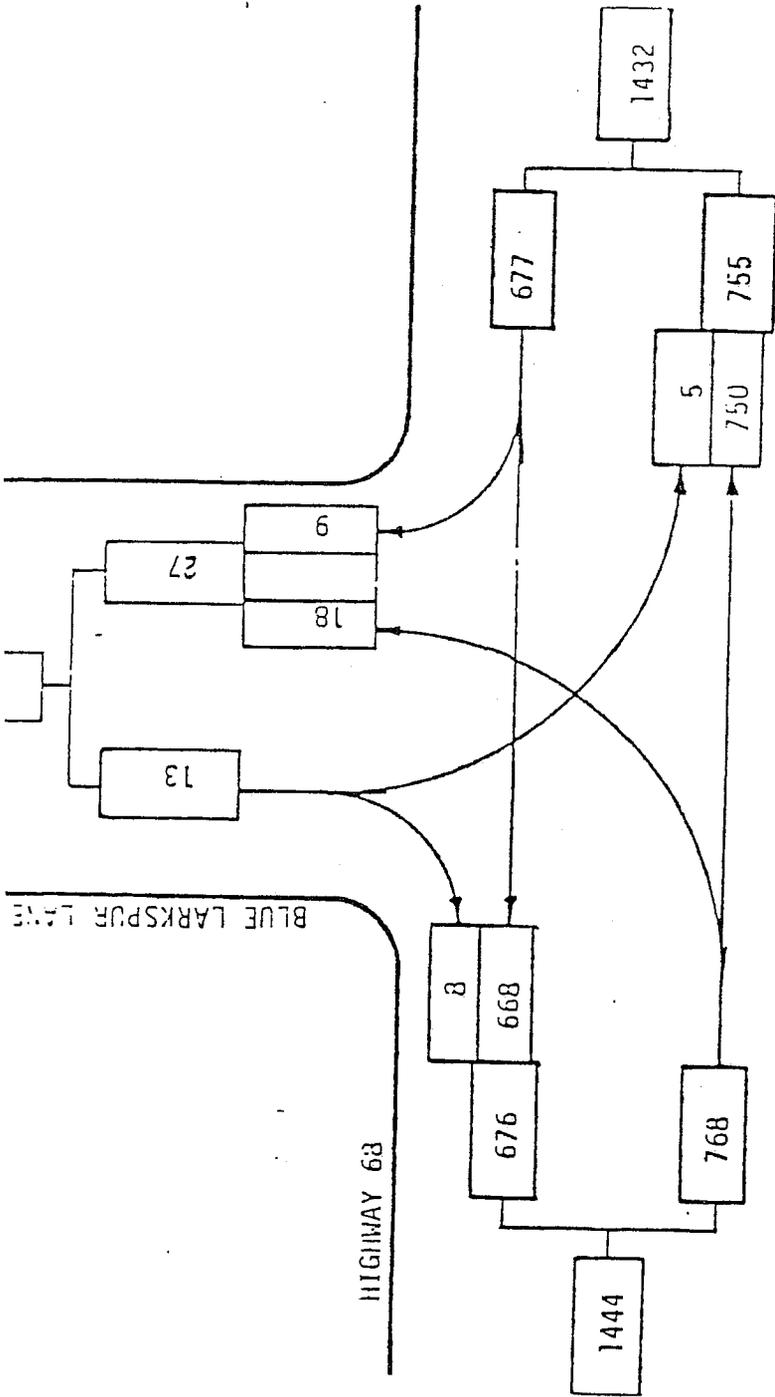
Legend
 Existing traffic counts
 ADJ - Average Daily Traffic

LAGUNA SECA OFFICE PARK
 1980 Peak Hour Volumes

Access to the project vicinity is provided by State Highway 68 (Monterey-Salinas Highway), which is a two-lane rural highway which runs in an east/west direction. It is the main traffic corridor between Salinas and Monterey. Current daily traffic volumes near the project site on Highway 68 average about 12,700 with peak hour volumes of approximately 1,250, based upon recent CalTrans counts summarized in Table 5 and illustrated in Figure 16. The peak hour level of service (L.O.S.) is D, with a volume to capacity (v/c) ratio of .67.

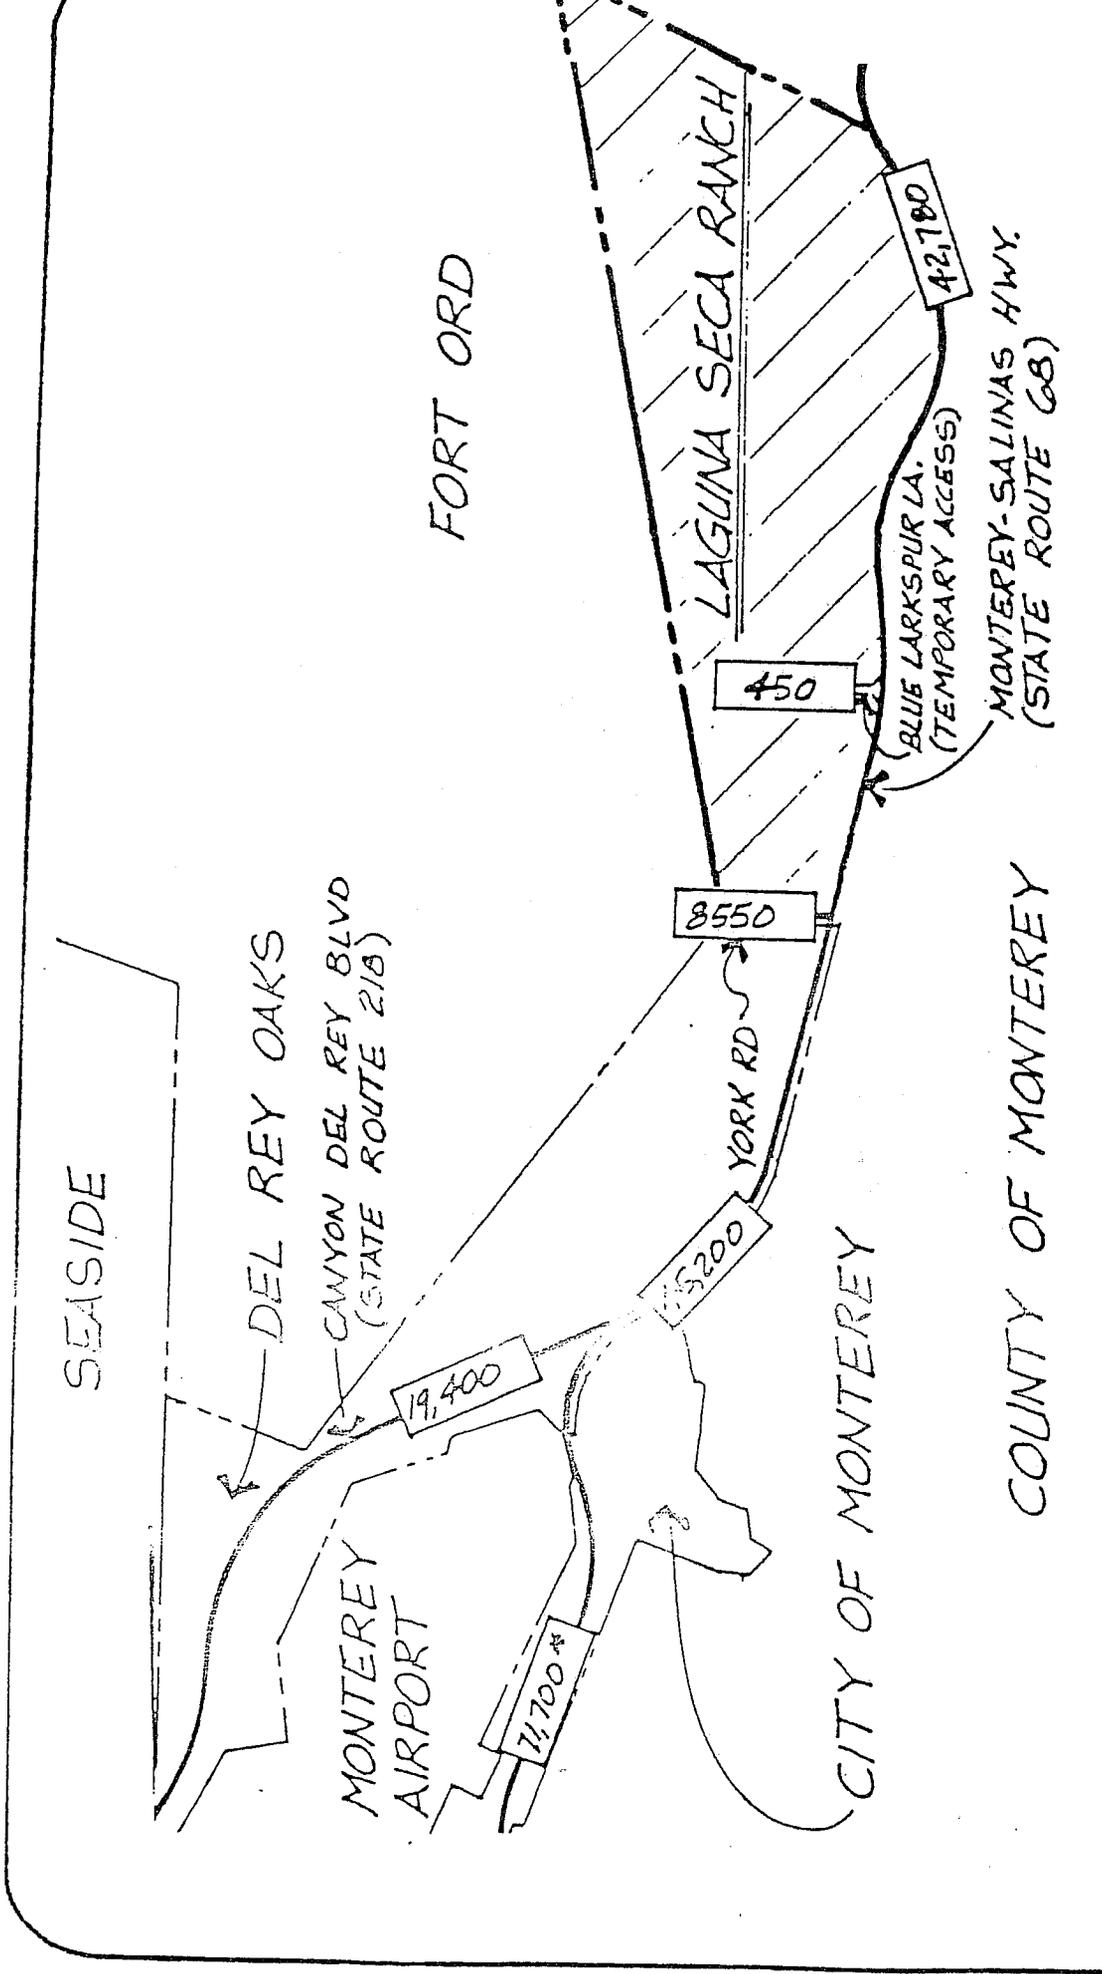
FIGURE 17

Legend
 ADT — Average Daily Traffic East of Highway 68

LAGUNA SECA OFFICE PARK
 Traffic Flow Map
 Year 2000 Volumes
 Excluding Project Traffic

Additional traffic growth on Highway 68 is expected to occur, due to regional growth, at a rate of two percent per annum. The resulting traffic volumes near the Office Park, excluding its future traffic, are shown in Figure 17.

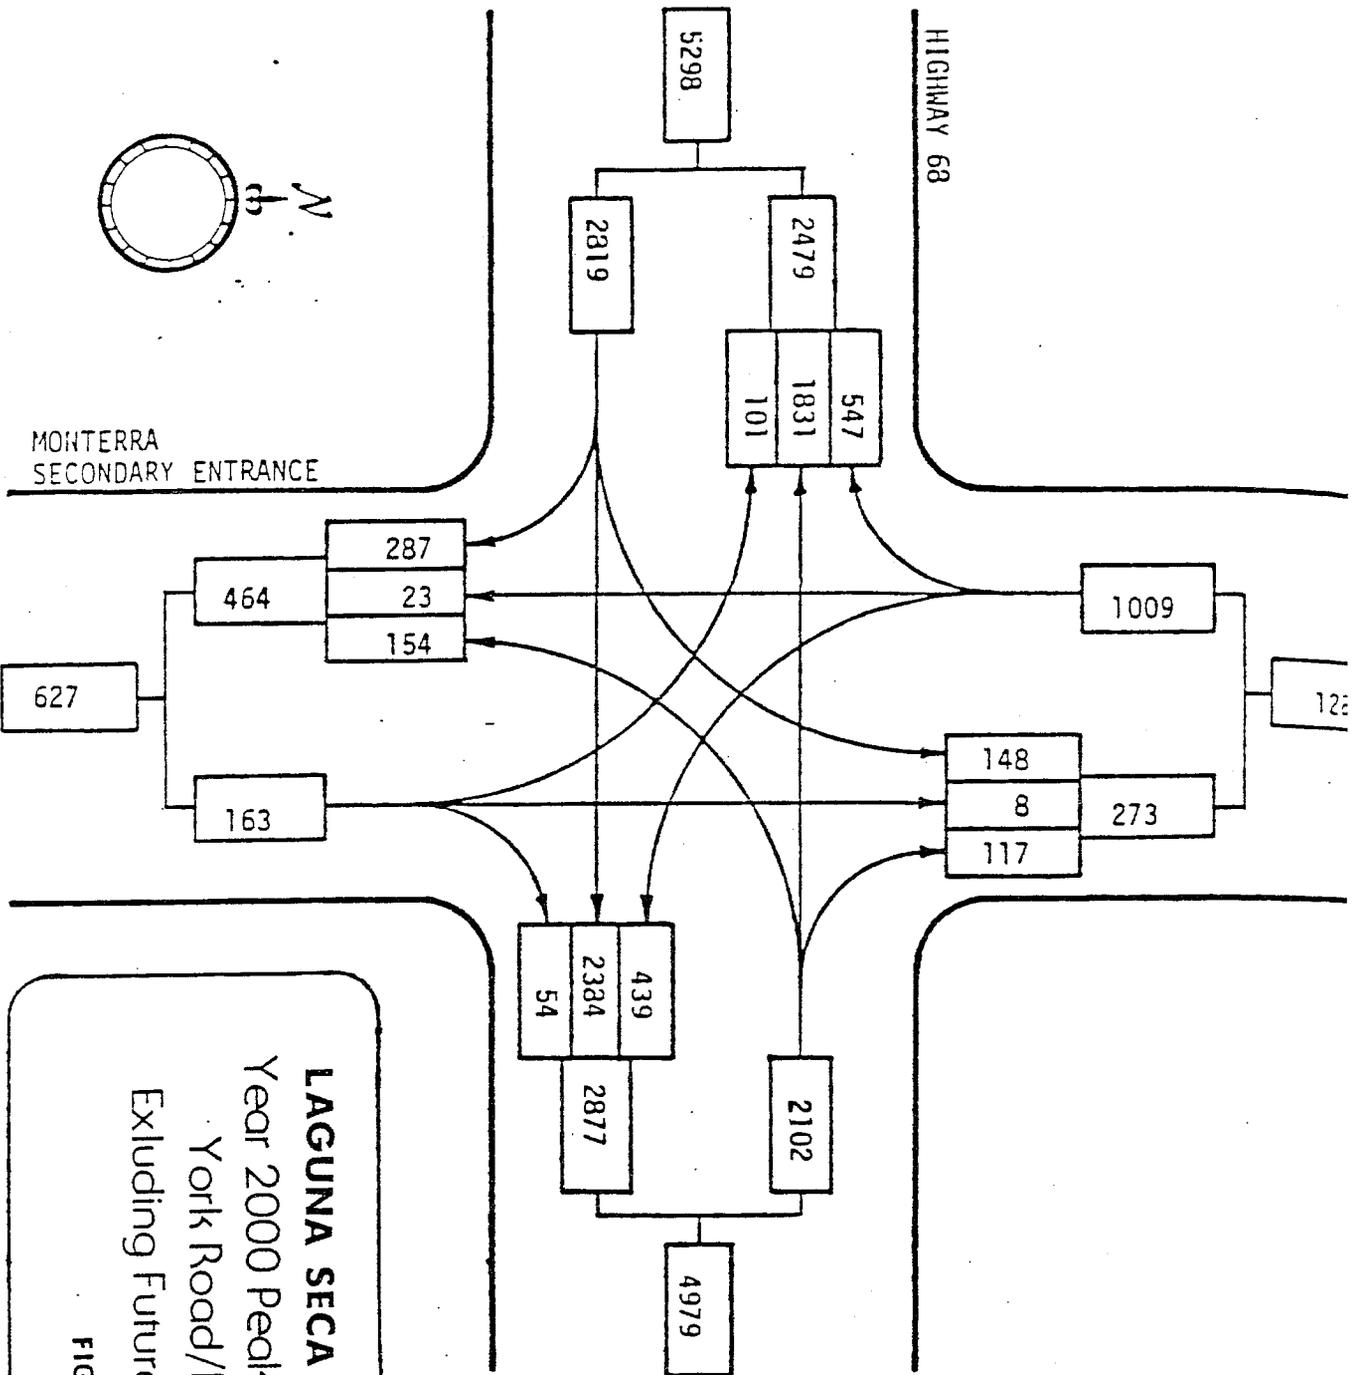
FIGURE 18

Legend
ADT - Average Daily Traffic

LAGUNA SECA OFFICE PARK
 Year 2000 Peak Hour Volumes
 York Road/Highway 68
 Excluding Future Project Traffic

Source: William Piyden, Consulting Engineers

The Ryan Ranch will utilize York Road as a major project entrance, and is expected to add 7,000 vehicle trips per day to York Road, with 1400 of these during the peak hour. The resulting turning volumes at the York Road intersection with Highway 68 are shown on Figure 18.
