FINAL
ENVIRONMENTAL IMPACT REPORT
GENERAL PLAN AMENDMENT
FOR THE
LAGUNA SBCA OFFICE PARK
DEVELOPMENT
BASE MAP #17

MARCH 1983

County of Monterey Planning Department

Scott Lefaver, A.I.-C.P.

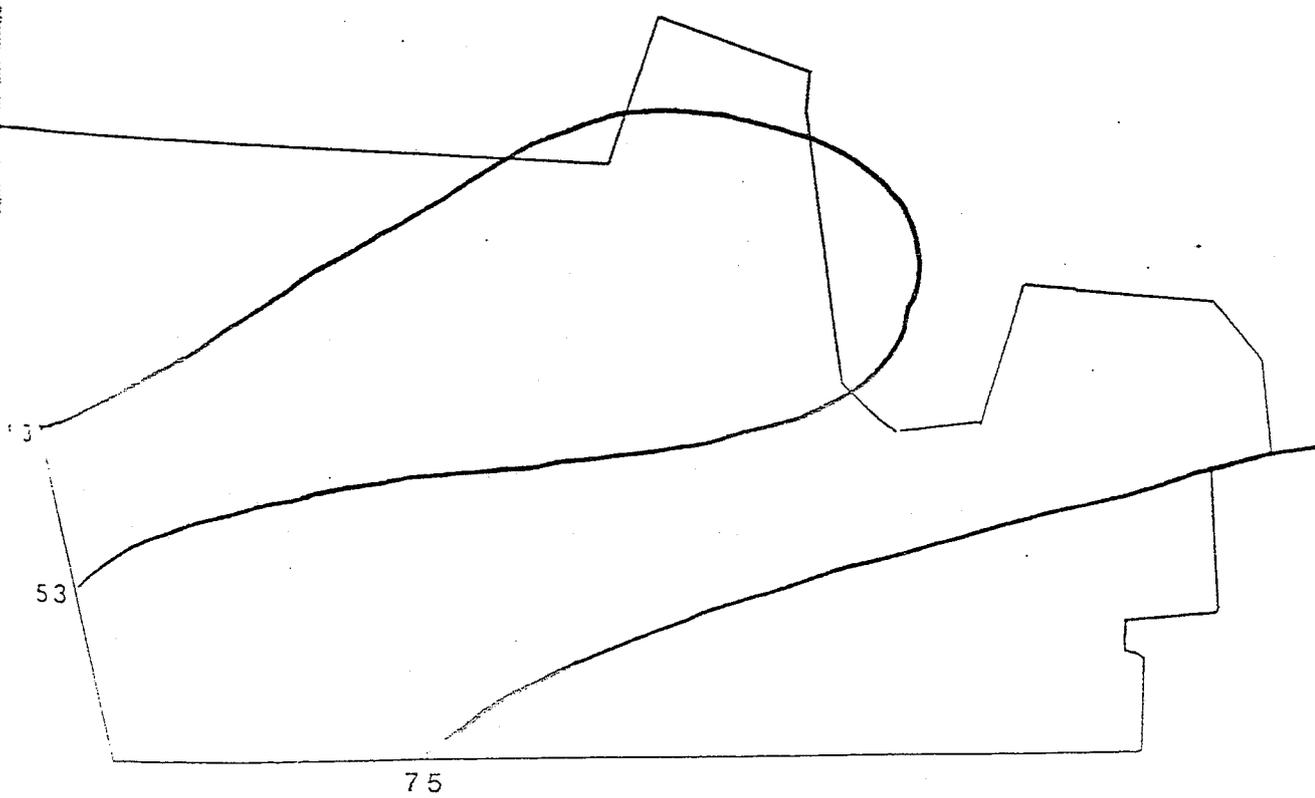
LAGUNA SECA OFFICE PARK
Existing Noise Contours
FIGURE 21

Environmental Management Consultants, Monterey, California conducted a noise survey on the entire Laguna Seca Ranch property on January 24, 25 and 26, 1981, to determine on-site noise decibel levels. A sound level meter, calibrated at 114 decibels (dbA) was used. Noise decibel levels were taken at peak traffic hours and were measured at 23 points on the property, including various building sites, elevations and proximity to Highway 68 and the Airport. The readings were measured at 15 second intervals at all locations. Table 7 summarizes the decibel measurement results for those areas around the Office Park and Figure 21 illustrates the noise contours of the Laguna Seca Office Park property. Appendix E provides a noise reading location map.

The average noise level was 57.1 decibels (dbA). The minimum reading was 43 dbA, which was taken in an area with vegetative screening and at a significant distance from any noise source. The maximum reading was 80, which occurred near Highway 68.

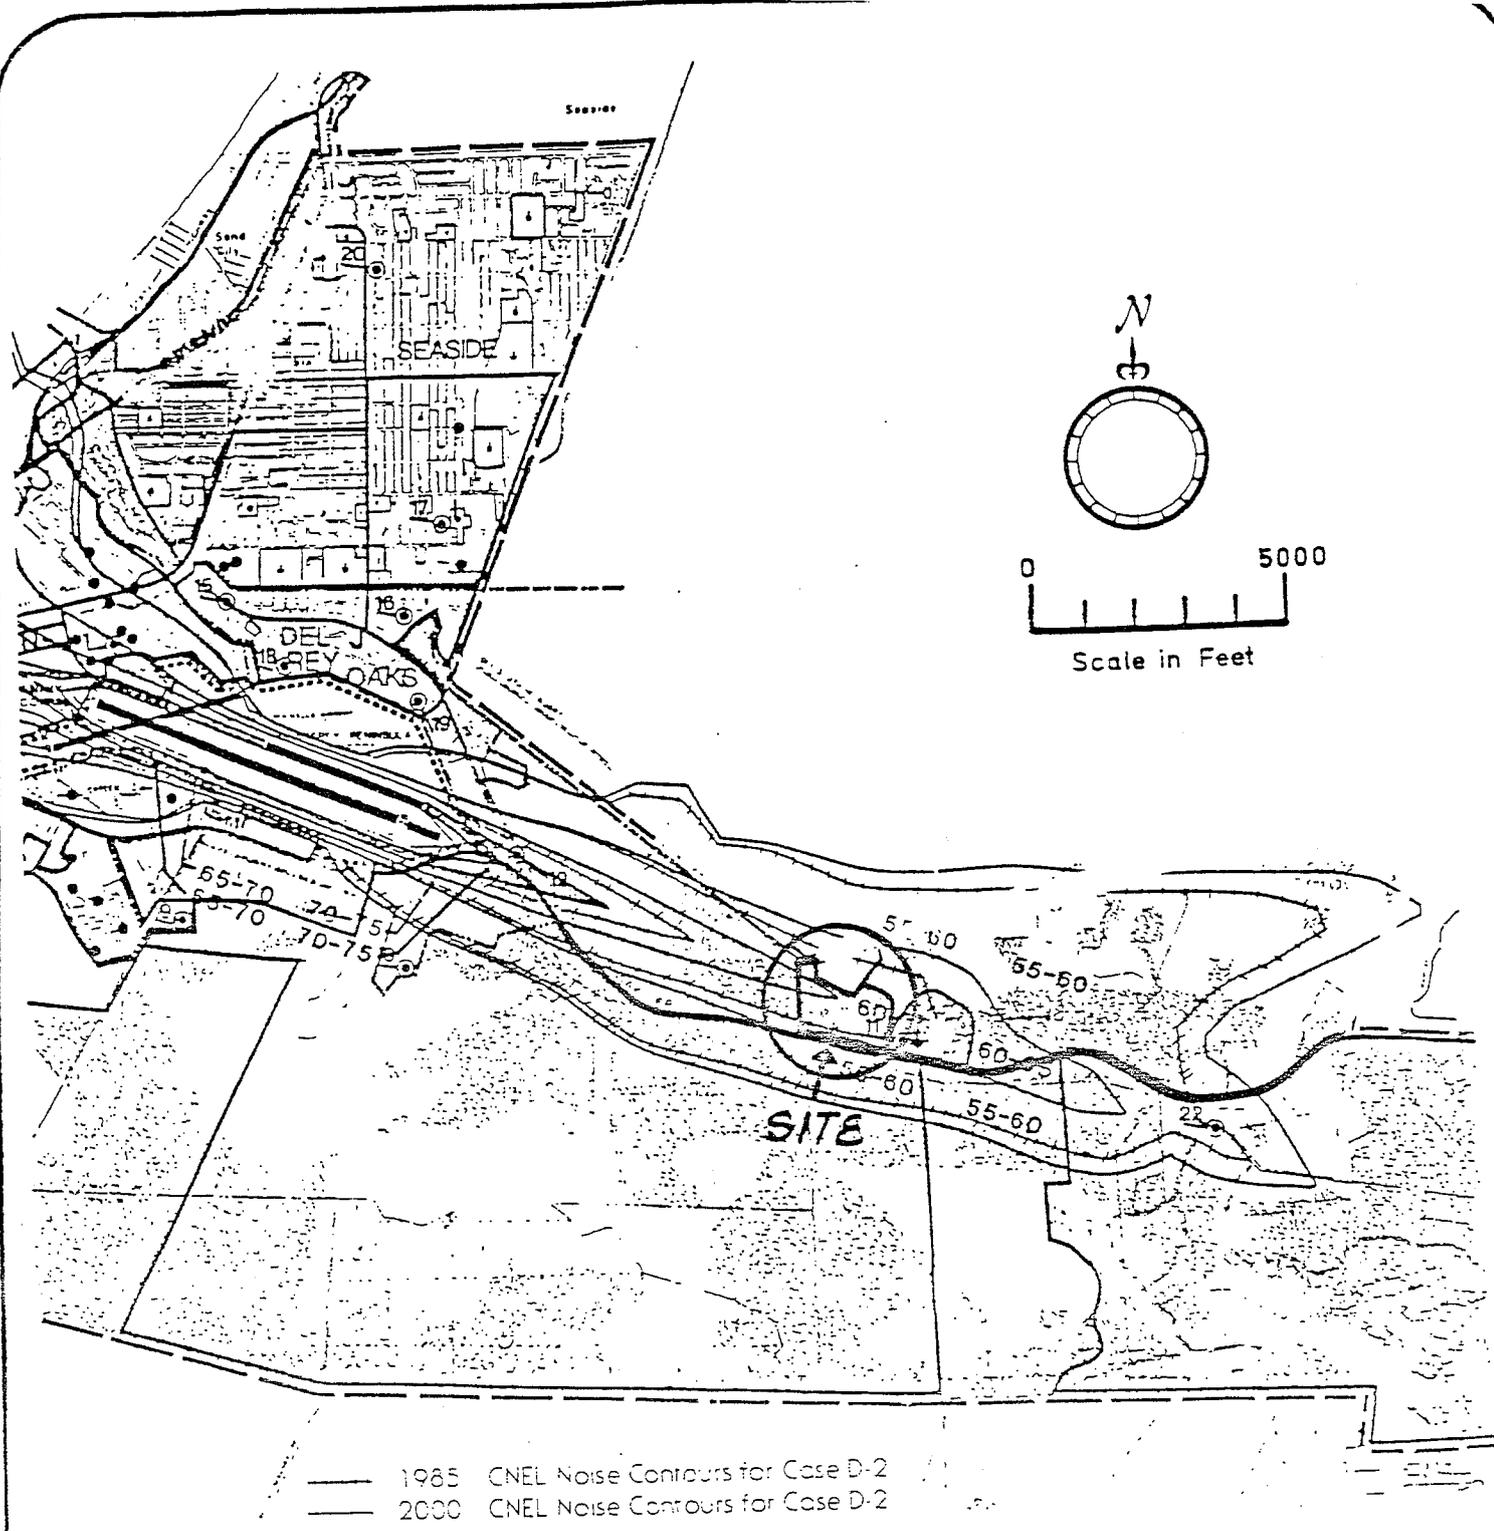
FIGURE 22

LAGUNA SECA OFFICE PARK
 Airport Future Noise Conditions

Approximately 50% of all flights arriving or departing from Monterey Peninsula Airport use the easterly flight path which passes directly over the project site. These aircraft overflights generate a great deal of noise. For the purposes of this report the following reports were consulted: The Proposed Master Plan for the Monterey Peninsula Airport (1975) and the Whisler-Patri Environmental Reconnaissance, prepared by Buonaccorsi and Associates (1975). In both reports, noise exposure is described in decibel (dbA) levels, using the CNEL system. The Whisler-Patri study depicts higher noise levels on the project site than does the airport Master Plan, with the 65 dbA CNEL countour impacting a larger portion of the site. Accordingly, the 60 CNEL contour in the Whisler-Patri report covers a larger area of the site than it does in the Airport Master Plan. (Figure 22 depicts the future noise contours on the site, according to the study conducted by Buonaccorsi and Associates.)

yet been adopted; however, data from the ANCLUC Study can be consulted. Projections of CNEL noise contours for years 1985 and 2000 recently have been developed as part of the ANCLUC study for the selected aircraft operational alternative D2 (the extended runway B case), as shown on Figure 22.

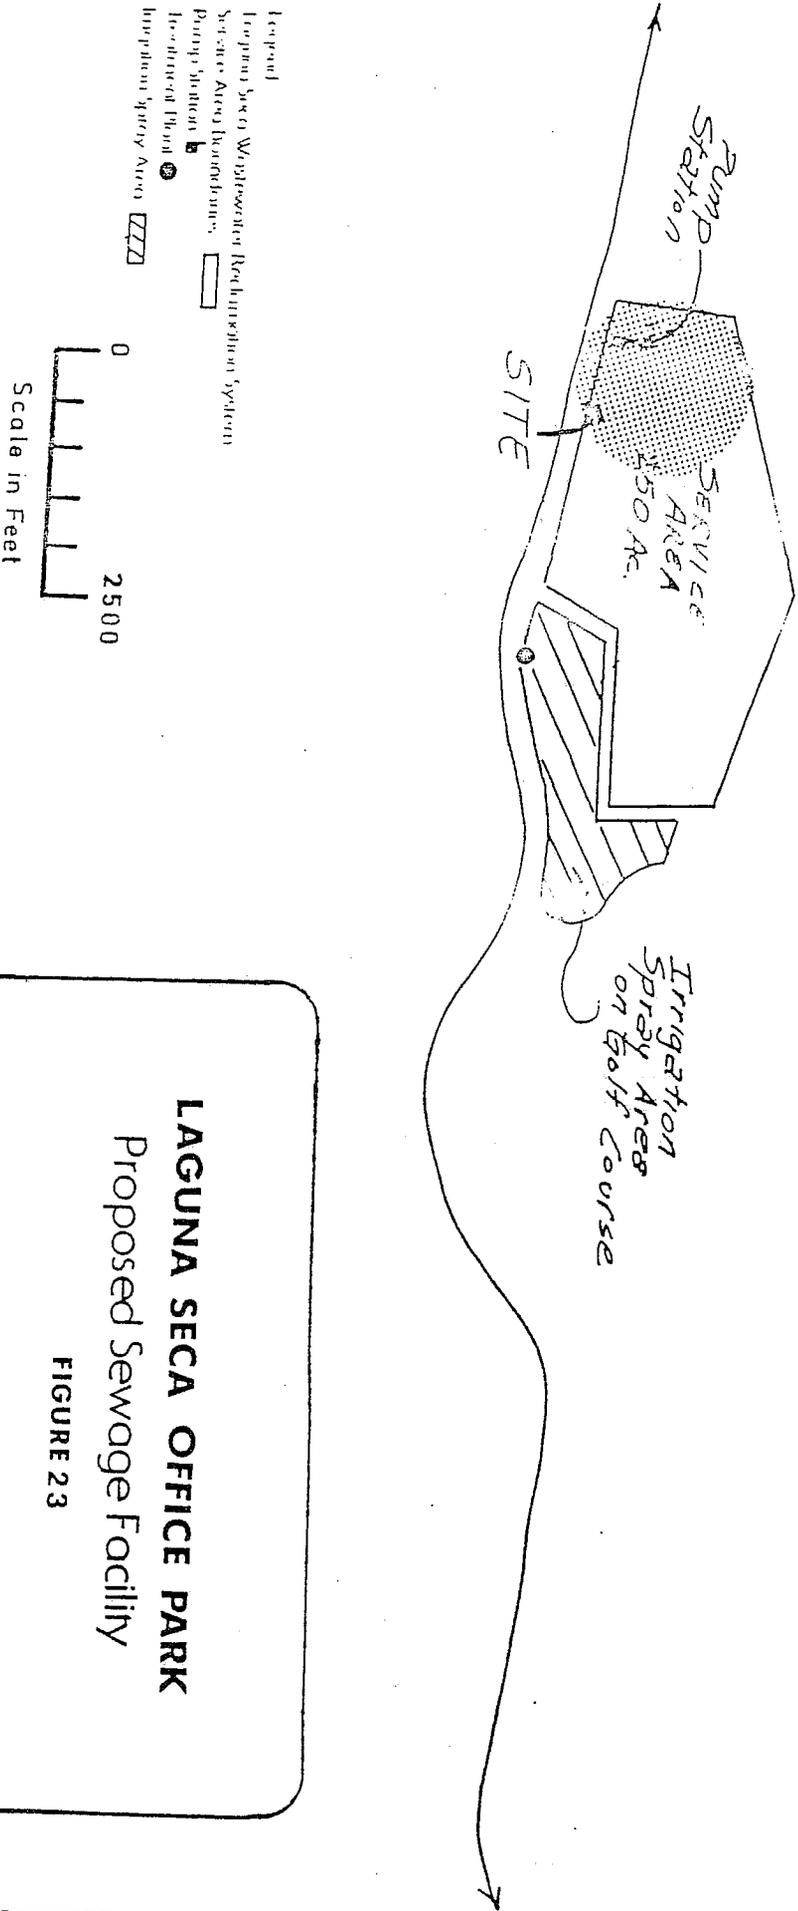
LAGUNA SECA OFFICE PARK
 Proposed Sewage Facility
FIGURE 23

Source: Bestor Engineers, Inc

The system would require a formal application to the Board of Supervisors to expand County Service Area #10. The proposed system is detailed in Appendix F of this document and is illustrated in Figure 23.

The sewage treatment plant would include a booster pump and lift station at the proposed Office Park development; the sewage from the Office Park and the Ranch Estates would be pumped to the secondary treatment plant location shown on Figure 23. Sewage would be treated; two storage ponds would be used to store wastewater; and eventually the blended reclaimed wastewater would be irrigated onto the existing golf course area, in the area shown on Figure 23, which is comprised of Fairways 1 through 9 and 16 through 18.

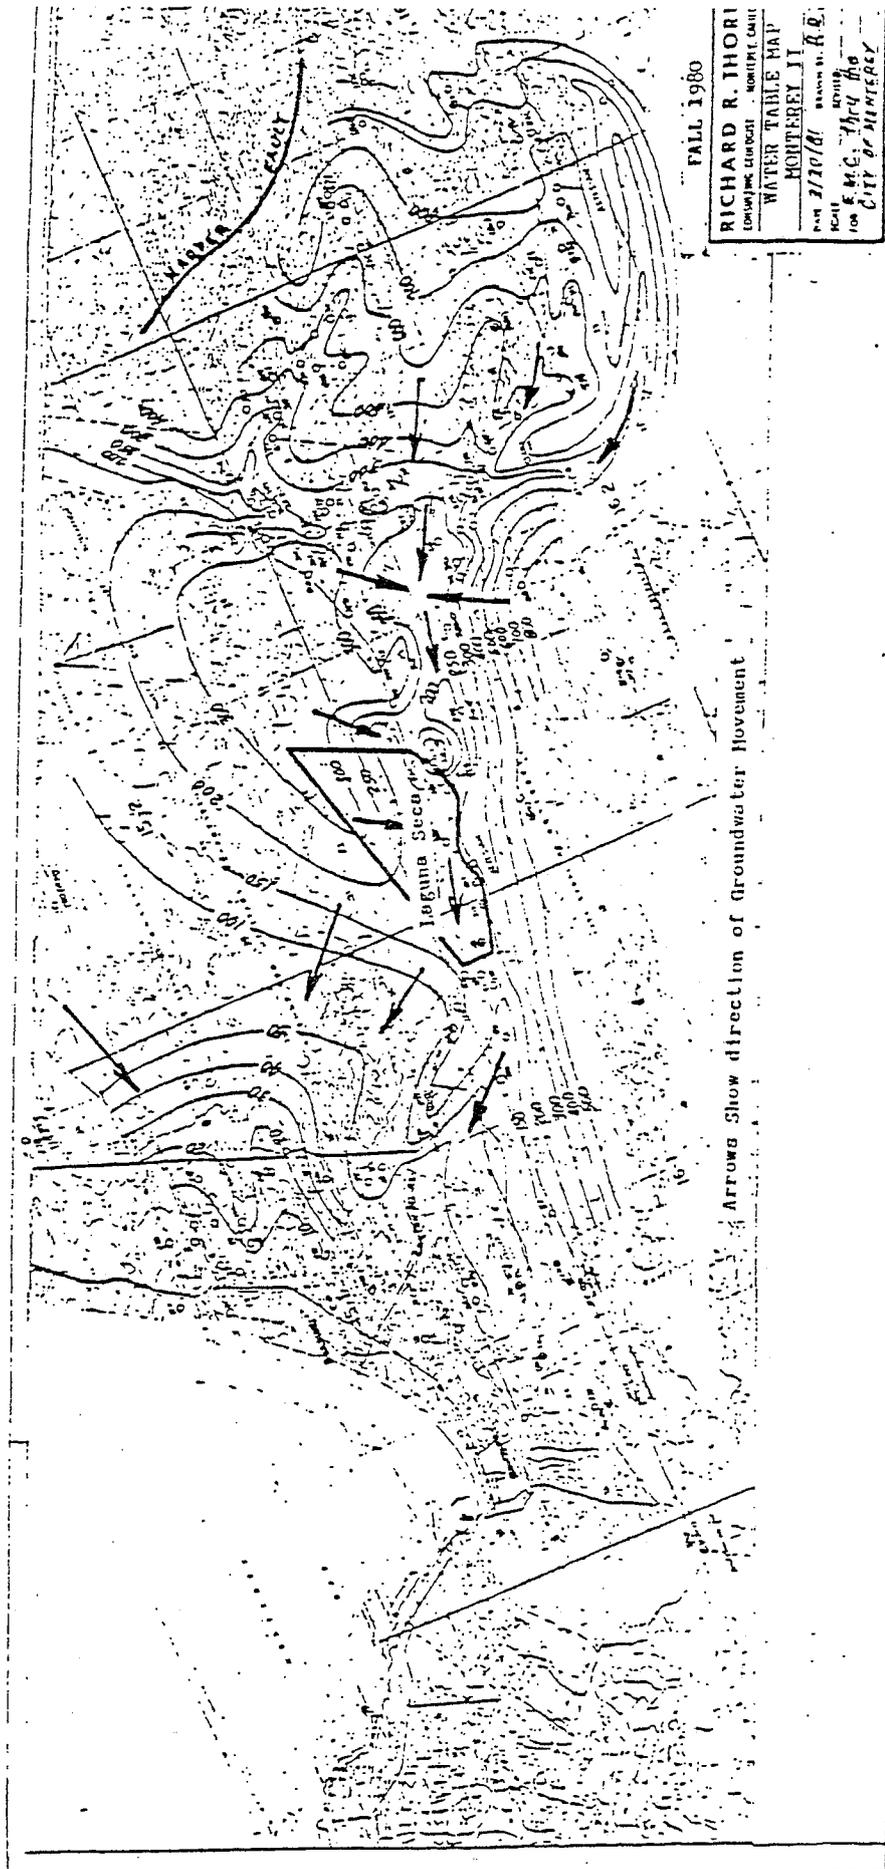
Arrows Show direction of Groundwater Movement

7. The Muir water table map covers principally the Seaside Area and Fort Ord. Unfortunately, it does not spill over in sufficient detail into the Laguna Seca and Corral de Tierra areas. Had all the measurements shown on the Thorup map been available to Muir, the 300 foot line would not have been drawn as shown. For example, a corrected surface elevation at the Laguna Seca County Park, G1 on Muir's Water Table Map, shows that the true water table elevation is 210 feet, not 305 feet as shown by Muir. Also, in February 1981.

Flood Control measured a well 3500 feet due south of G1 and recorded a water level elevation of 208 feet. Well perforations are in the Santa Margarita sandstone. These two measurements, plus others, delineate the Laguna Seca trough as extending uninterrupted from the Corral de Tierra Road, down the gradient, into Monterey and Seaside.

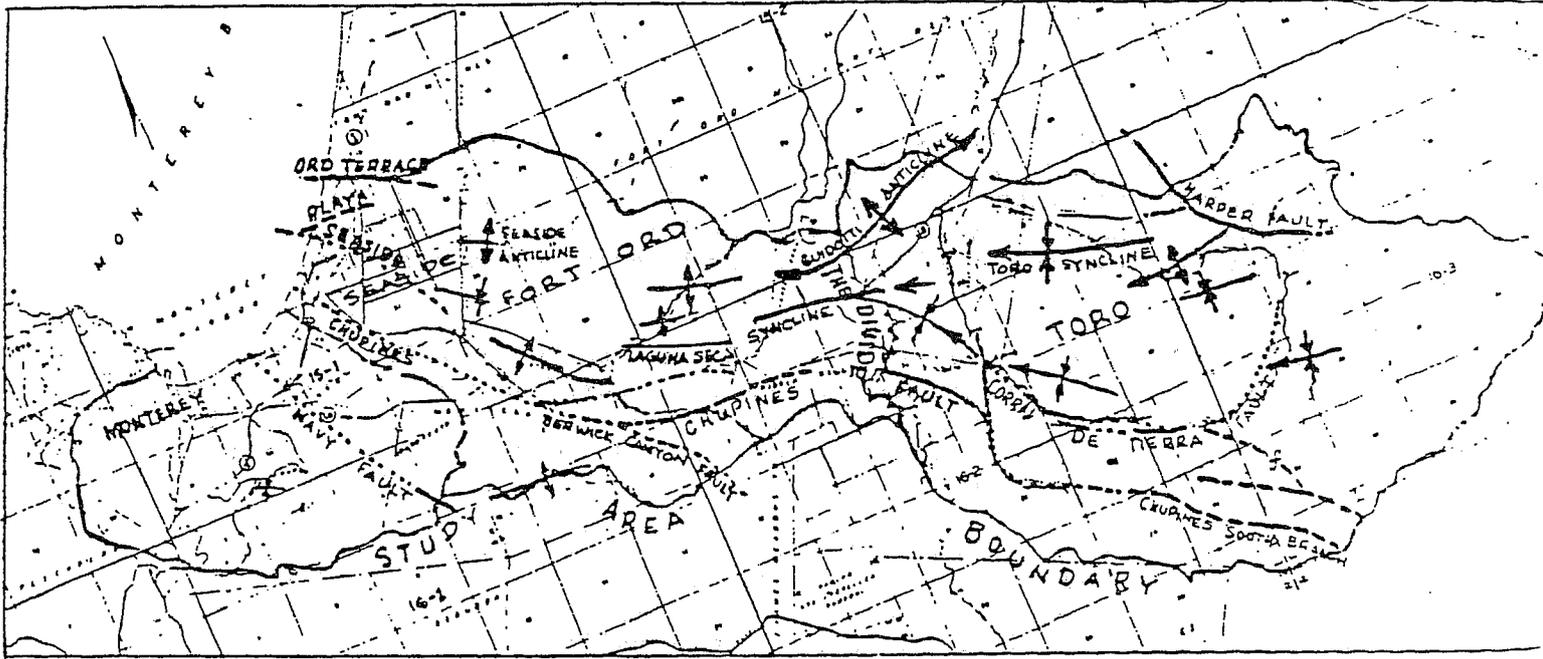
FIGURE 5

TECTONIC MAP
Seaside to Toro

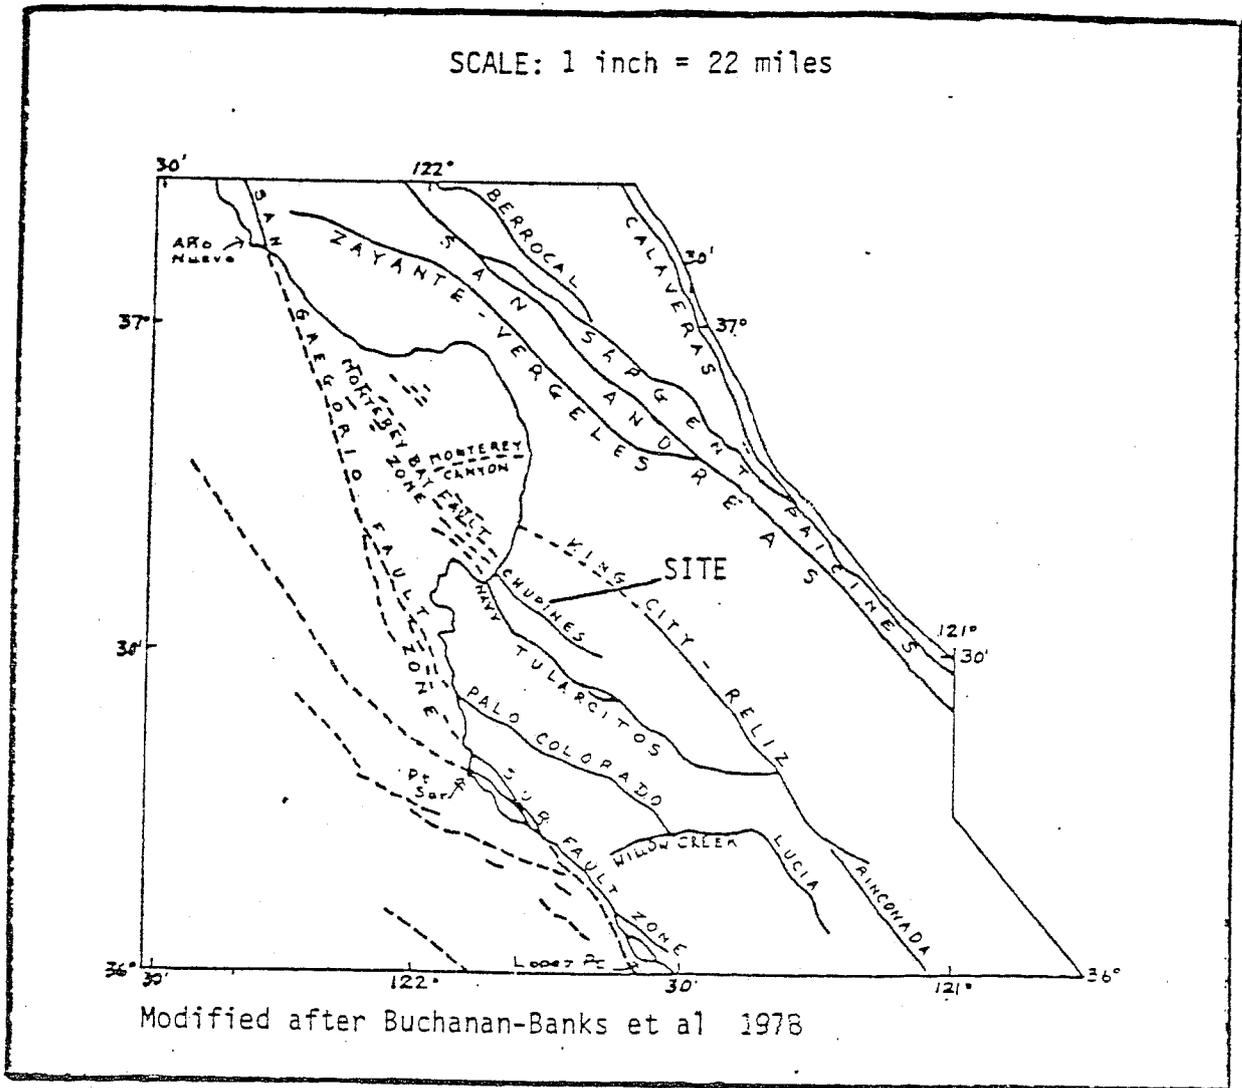
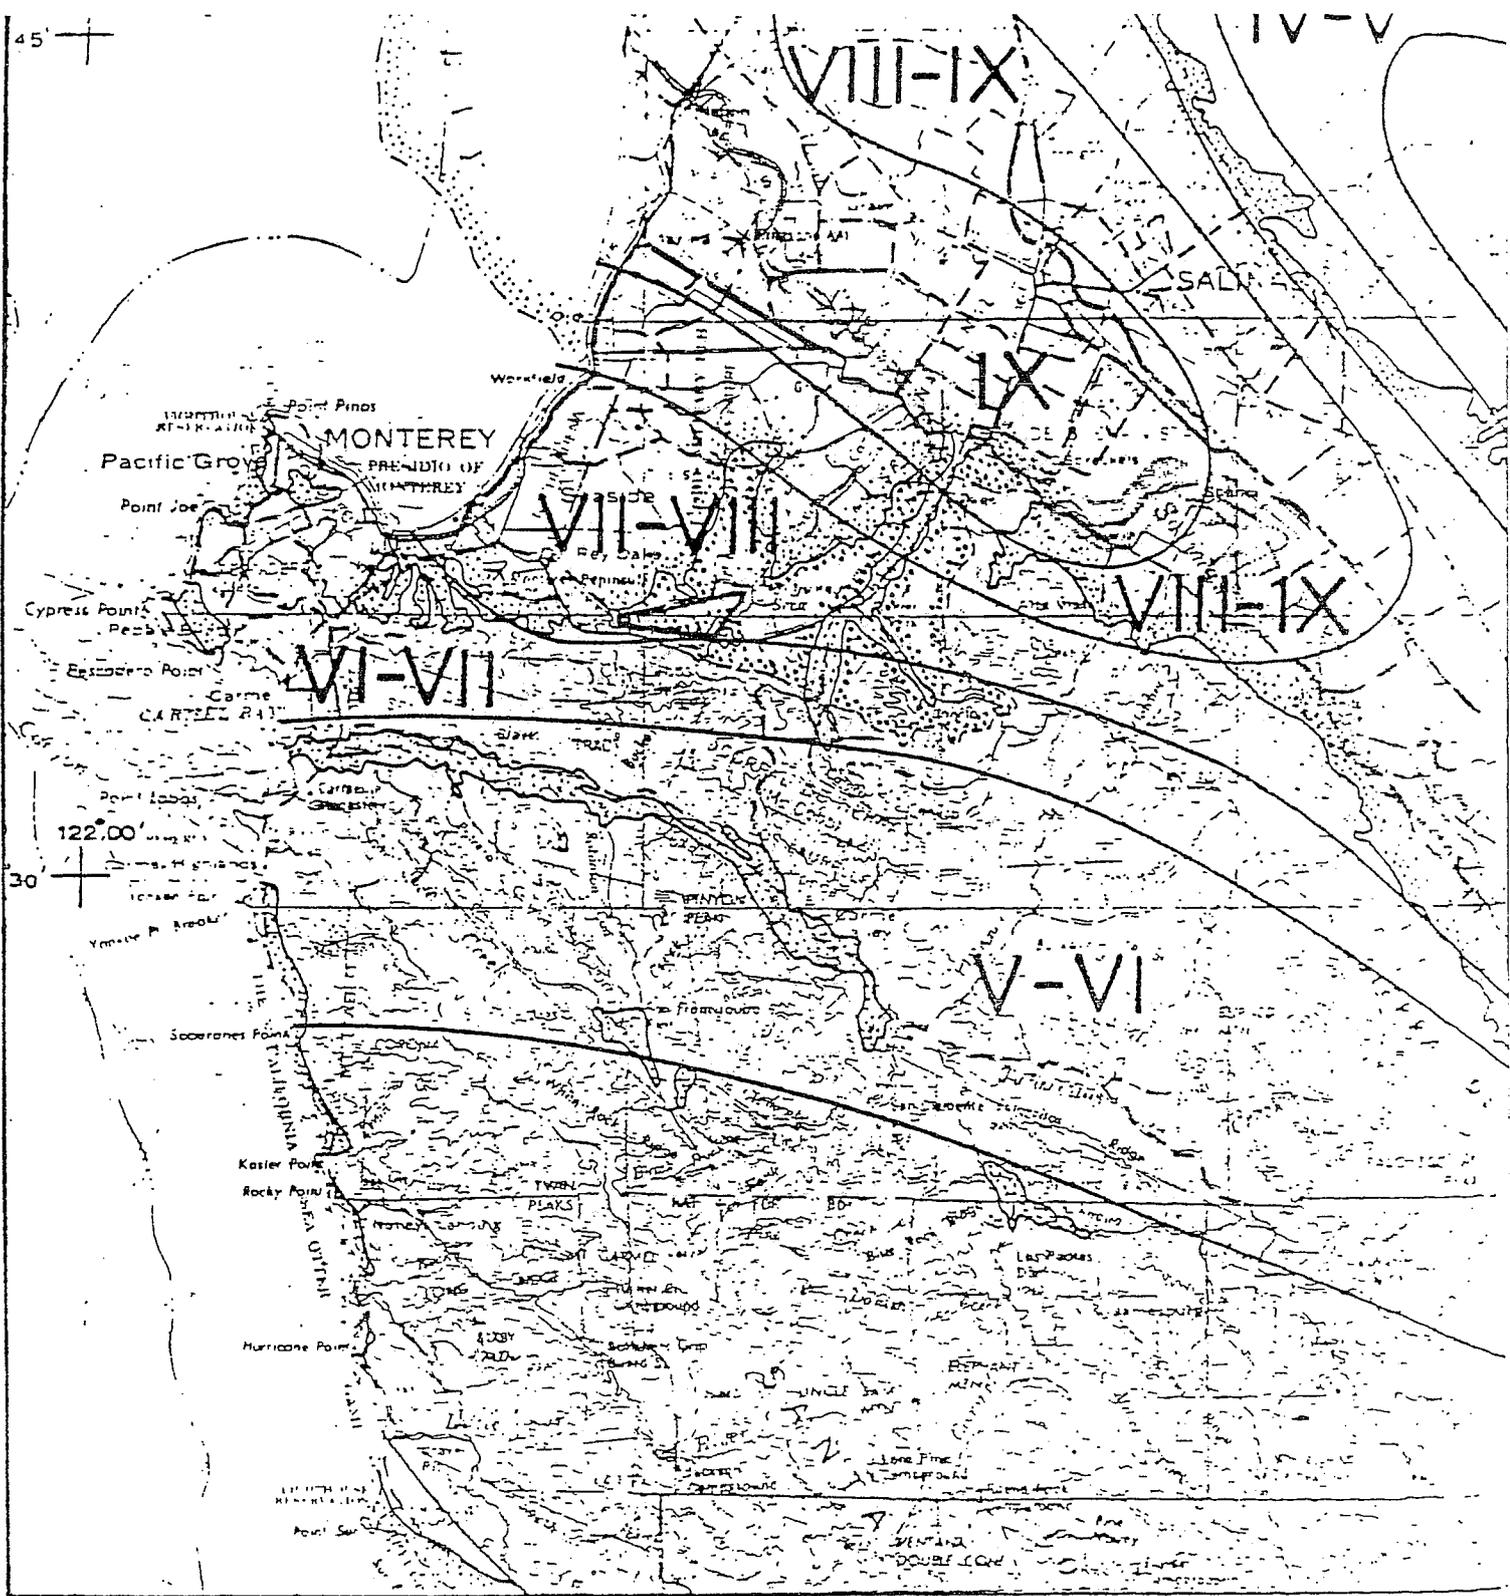
REGIONAL FAULT ZONES

MONTEREY BAY AND VICINITY
MONTEREY COUNTY, CALIFORNIA

McCroory et al 1977

Scale: 1 inch = 4 miles
