**GEOLOGIC HAZARDS REPORT AND  
BLUFF RETREAT STUDY  
255 HIGHWAY 1  
CARMEL HIGHLANDS  
MONTEREY COUNTY, CALIFORNIA**

PROJECT: CORTOPASSI RESIDENCE  
255 HIGHWAY 1  
CARMEL HIGHLANDS, CALIFORNIA

SUBJECT: Geologic Hazards and Bluff Retreat Report

**GEOTECHNICAL INVESTIGATION  
For  
255 Highway 1  
Wildcat Cove  
Carmel Highlands, California**

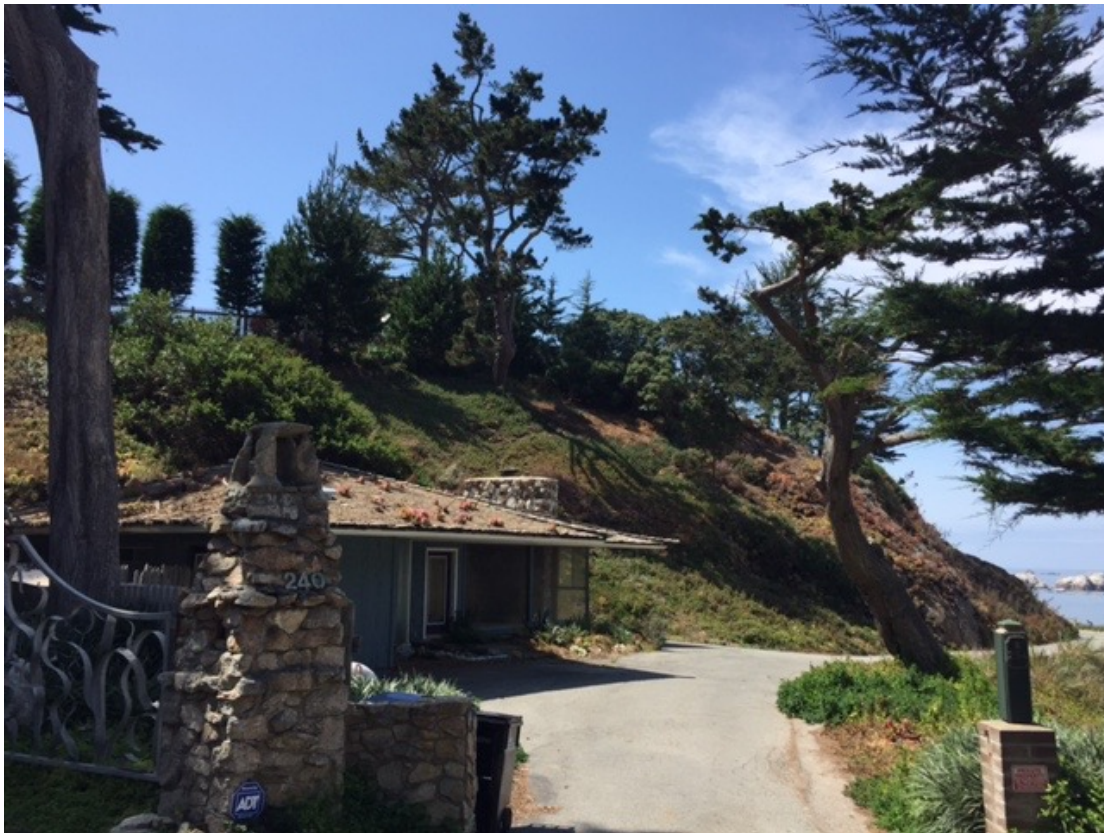
Figure 1. View of subject property looking north. The small unoccupied home (left of center) will be remodeled using the existing building footprint and a garage will be constructed immediately behind the home next to the shared driveway. Most of the impacted areas are dominated by exotic ice plant and impacts to biological resources will be minimal.

of coastal waters below. Currently, there is a small unoccupied home on the parcel that is accessed by a shared paved driveway (refer to *Figures 1 & 2*). The proposed home remodel and addition project (refer to the *Exhibit A. Site Plans*) will utilize the existing building footprint as well as a relatively small previously disturbed area immediately to the northwest of the existing structure that is dominated by non-native invasive ice plant (*Carpobrotus edulis*; refer to *Figure 3*)

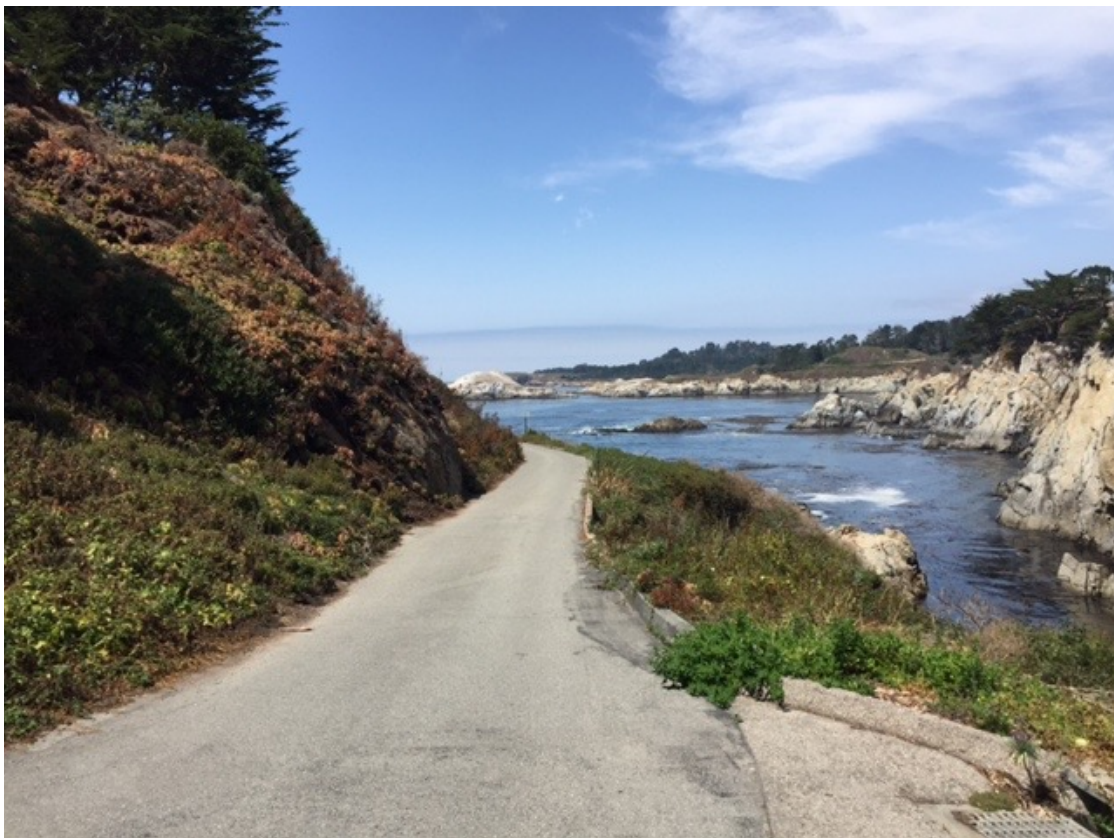
Figure 2. View of shared private driveway looking north and coastal cove is to the east of the driveway. Proposed garage will impact the ice plant dominated area along the left edge of photo, which will include the removal and relocation of two small sea cliff buckwheat plants.

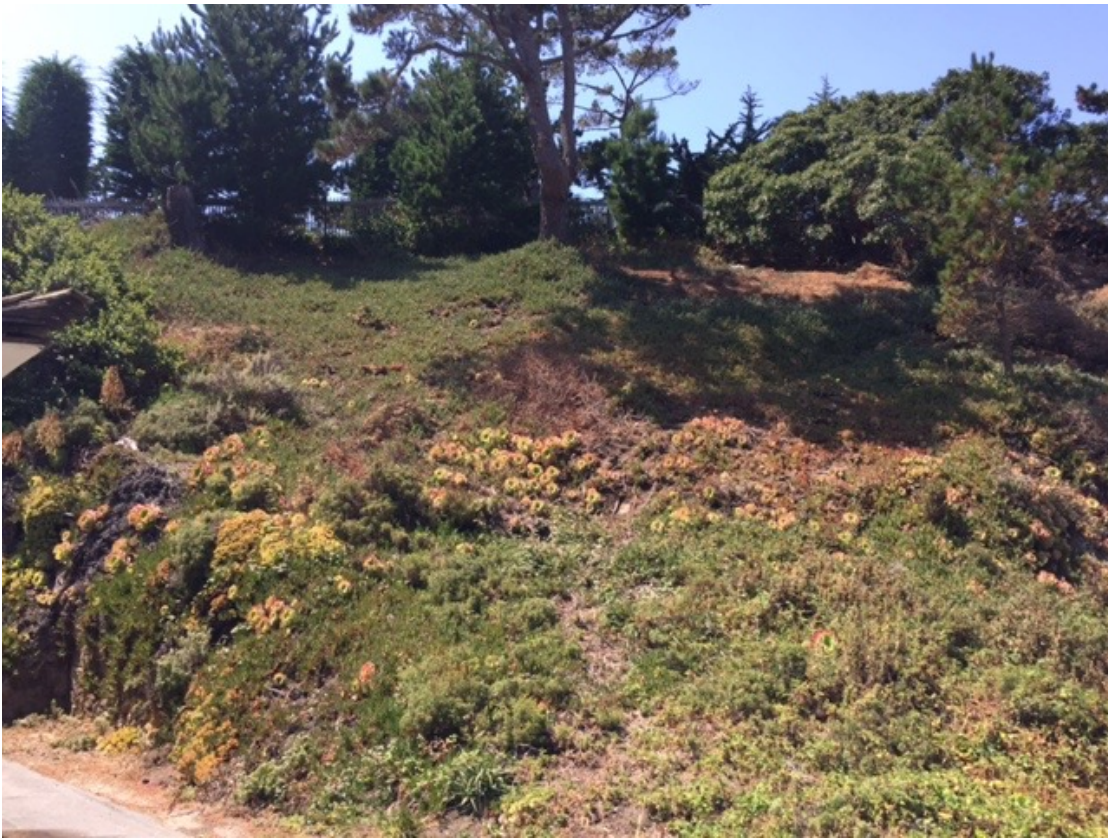
Figure 3. Site of proposed garage addition, which is dominated by non-native succulents (i.e., ice plant and echeveria). Edge of existing structure is visible along left edge of photo. Two sea cliff buckwheat plants that are marked with orange pin flags (not visible in photo) are located in this area within or directly adjacent to proposed construction activities.

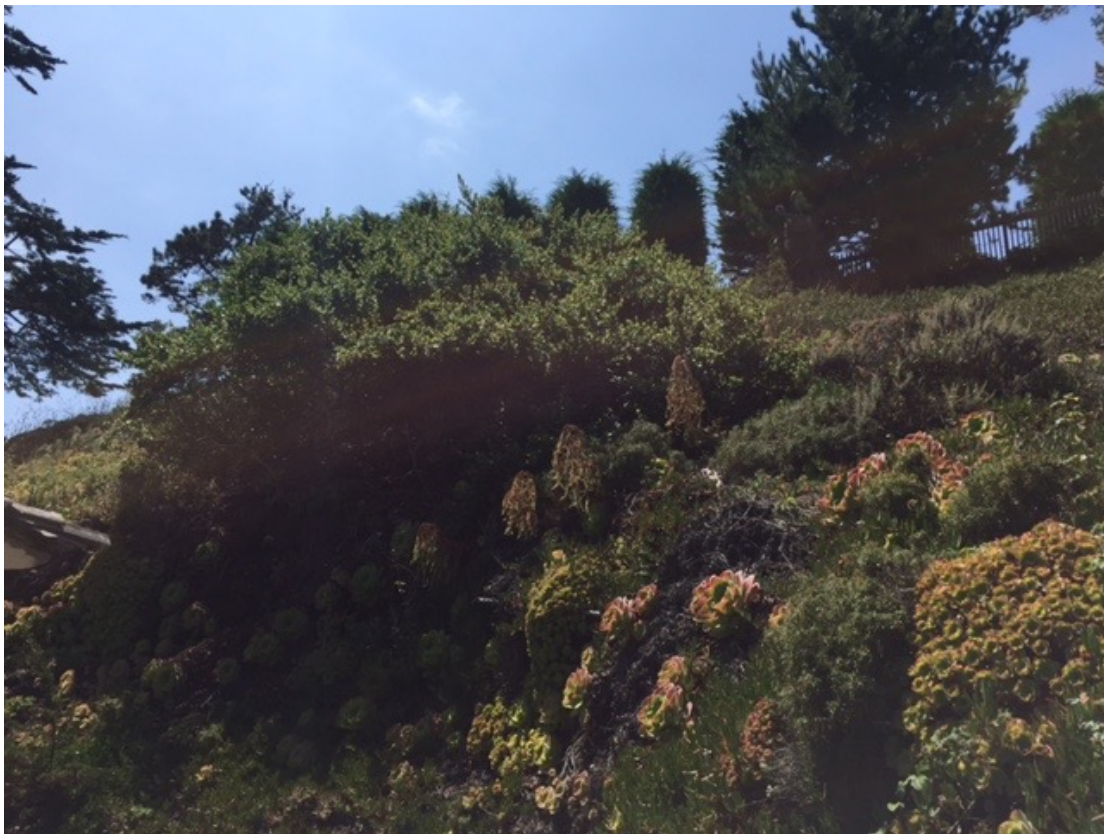
Figure 4. The ice plant dominated slope behind the existing unoccupied home will not be impacted. A retaining wall will be installed along toe of slope, but the large native ceanothus bush and California sagebrush patches visible in photo will be retained and protected.
