Submitted herewith is the report of our Geotechnical and Geological Investigation for the proposed new additions to the existing residence located at 170 Mal Paso Road, APN 243-292-002, in Carmel Highlands, California. Two borings were drilled on June 9, 2017 for geotechnical investigation purposes. Laboratory tests were subsequently made on driven soil core samples taken from the borings to determine the near surface and subsurface soil conditions and suitability for the construction of the proposed new additions to the existing residence. We find that the project site is suitable for the proposed use with the recommendations made herein.

GEOTECHNICAL INVESTIGATION

FOR THE PROPOSED NEW ADDITIONS TO THE EXISTING RESIDENCE

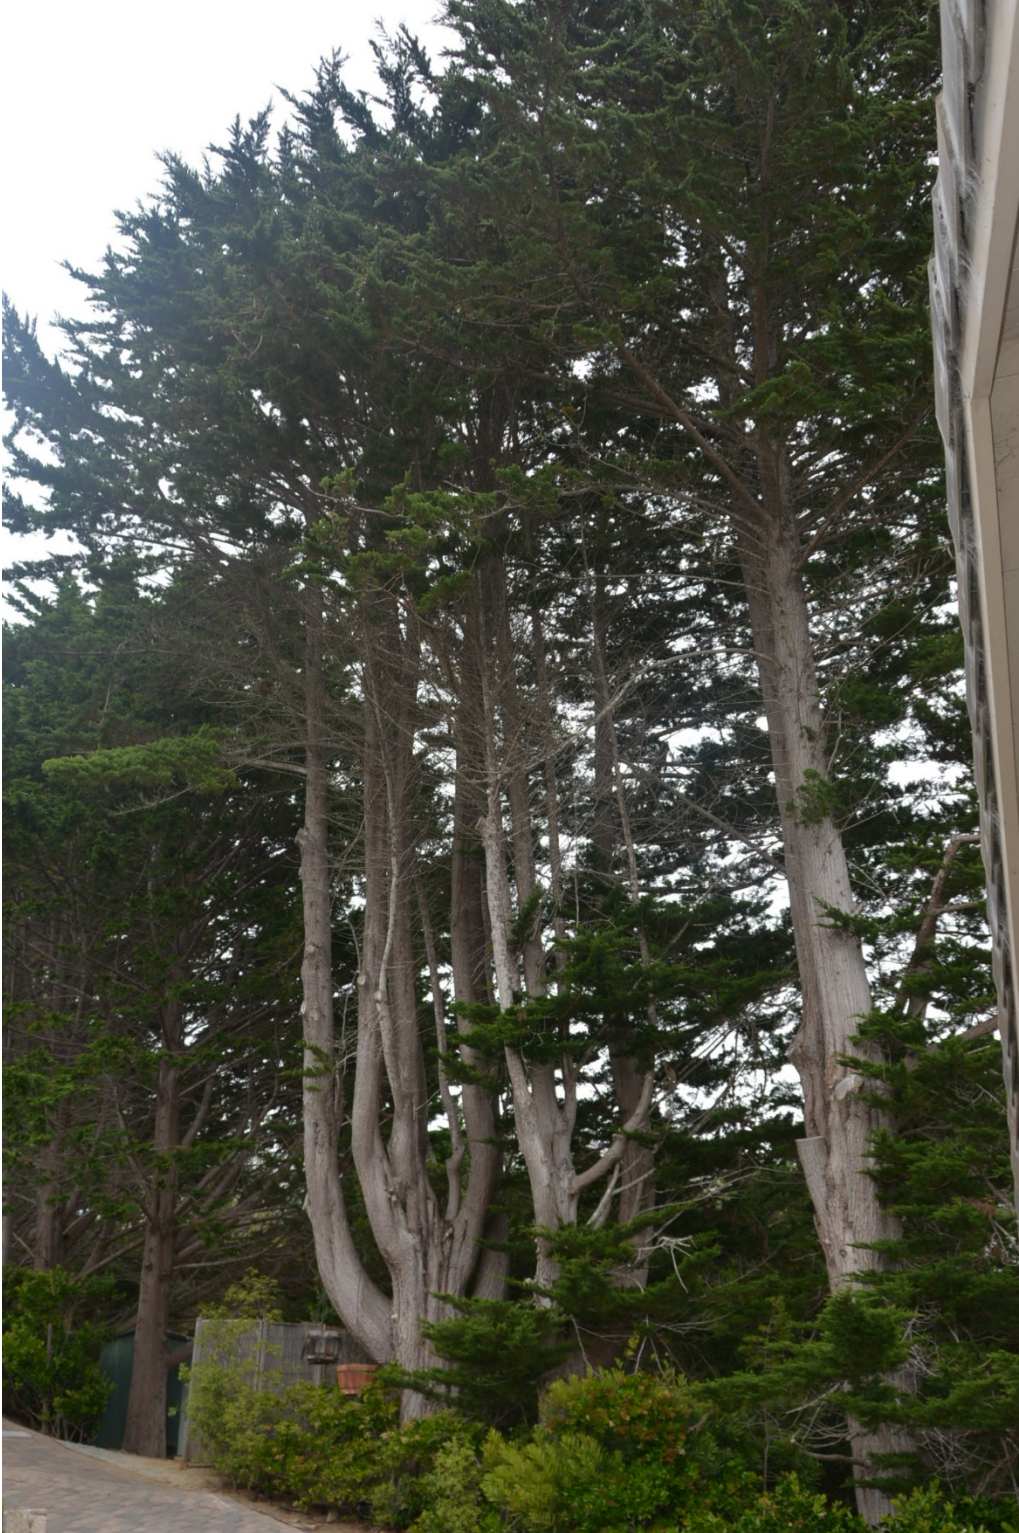
Cypress trees, located on adjacent property; will need to have their base protected from ingress and egress of construction equipment and to prevent them from being staging areas.

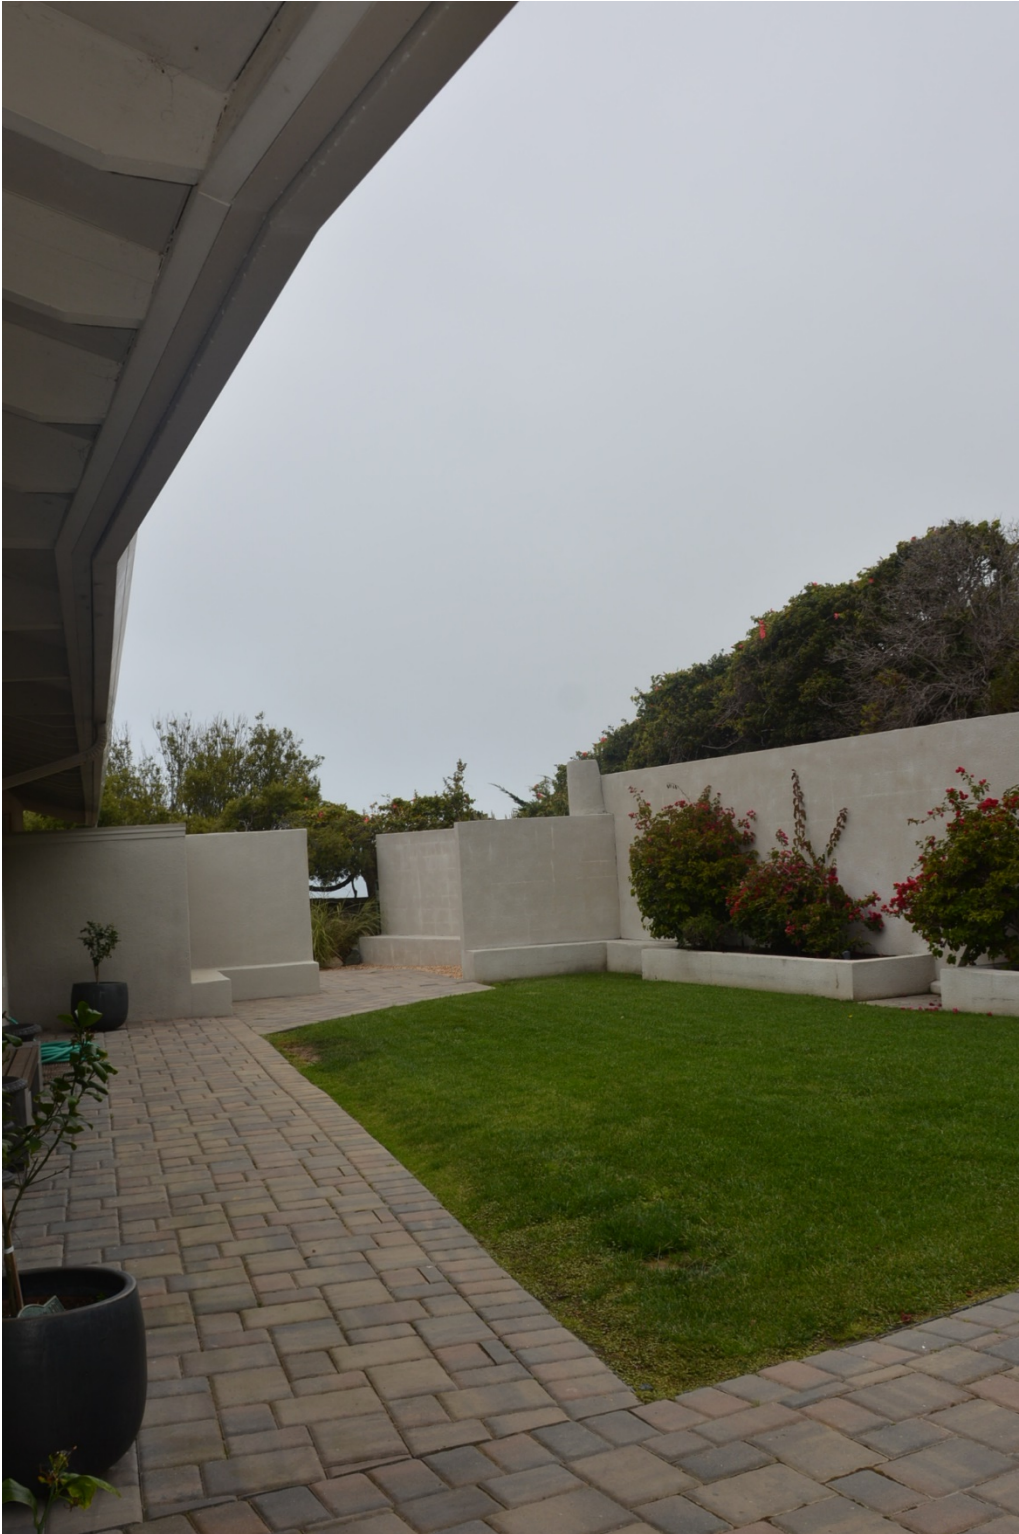
Retaining and privacy walls will be removed and reconfigured, there are no obvious trees adjacent these walls.

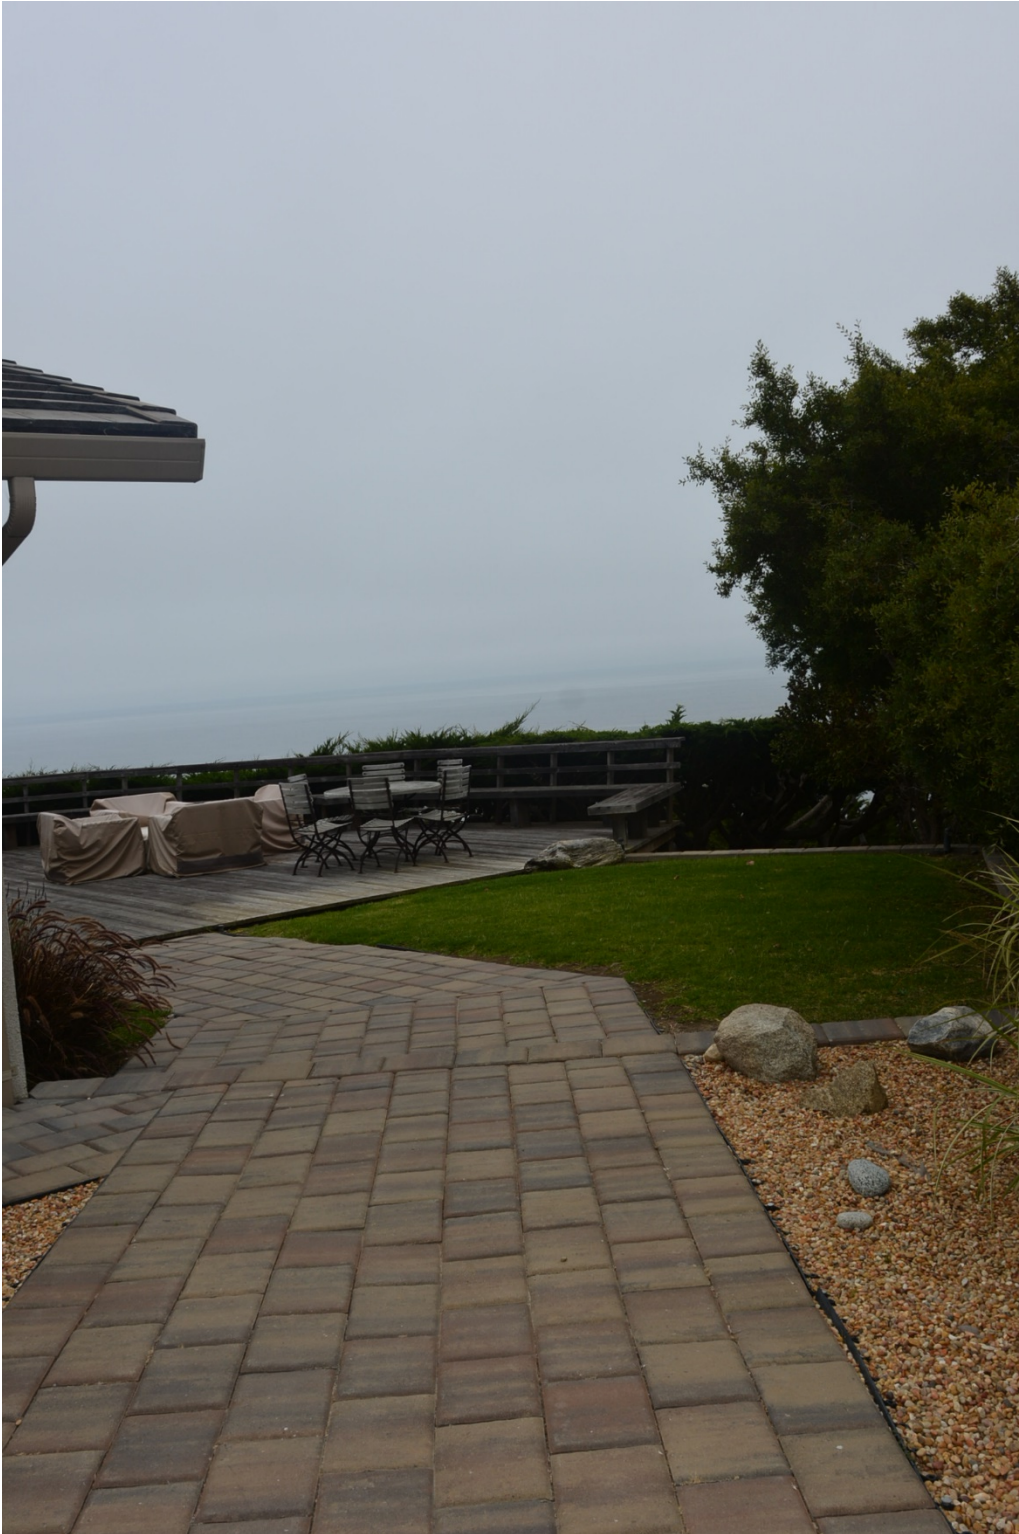
Cypress trees are located below the main deck. These trees are far enough from the new construction they should not be impacted. They will need their root zones and bases protected from excavation for the fire pit and foundation work.

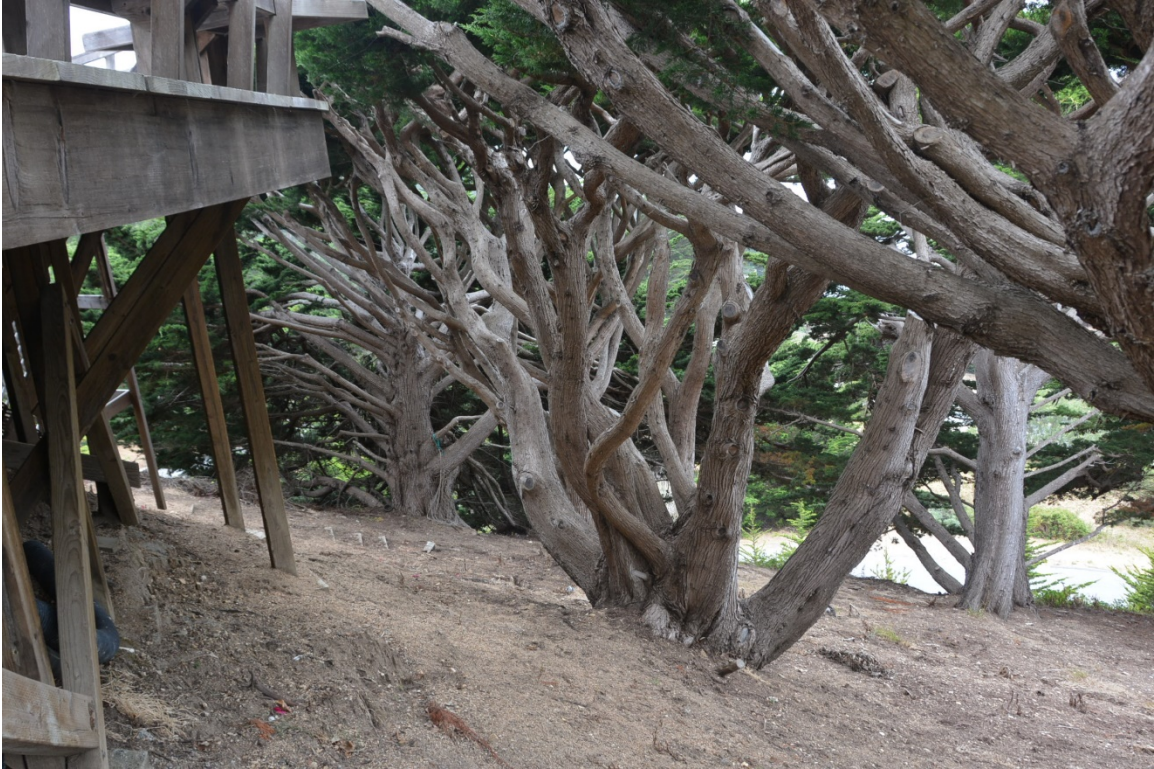
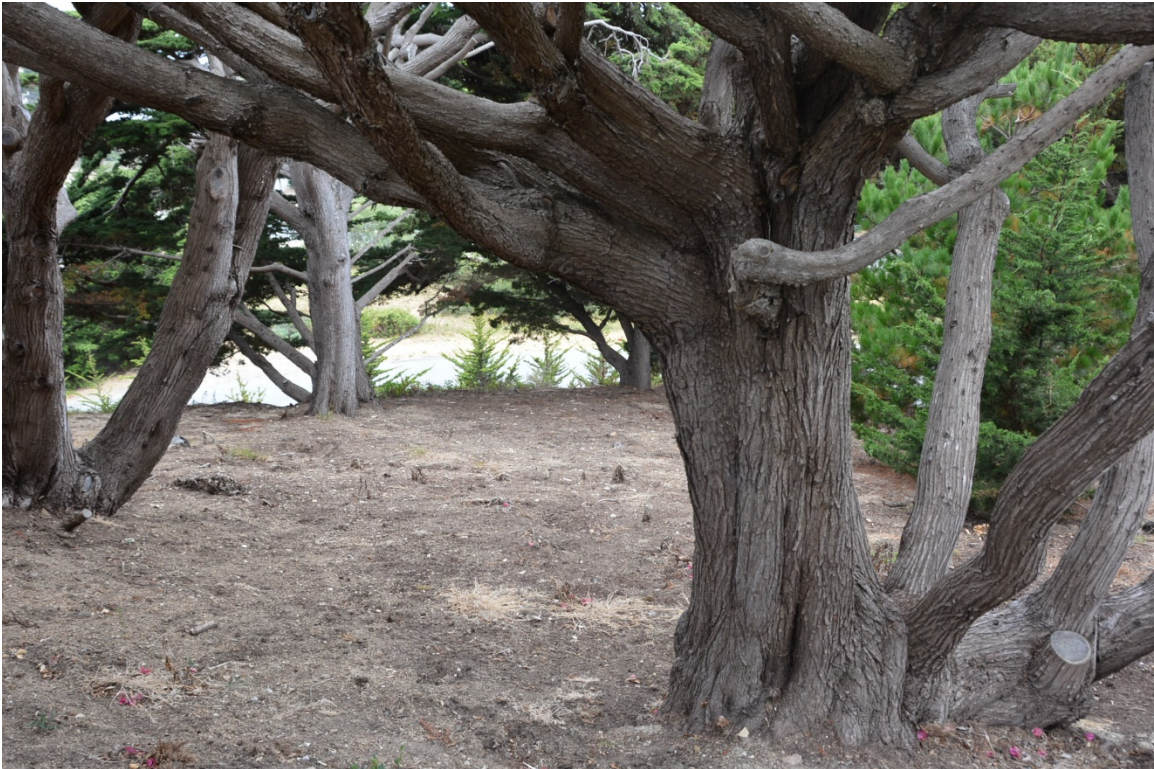
Bases of trees (#94-#97) located outside of main deck, these trees will need protection from construction

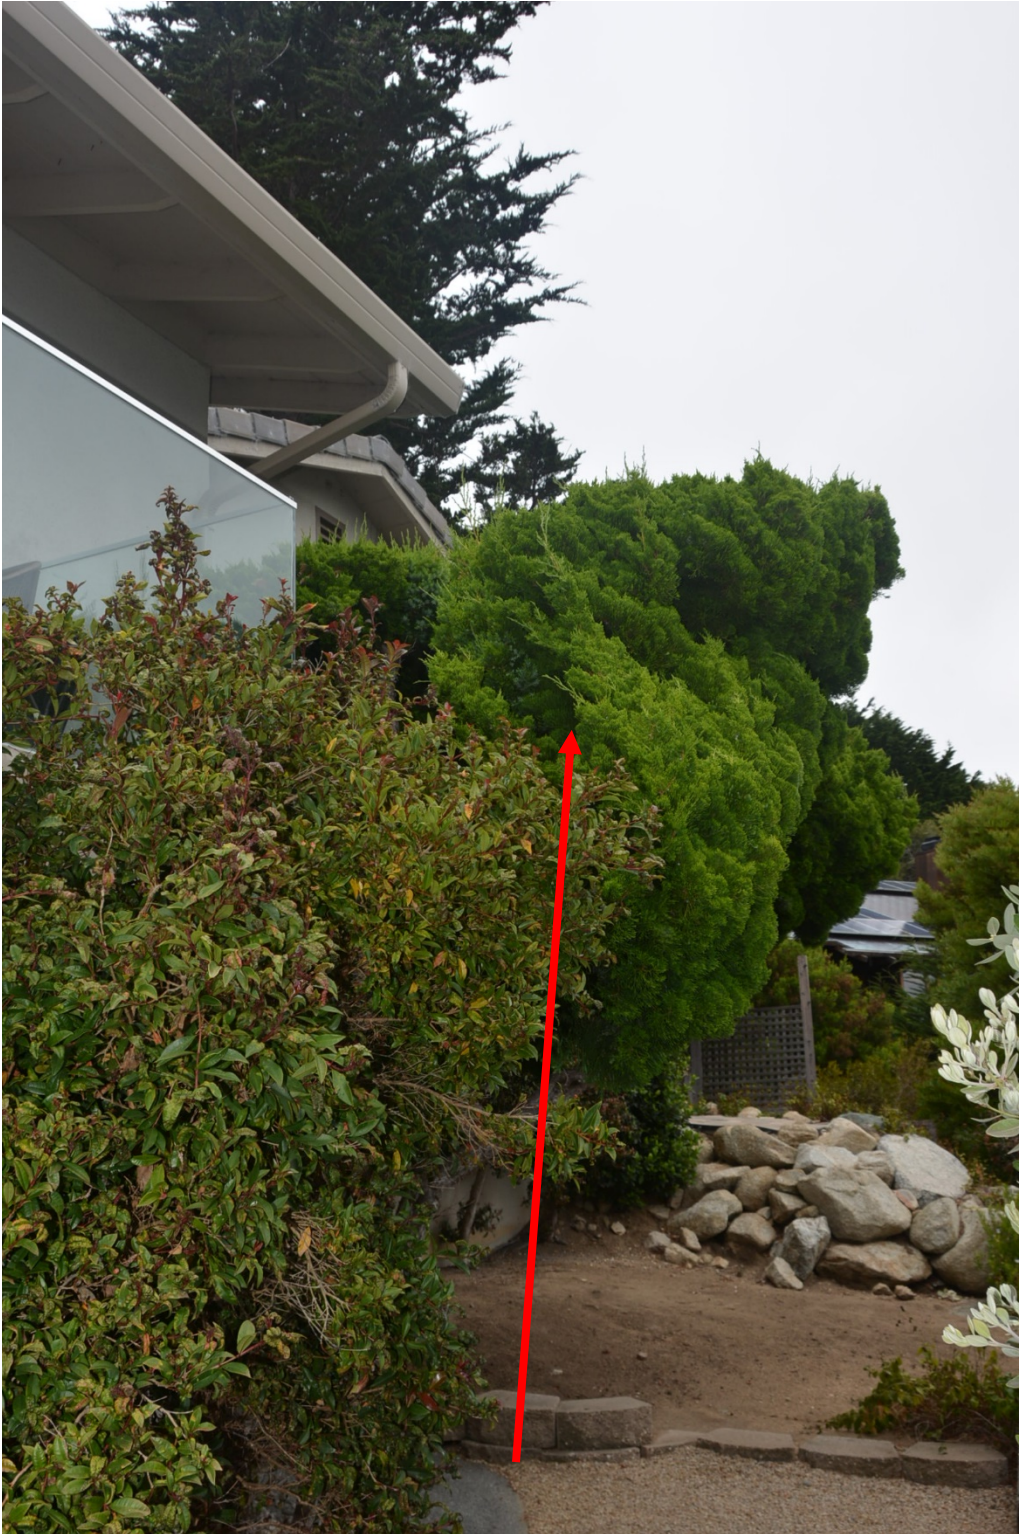
Hollywood juniper (#93) that will be removed

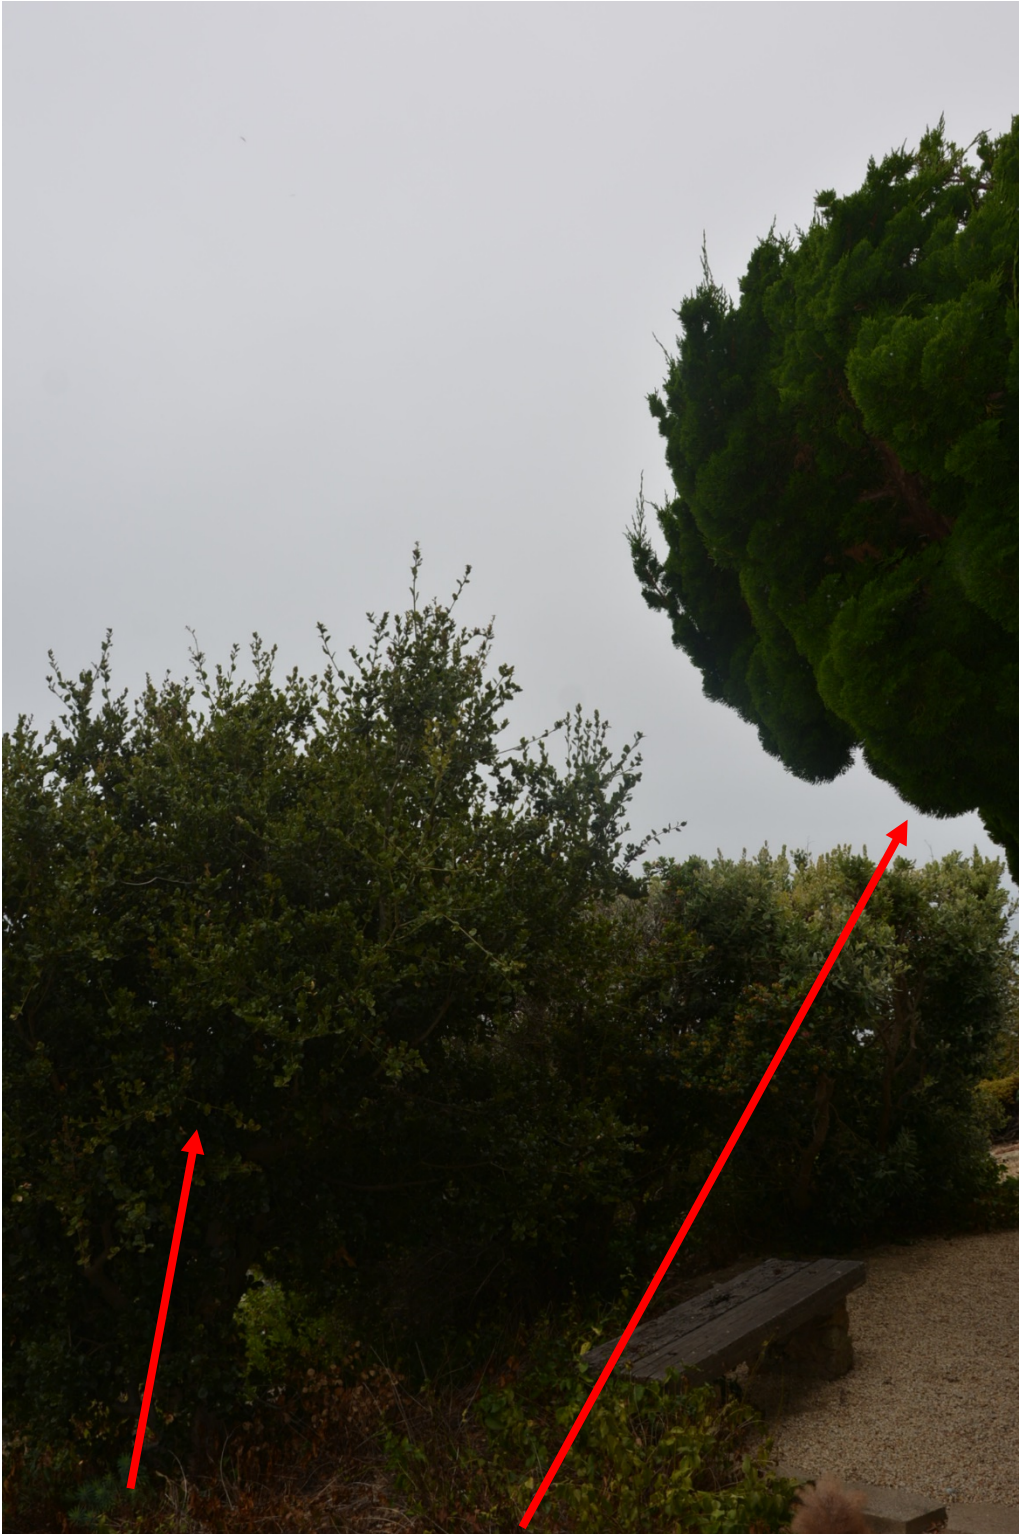
Oak tree (#91) to be protected and Hollywood juniper (#92) to be removed
