SOIL INVESTIGATION REPORT (Design Phase)

Project Number: GMD 202110

Project: New Single Family Dwelling

Location: 1187 Lookout Rd Pebble Beach, CA 93953

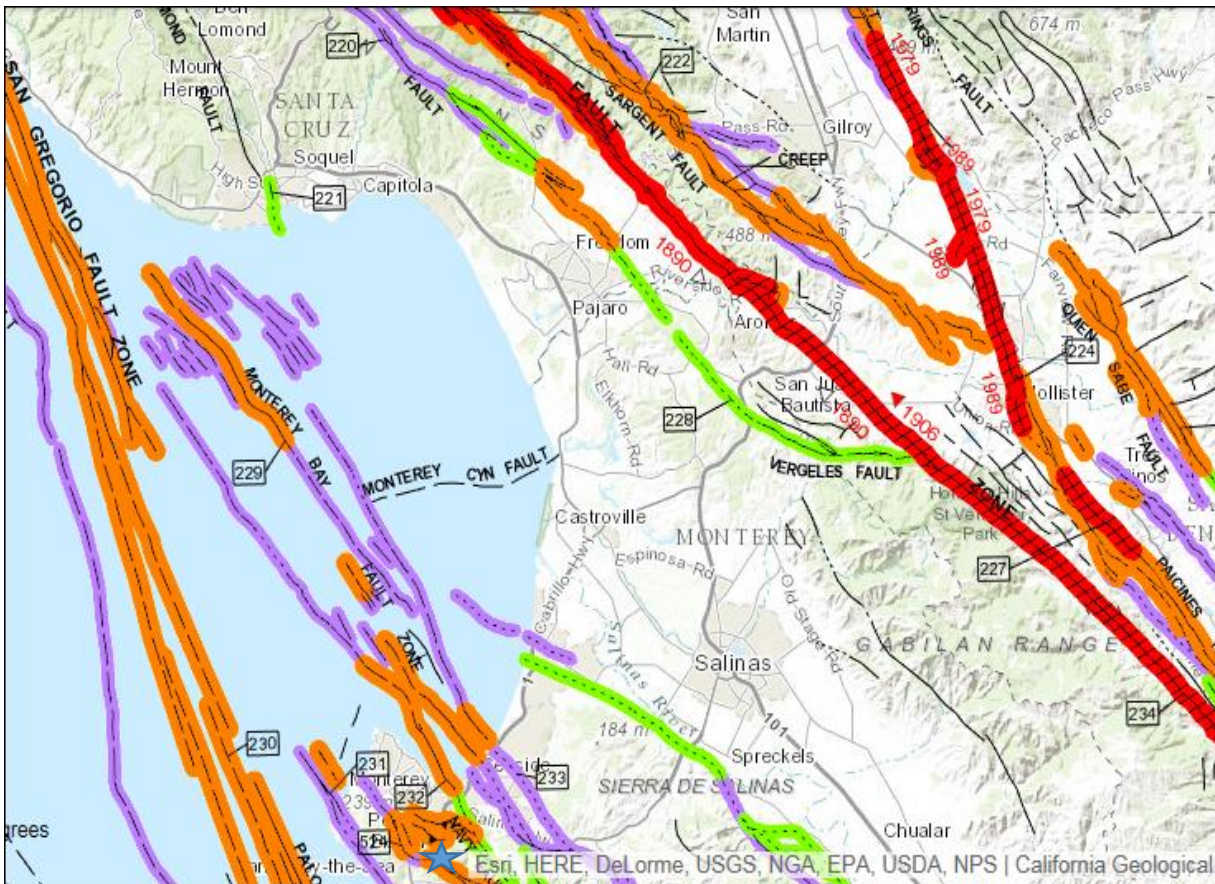
Upon review of the Maps of Known Active Fault Near-Source Zones in California and Adjacent Portions of Nevada, Monterey is traversed by: San Andreas Fault, 19 miles from the site. Other faults that may cause very strong and violent ground shaking are: Berwick Canyon (reverse), Chupines (strike-slip), Cypress Point (reverse), Hatton Canyon (reverse), Sylvan thrust (reverse), Tularcitos/Navy/Monterey Bay (strike-slip) & Tularcitos/Navy/Monterey Bay (reverse) and and Vergeles. For each of the active faults, the distance from the planning area and estimated maximum moment magnitude are summarized in following table on regional faults & seismicity:

REGIONAL FAULT NEAR PROJECT SITE

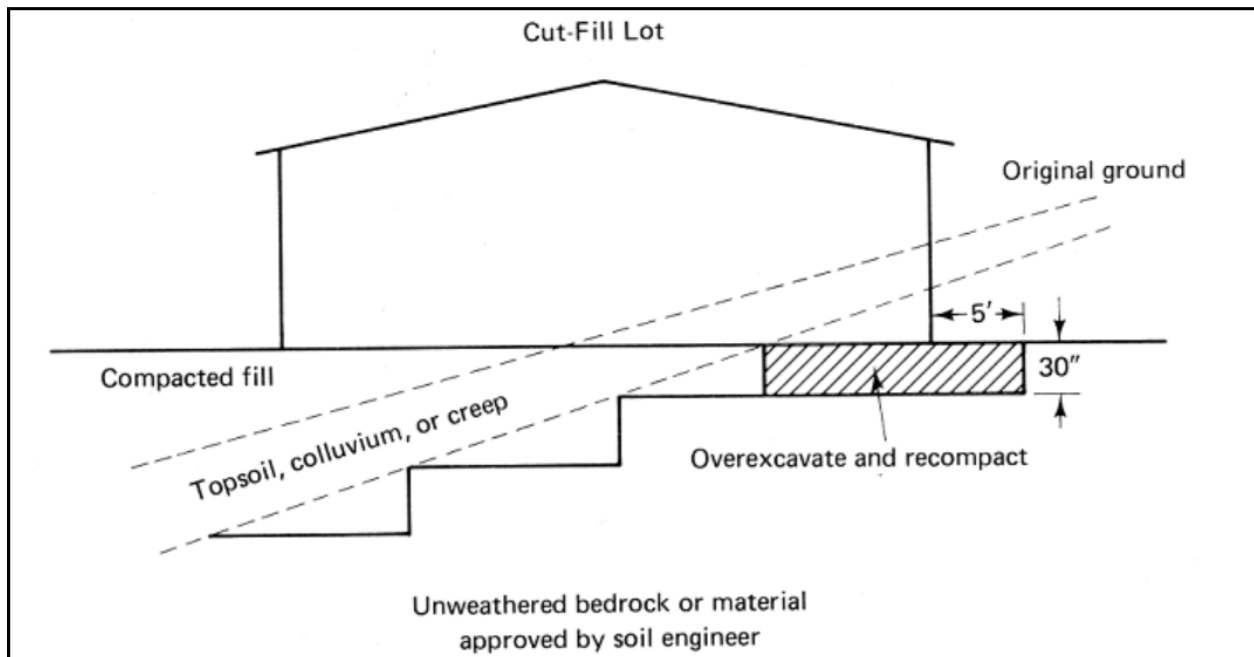
(From: Special Publication 117a)

Below is typical mitigation for a Cut-and-Fill:

The typical mitigation for a Cut-and-Fill lot is to construct a gradual “stepped” transition between bedrock and fill, over-excavating unstable soils and re-compacting

RECOMMENDED MITIGATION. The standard practice for stabilizing settlement failures at cut-fill transitions is to over-excavate during construction and grade the bedrock surface in multiple steps to provide a gradual slope transition. Fill should be compacted to a minimum of 90 percent of the maximum density as per ASTM D1557. Scarification provides a bond between the fill material and the underlying native rock. The overall grading goal is to minimize the difference in bearing capacity across the cut-fill boundary.

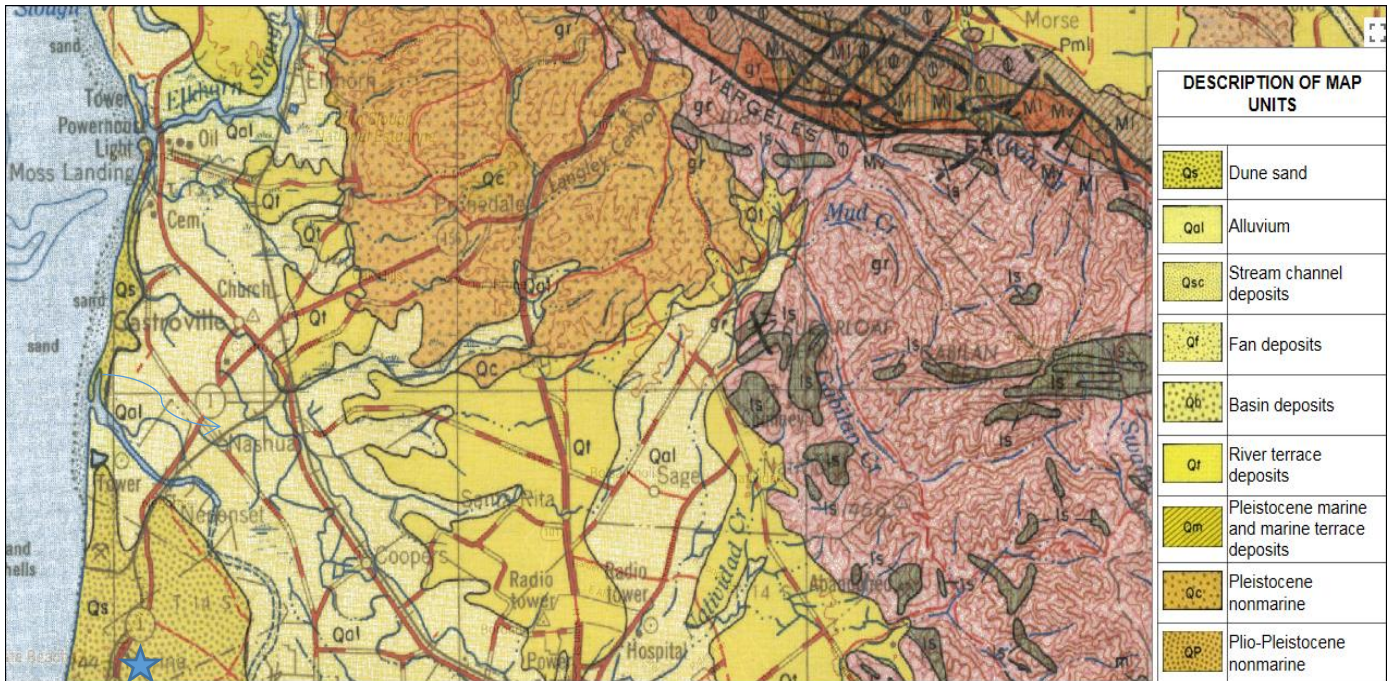
GEOLOGICAL MAP

REGIONAL GEOLOGY MAP NEAR PROJECT SITE

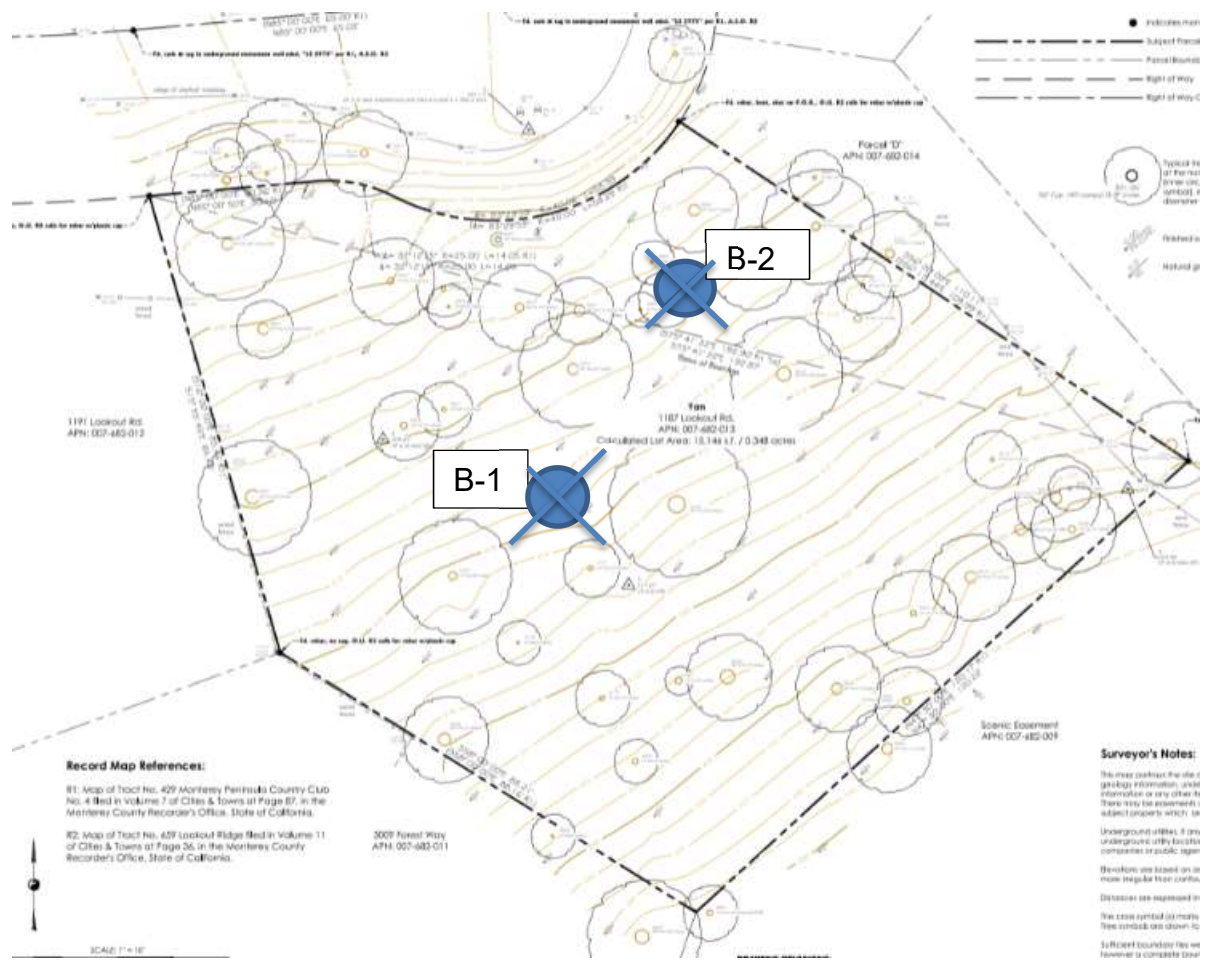
Location Plan

APPROXIMATE BORING LOCATION

We observed drilling of one boring and logged the subsurface conditions eastern portion of the property. Boring location is shown on Site Plan, Appendix. We retained a portable drill rig and crew to advance the boring using 4-inch diameter solid flight auger methods.

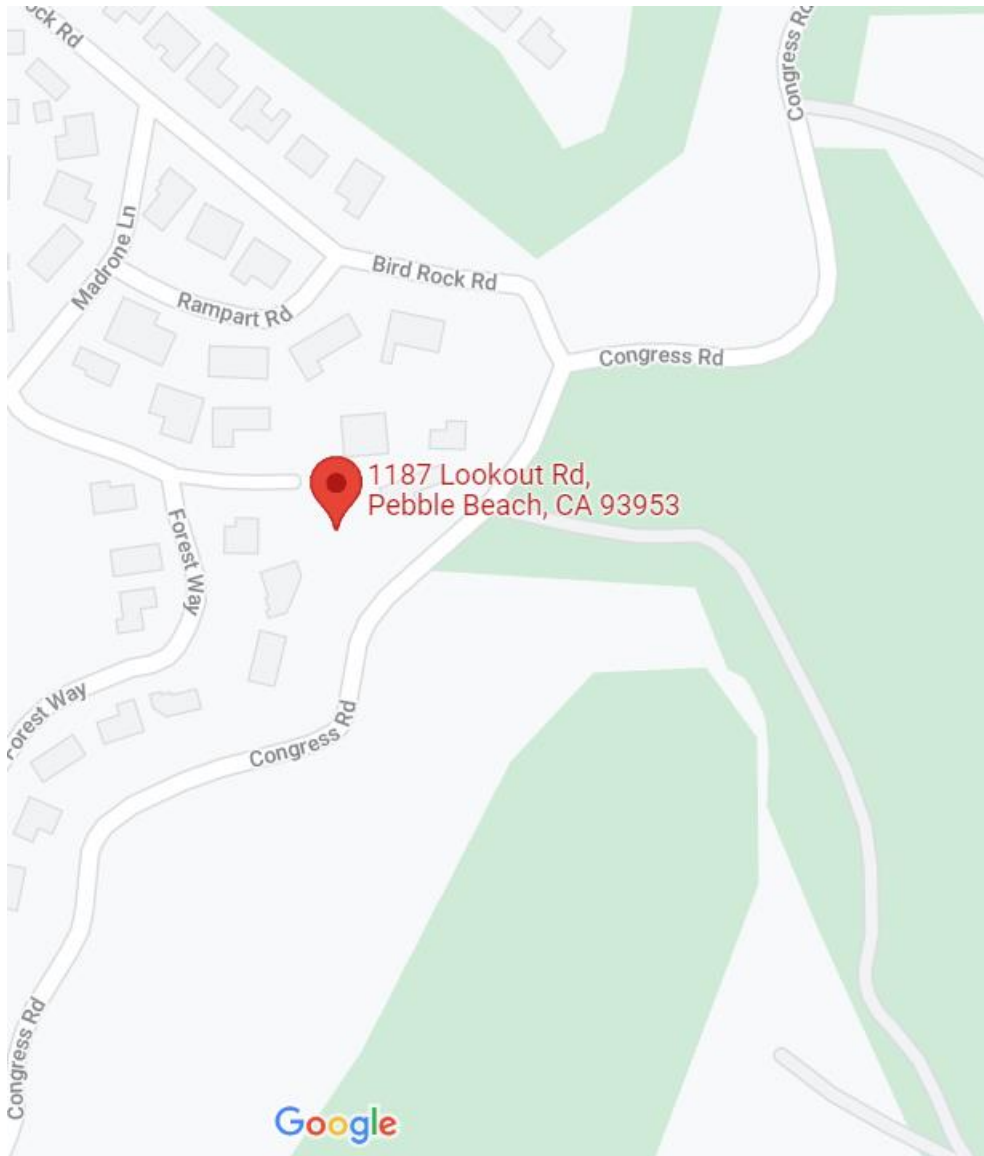
SITE MAP

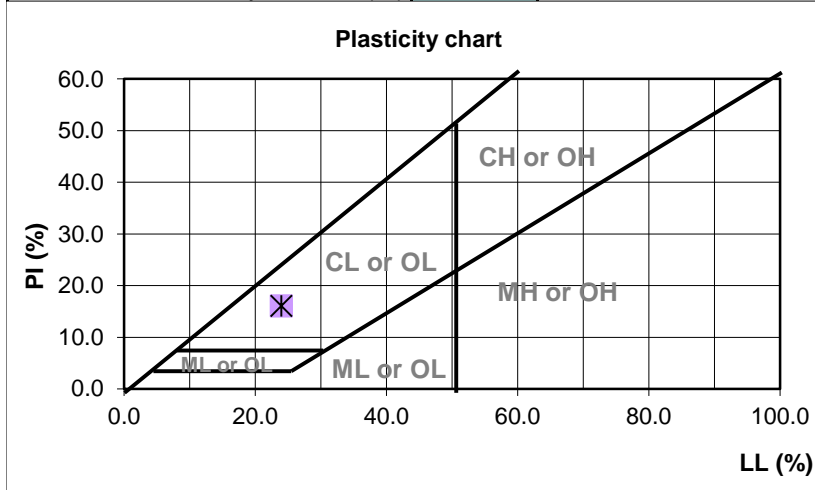
II. PLASTICITY OF FINES (PASSING SIEVE No.40)	
Liquidity Limit LL (%)	24.0
Plasticity Index PI(%)	16.0
<input type="checkbox"/> Organic with LLdry/LL<0.75

<p style="margin: 0;">GMD ENGINEERS SOIL & FOUNDATION ENGINEERING 11 WEST LAUREL DRIVE SUITE 225 SALINAS CA 93906 (831) 840-4284 gmdalivaengineers@gmail.com</p>	<p style="text-align: center;">BORING #2 @ 6 FT</p> <p>1187 Lookout Rd Pebble Beach,</p>	<p>Project #: GMD 202110 DATE: 3/05/2020 PLATE NO: B-2</p>
--	---	--

The following tests had been performed: moisture test (ASTM D2937-04) and D2216-05; a grain size distribution test (ASTM D 422-63 (2002) & plasticity index test (ASTM D 4318-05).

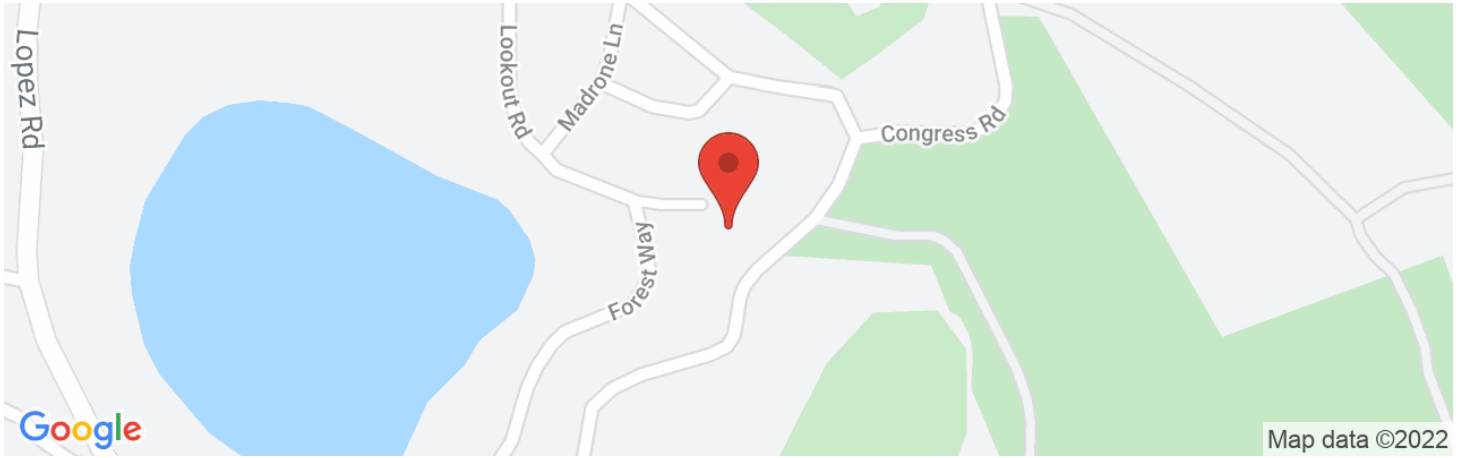
Date	1/15/2022, 12:31:14 AM
Design Code Reference Document	ASCE7-16
Risk Category	II
Site Class	D - Default (See Section 11.4.3)

Type	Value	Description
S_S	1.291	MCE_R ground motion. (for 0.2 second period)
S_1	0.487	MCE_R ground motion. (for 1.0s period)
S_{MS}	1.55	Site-modified spectral acceleration value
S_{M1}	null -See Section 11.4.8	Site-modified spectral acceleration value
S_{DS}	1.033	Numeric seismic design value at 0.2 second SA
S_{D1}	null -See Section 11.4.8	Numeric seismic design value at 1.0 second SA
