# Exhibit C

## Storesund Consulting

Re: Vega Road Project Geotechnical Evaluation

The proposed project is located (Figure 1, Figure 2) in Royal Oaks, California (36.887574N; 121.716173W), south of the Pajaro River. The anticipated work consists of enhancing an existing jeep trail to a paved private hillside road. This letter addresses design considerations for roadway grading and installation of subsurface utilities.

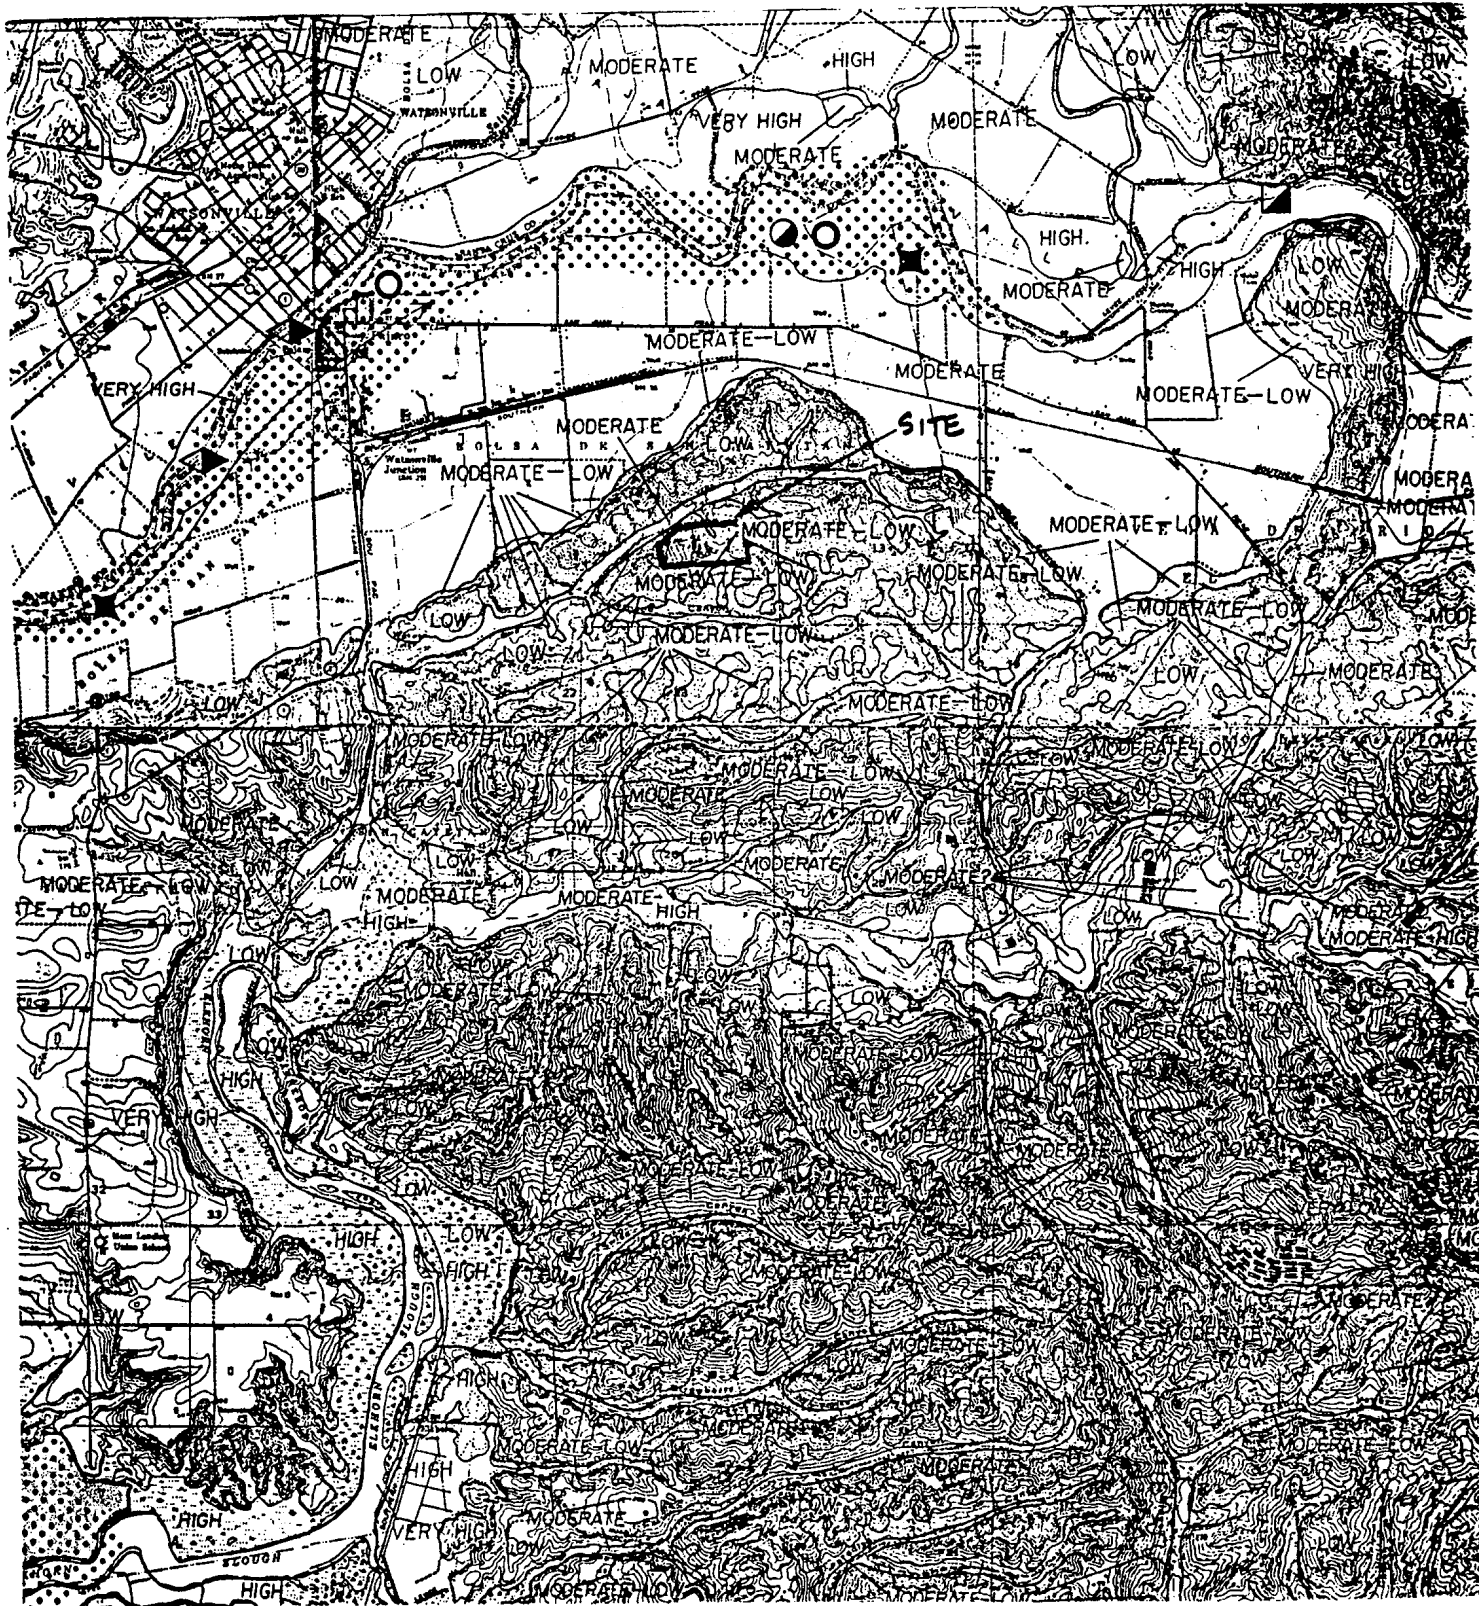
FIGURE NO. 6

LIQUEFACTION POTENTIAL MAP

Canyon. These areas may be susceptible to liquefaction during major seismic events where shallow aquifers are contained in loose sands which may consolidate (see Figure No. 6 for locations of these areas).

Liquefaction potential for the property is rated as moderate-low, except near Vega Road (see Figure No. 6). Based on our investigation, we do not consider liquefaction a hazard at this site due to the absence of shallow groundwater. Bore Hole No. 1 at Lot No. 1 located in the Vega Road area, rated as moderate, did not encounter any free groundwater to a depth of 12 feet; hence is also rated as low.

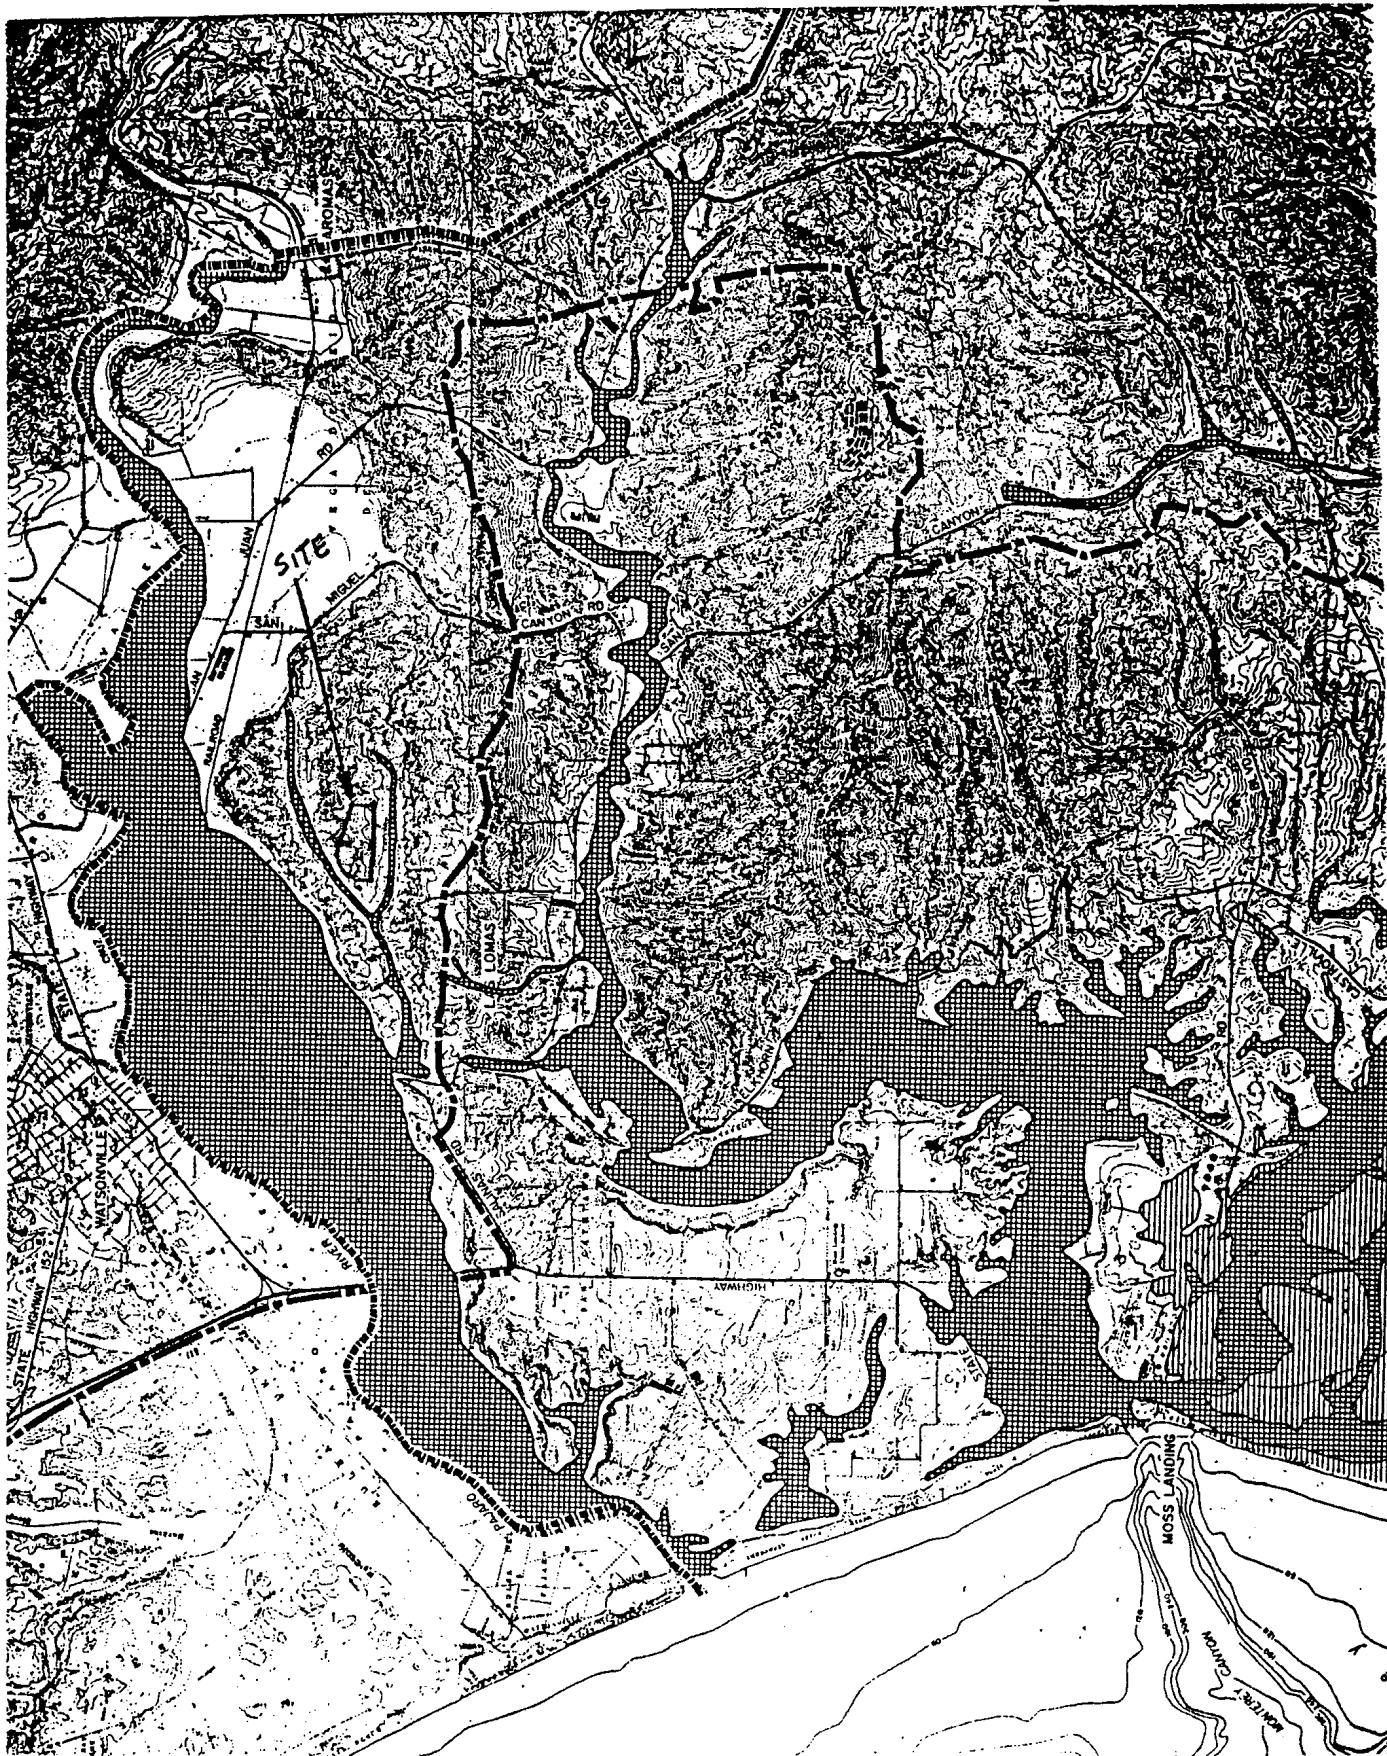
FIGURE NO. 7

FLOOD PLAIN (100-YEAR FREQUENCY)

Lot No. 1 is the only area of the property which may extend into the 100-Year Frequency Flood Zone along Vega Road shown on Figure No. 7. The building envelope should be located above this elevation.
