Salinas River Stream Maintenance Program 2016 Work Season

Annual Report

United States Army Corps of Engineers

Regional General Permit 20, Corps File # 1996-22309S, Effective September 28, 2016

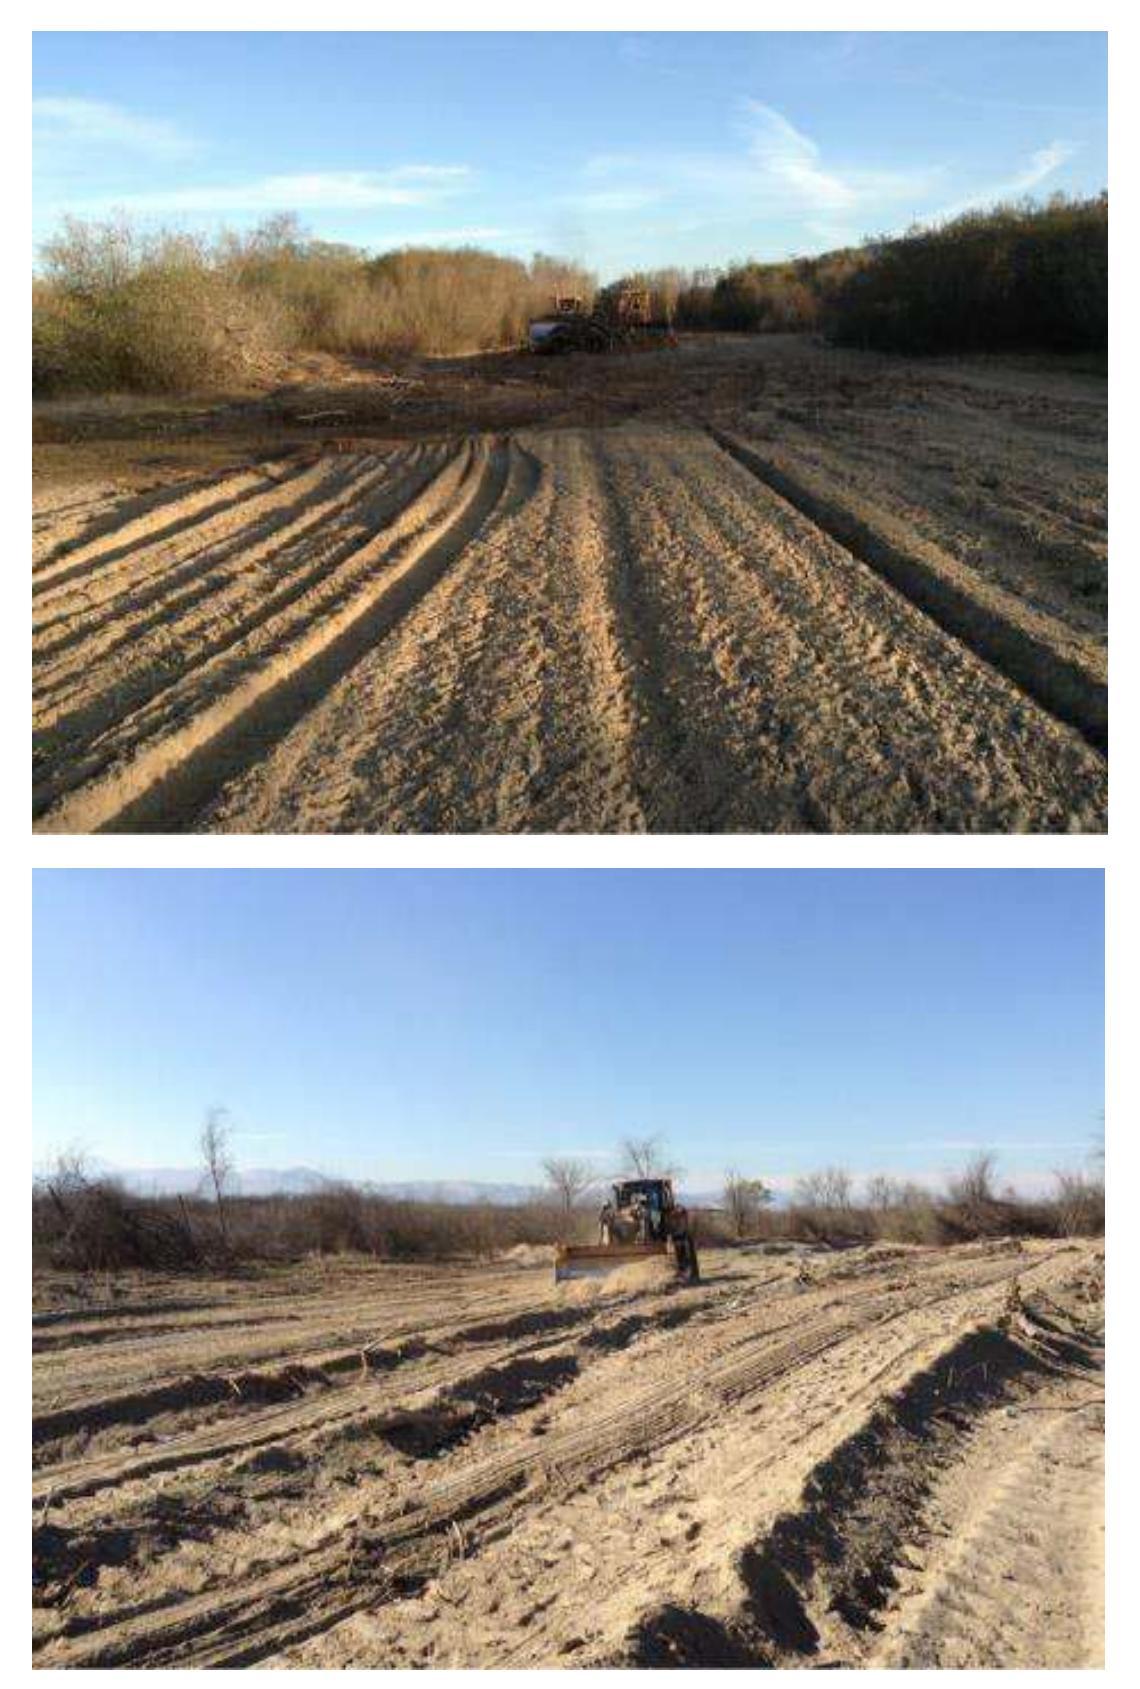
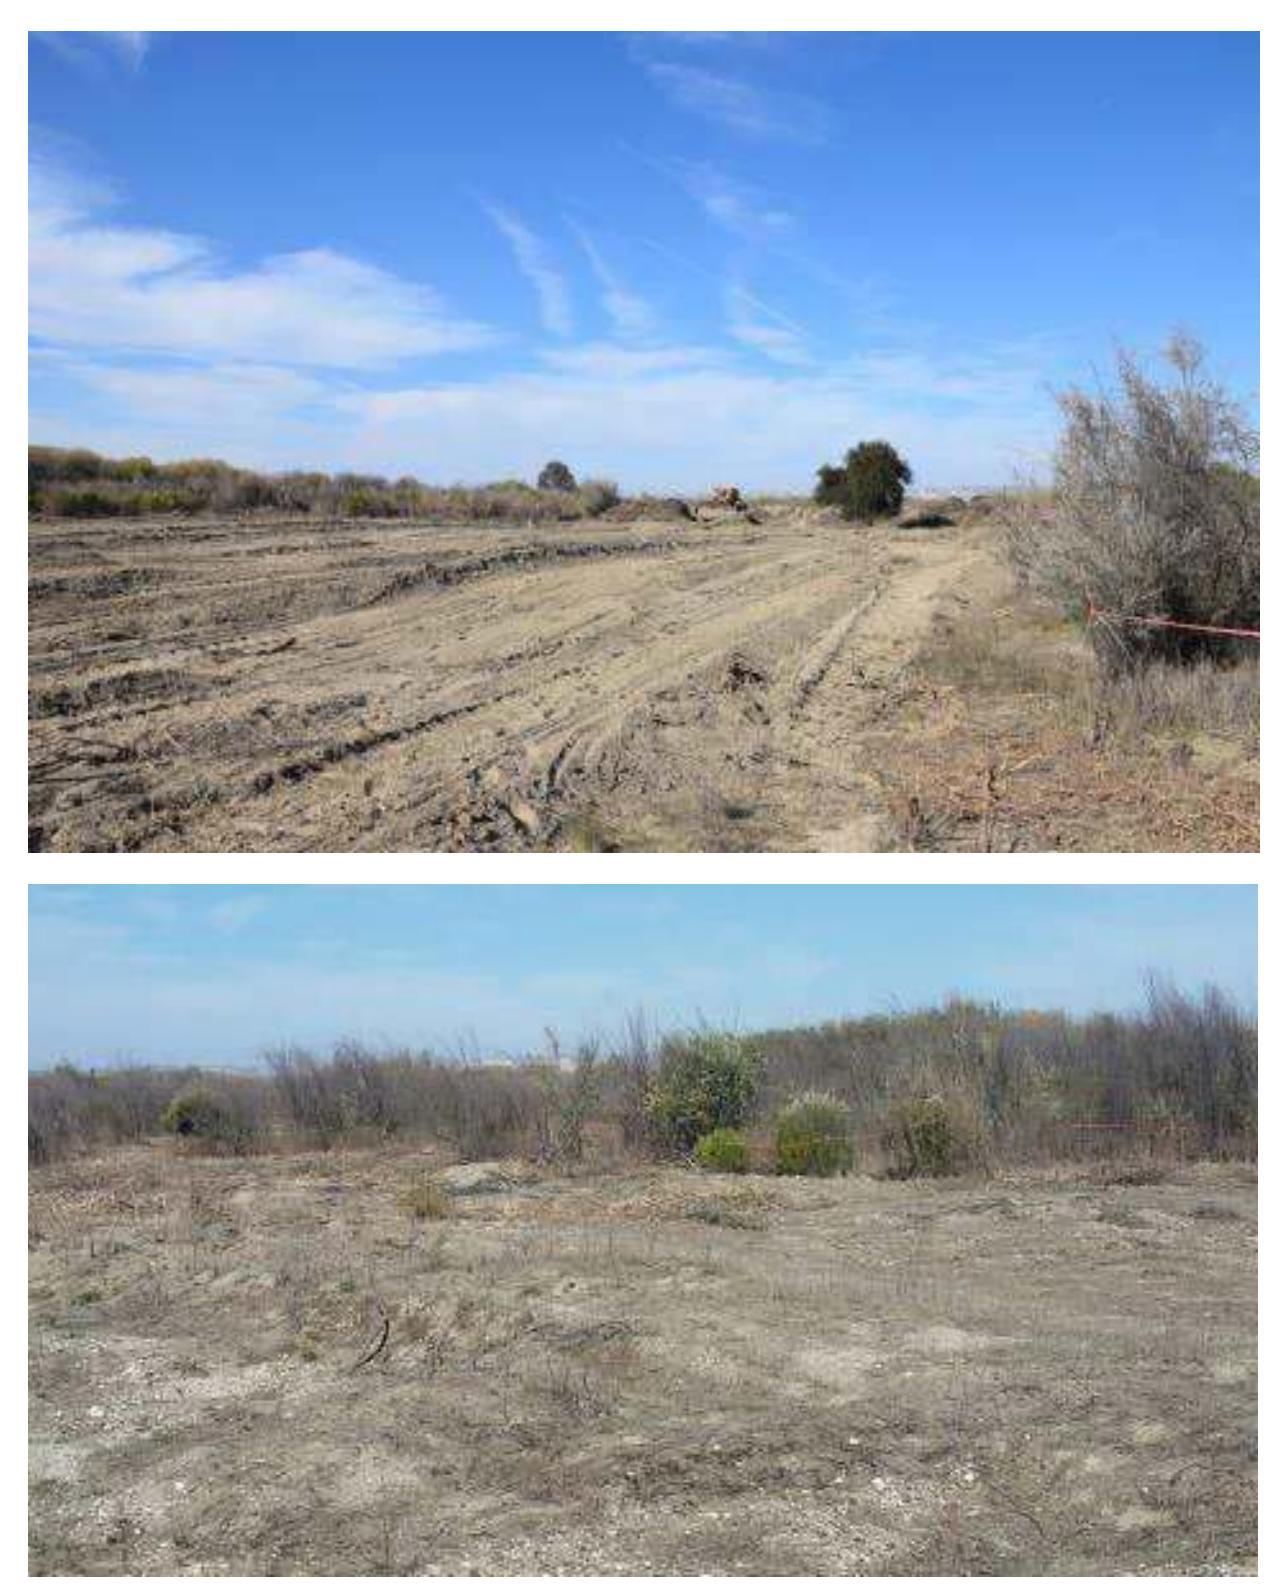
Grading

Post-work Avoidance Areas (wood rat nests & wetlands shown with red flagging)

No sediment removal occurred and no stockpile locations were utilized during the maintenance season. No open trenches or other excavations with a 6 inch depth were made during the maintenance season. There was some grading performed within the maintenance areas as shown in the tables below.
