P A S T  
CONSULTANTS LLC

September 27, 2022

Re: Focused Phase Two Historic Assessment for 1451 Ondulado Rd., Pebble Beach, CA  
APN. 008-441-033-000

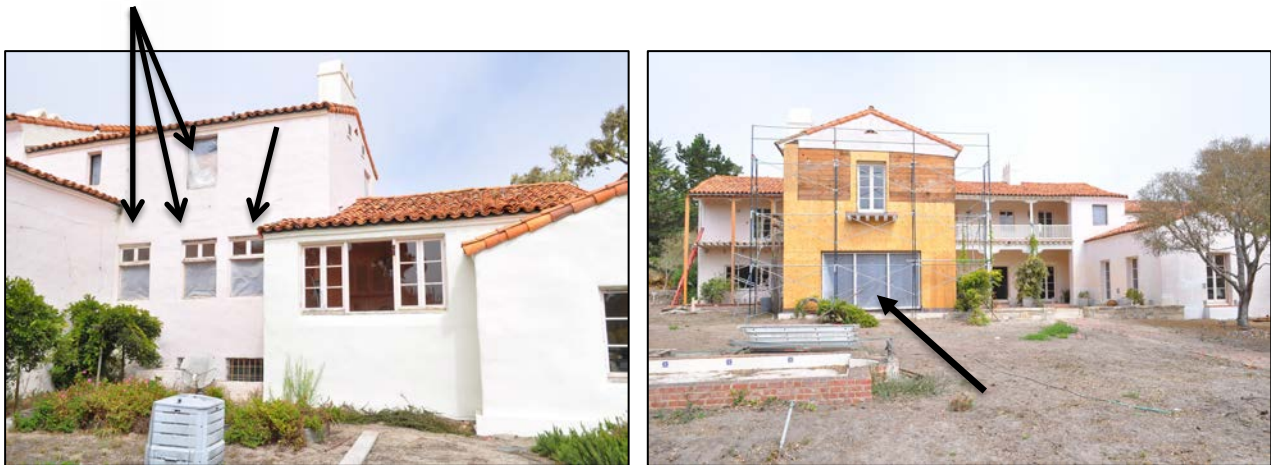
**Figures 1 and 2.** Left image details the rear (south) elevation, where windows will be replaced in-kind (arrows). Right image shows the rear (south) elevation. The large area of plaster repair was due to poor waterproofing, allowing water to enter behind the wall. Stucco will be reapplied in-kind to match the original stucco. The wide picture window (arrow) can be replaced because it is a non-historic addition to the building.

- Replace kitchen and upper-floor windows at various locations in-kind with regard to material and number of panes.
- Repair dining room balcony deck paving in-kind. Raise balcony height to code-required 42 inches. Repair stucco around balcony in-kind.
- Repair wood deterioration of upper floor, courtyard balcony.
- Repair large area of deteriorated stucco in-kind. Repair upper-floor balcony deck paving in-kind. Raise balcony height to code-required 42 inches. Repair stucco around balcony in-kind.

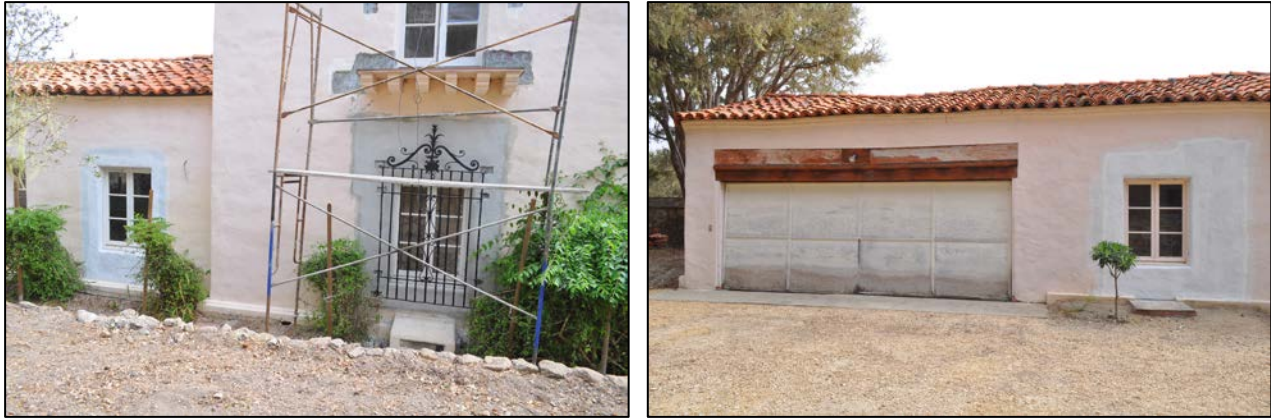
**Figures 3 and 4.** Left image details the west elevation showing typical stucco decay at window corners and at balcony, due to waterproofing issues. Wood balcony supports and balcony paving will be repaired or replaced in-kind and balcony rails raised to 42 inches to accommodate current code requirements. Right image details the west elevation garage, showing the present non-historic, single garage door. This deteriorated door will be removed and the opening returned to its original two-door configuration.

- Repair/replace deteriorated stucco in-kind around windows at various locations.

- Repair balcony corbels and deck paving in-kind. Raise balcony height to code-required 42 inches. Repair stucco around balcony in-kind.
- Remove non-historic, circa-1950s two-car garage door and return garage opening to its original two-bay composition. Repair stucco around garage openings in-kind.
