California Department of Transportation

Subject: Response to County Questions Raised in Historic Resources Review Board Staff Report, dated December 1, 2022
Reference: Garrapata Creek Bridge Railing Replacement Project (PLN220090)

The California Department of Transportation (Cal Trans) proposes to remove and replace the bridge rails on the Garrapata Creek bridge. This bridge is one of seven historic bridges in Big Sur, six of which have open spandrel designs. All seven bridges are part of the Carmel San Simeon Historic District (CSSHD), a non-contiguous district named after the rural state highway constructed between 1922 and 1938, which stretches approximately 75 miles from the San Carpoforo Creek in San Luis Obispo County to the Carmel River in Monterey County. The district includes 241 contributing elements, primarily engineering features which are a part of or adjacent to the highway: rubble masonry roadside water fountains (5), retaining walls (10), parapet walls (61), culvert headwalls (158), and concrete arch bridges (7). The Garrapata Creek Bridge is also individually eligible for listing on the National Register of Historic Places (NRHP) and the California Register of Hi

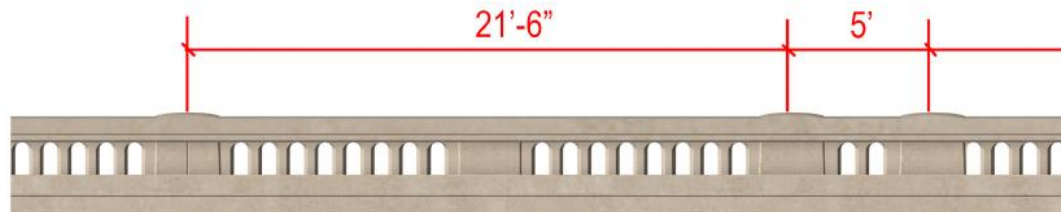
Exhibit 1: Proposed and Existing Rail Looking Toward Bridge

86H WITH TOP BEAM GROOVE LINE BACK ELEVATION

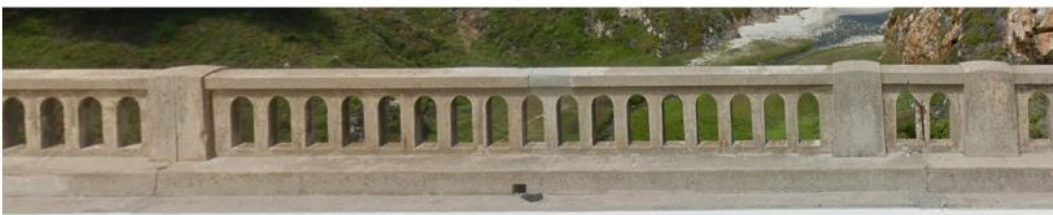
Exhibit 2: Proposed and Existing Rail Away from Bridge

86H WITH TOP BEAM GROOVE LINE FRONT ELEVATION

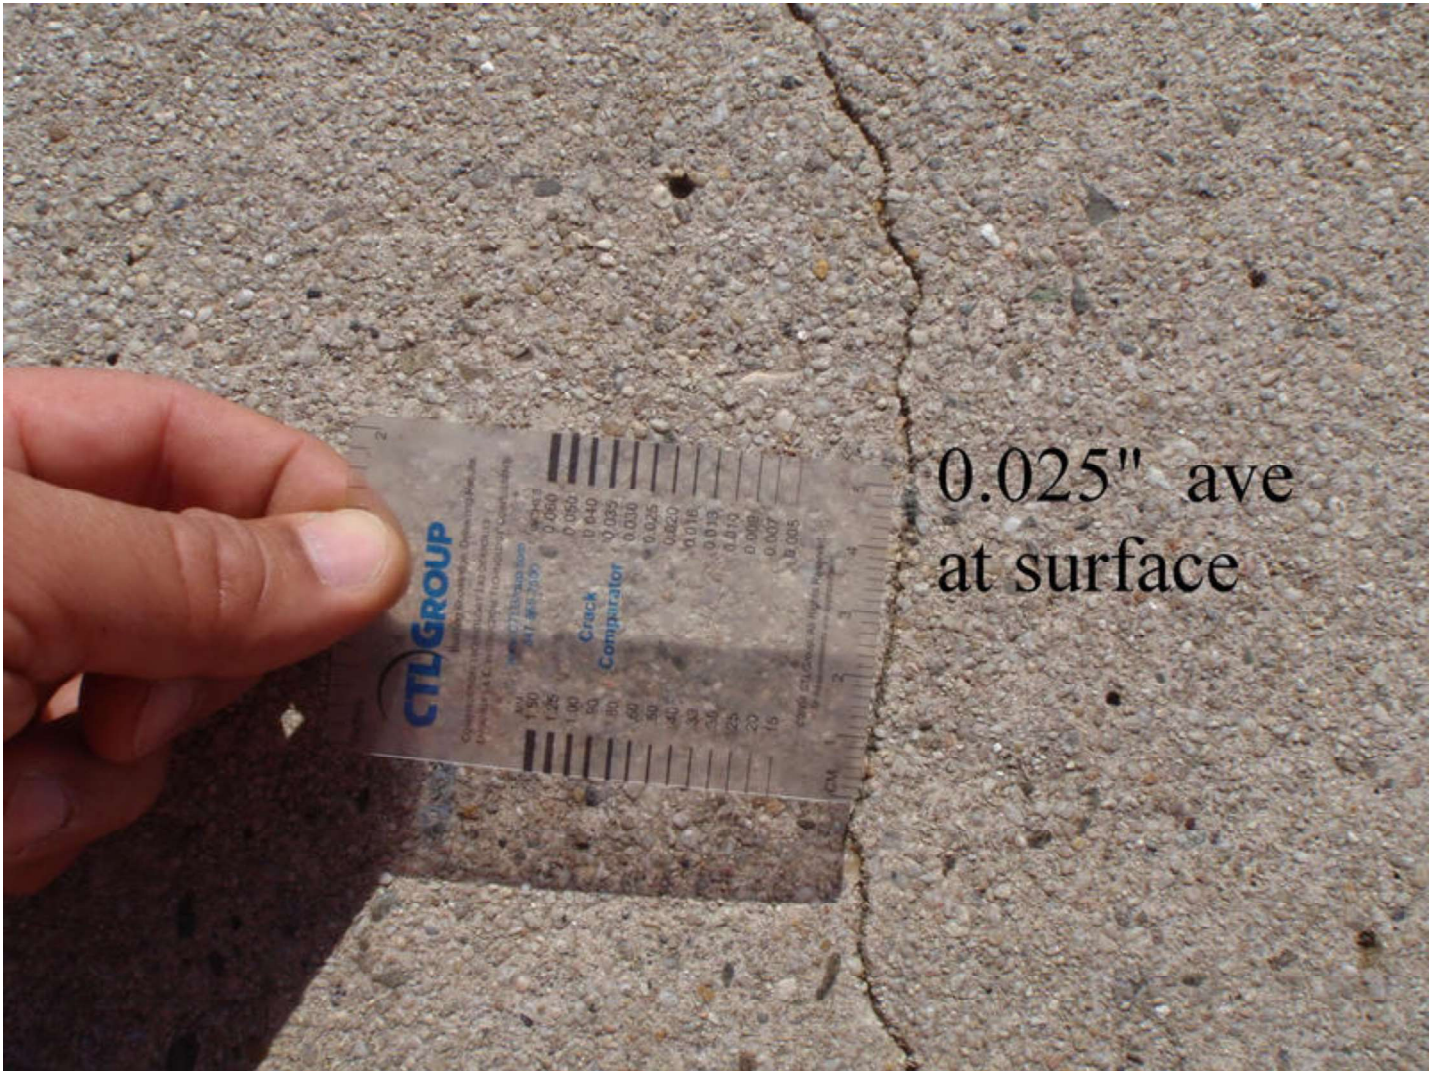
Photo #2
Typical deck crack size.

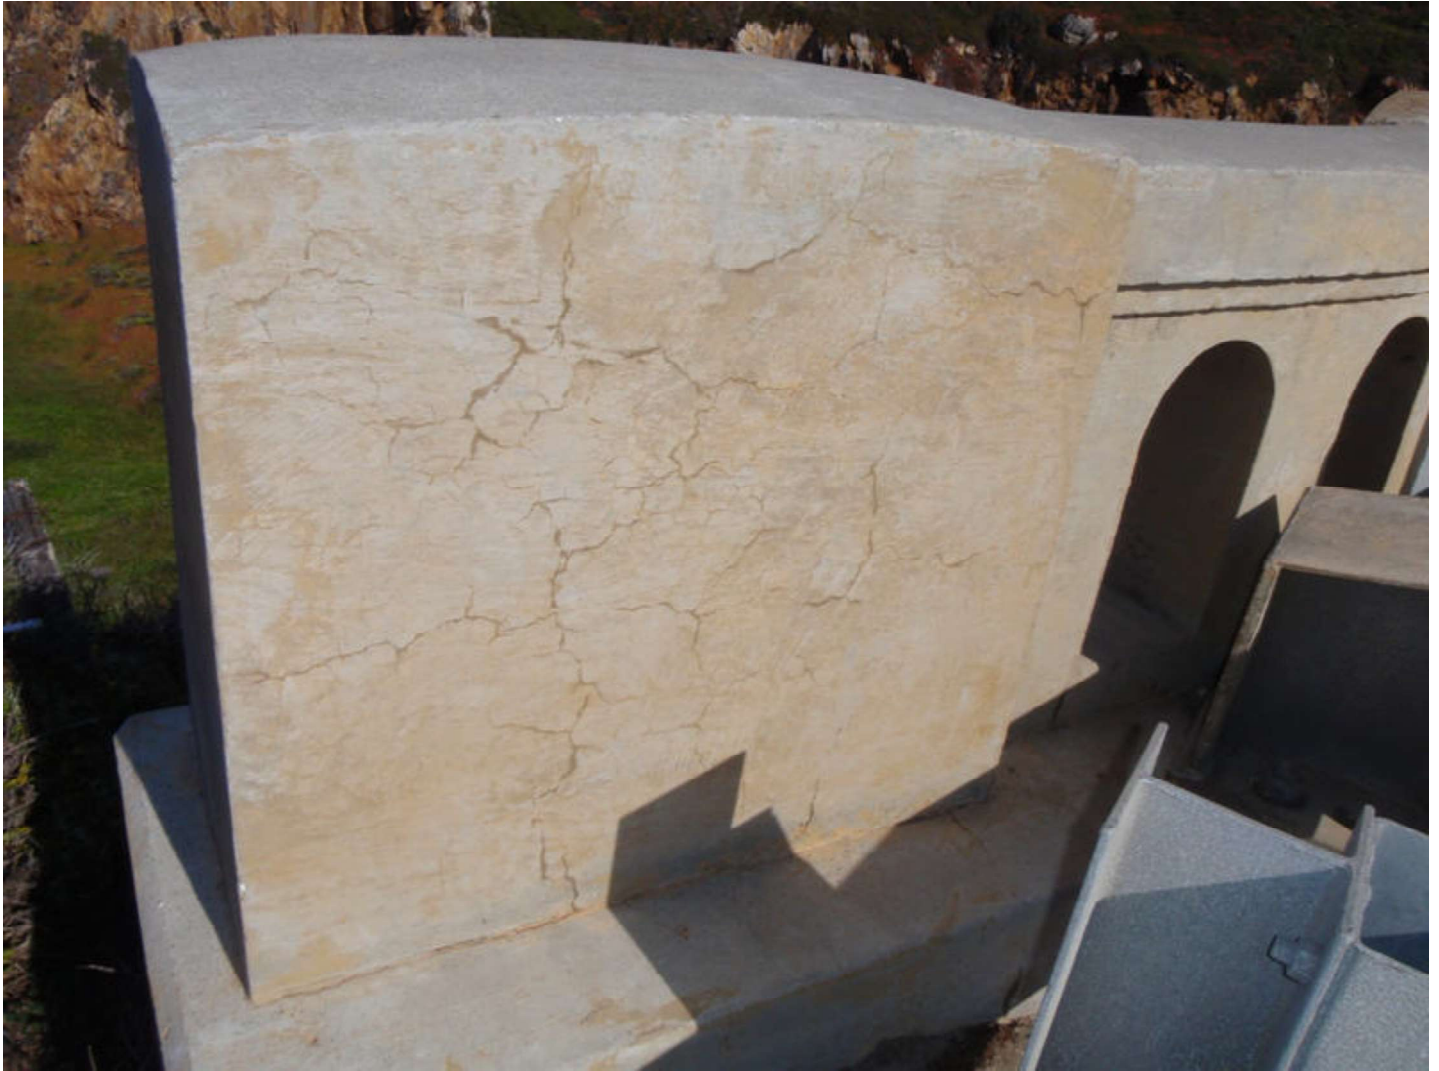
Photo #3
Pattern cracking on bridge rail end posts.

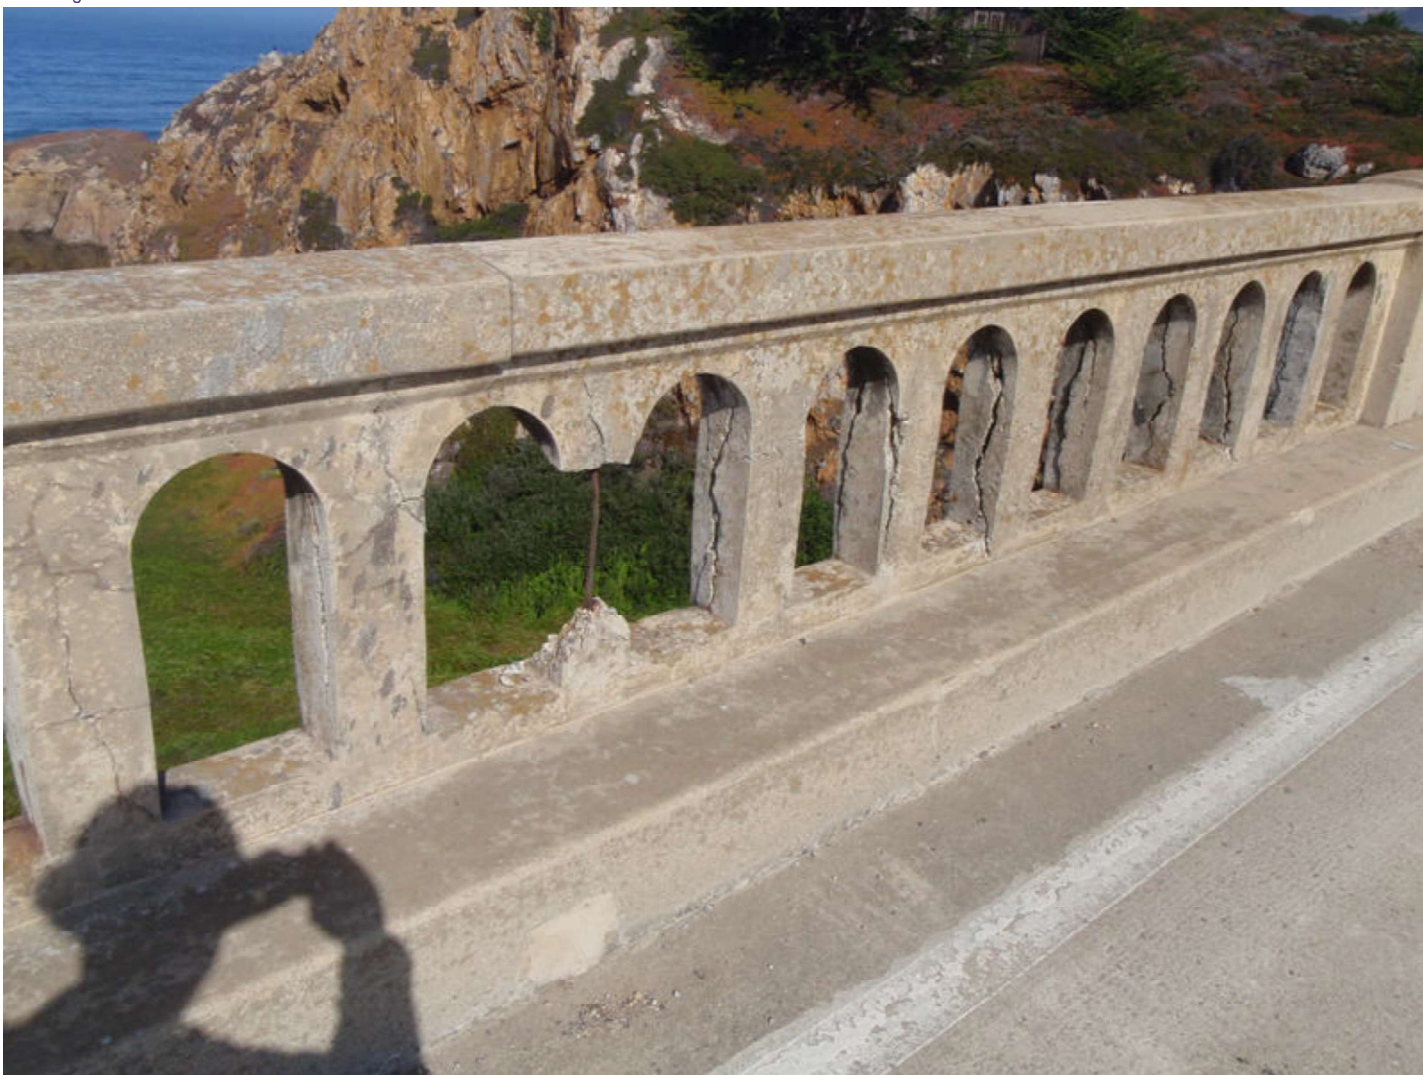
Photo #4
Gross deterioration of bridge railing.

The Tier 2 Garrapata Creek Bridge Rail Replacement project is needed because the existing rails do not meet current traffic safety standards, and as stated in the 2015 Bridge Inspection Report, portions of the existing Garrapata Creek Bridge rails have developed severe cracking caused by deterioration of concrete and reinforcing steel.

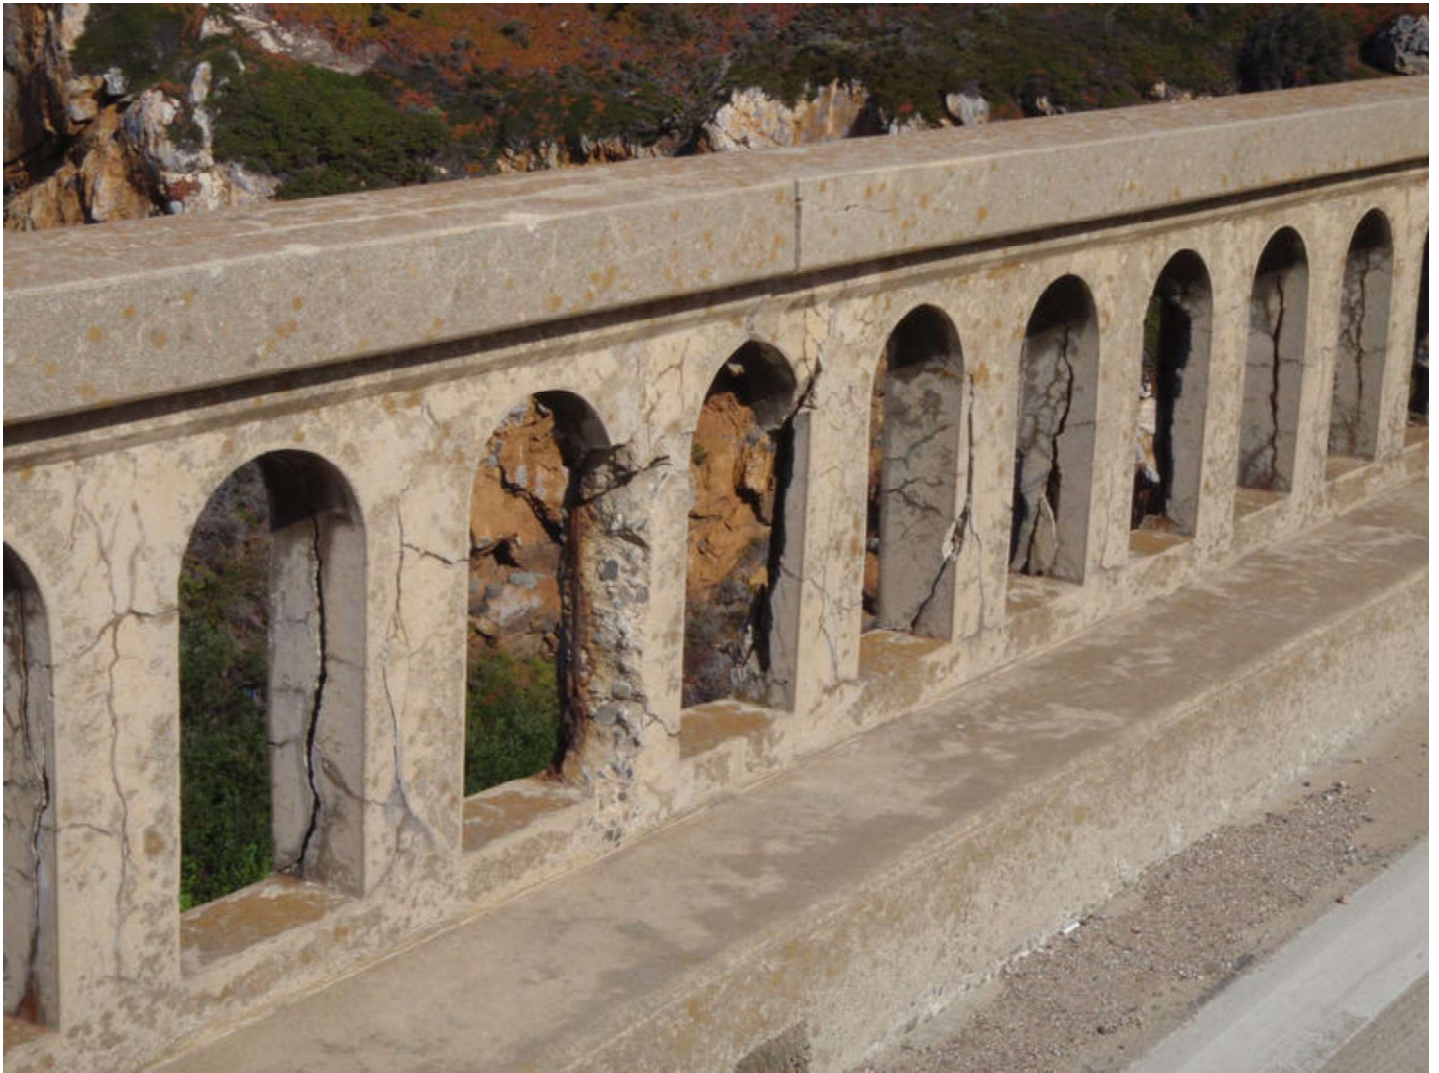
Photo #5
Gross deterioration of bridge railing.

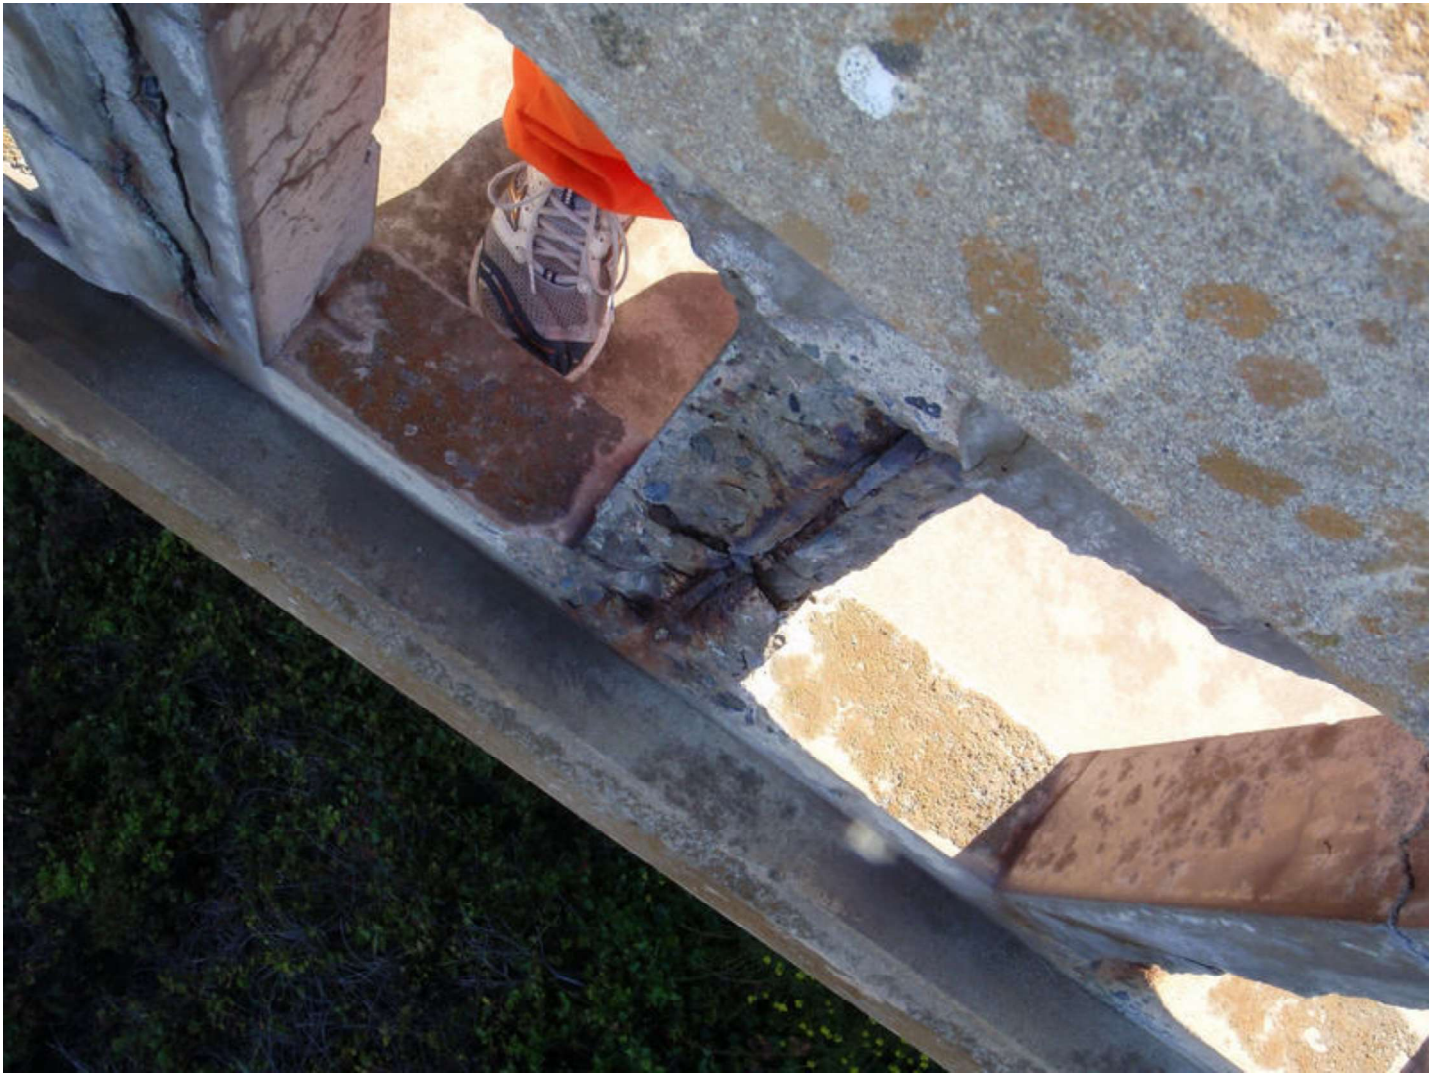
Photo #6
Gross deterioration of bridge railing.

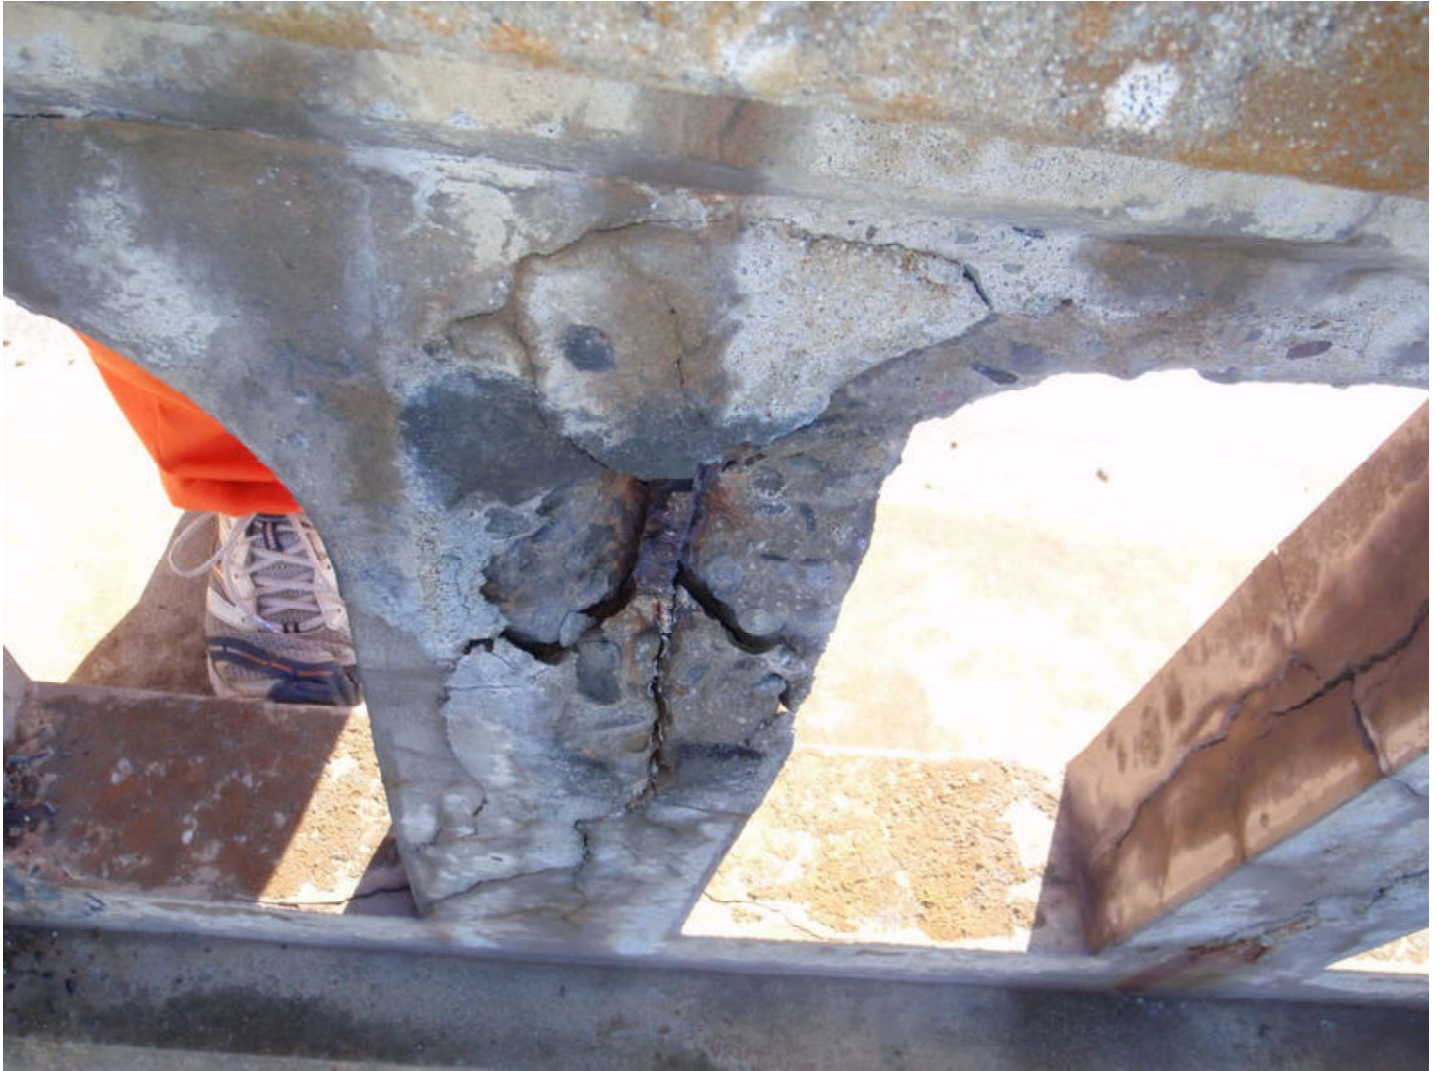
Photo #7
Gross deterioration of bridge railing.
