Exhibit A

ATTACHMENT A PROJECT DISCUSSION

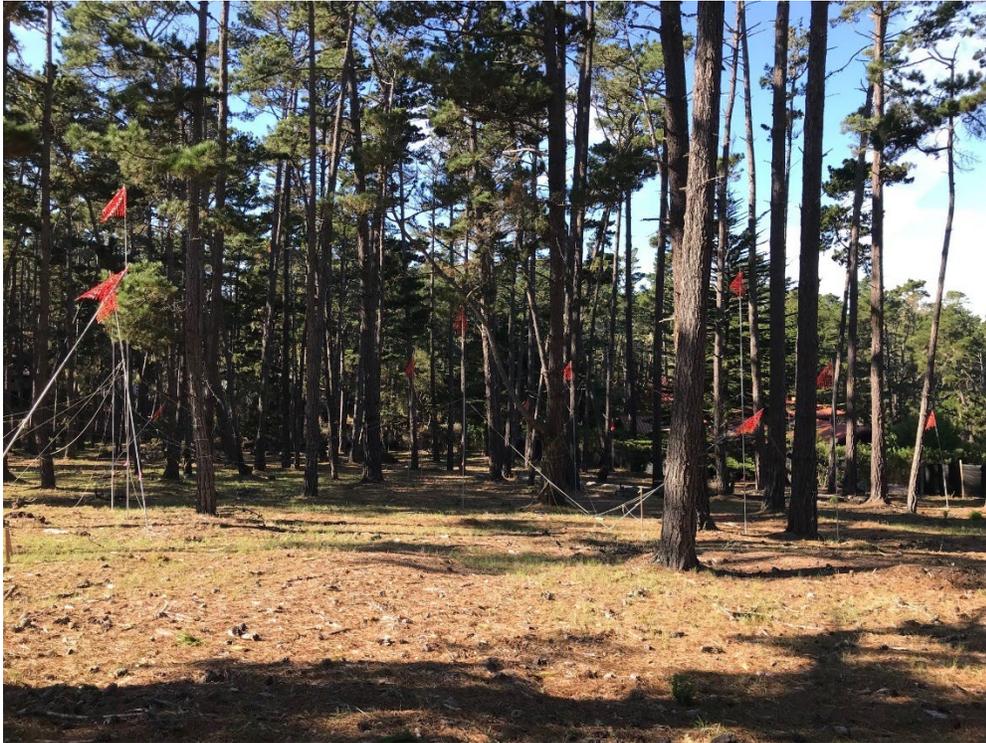
Figure 1. Photo of staking and flagging from staff's site visit

has designed their project to minimize ground disturbance and mitigate cut and fill. The trees with critical root zones that extend into the construction footprint have been recommended for removal. Therefore, staff recommend removal of the trees within the development footprint, within 5 feet of the development or are dead near the development (approx. 41) is this would be the minimum amount of tree removal in this case.
