Re: Response to HCD Staff Report Re Land Use Appeal (Resolution No. 24-039)
10196 Oakwood Circle (APN 416-542-011) - Application No. PLN230127

Re: Seismic Fault Investigation Report for 10196 Oakwood Circle, Carmel Valley, CA

FOR
PROPOSED RESIDENTIAL CONSTRUCTION
10196 OAKWOOD CIRCLE
CARMEL, MONTEREY COUNTY, CALIFORNIA

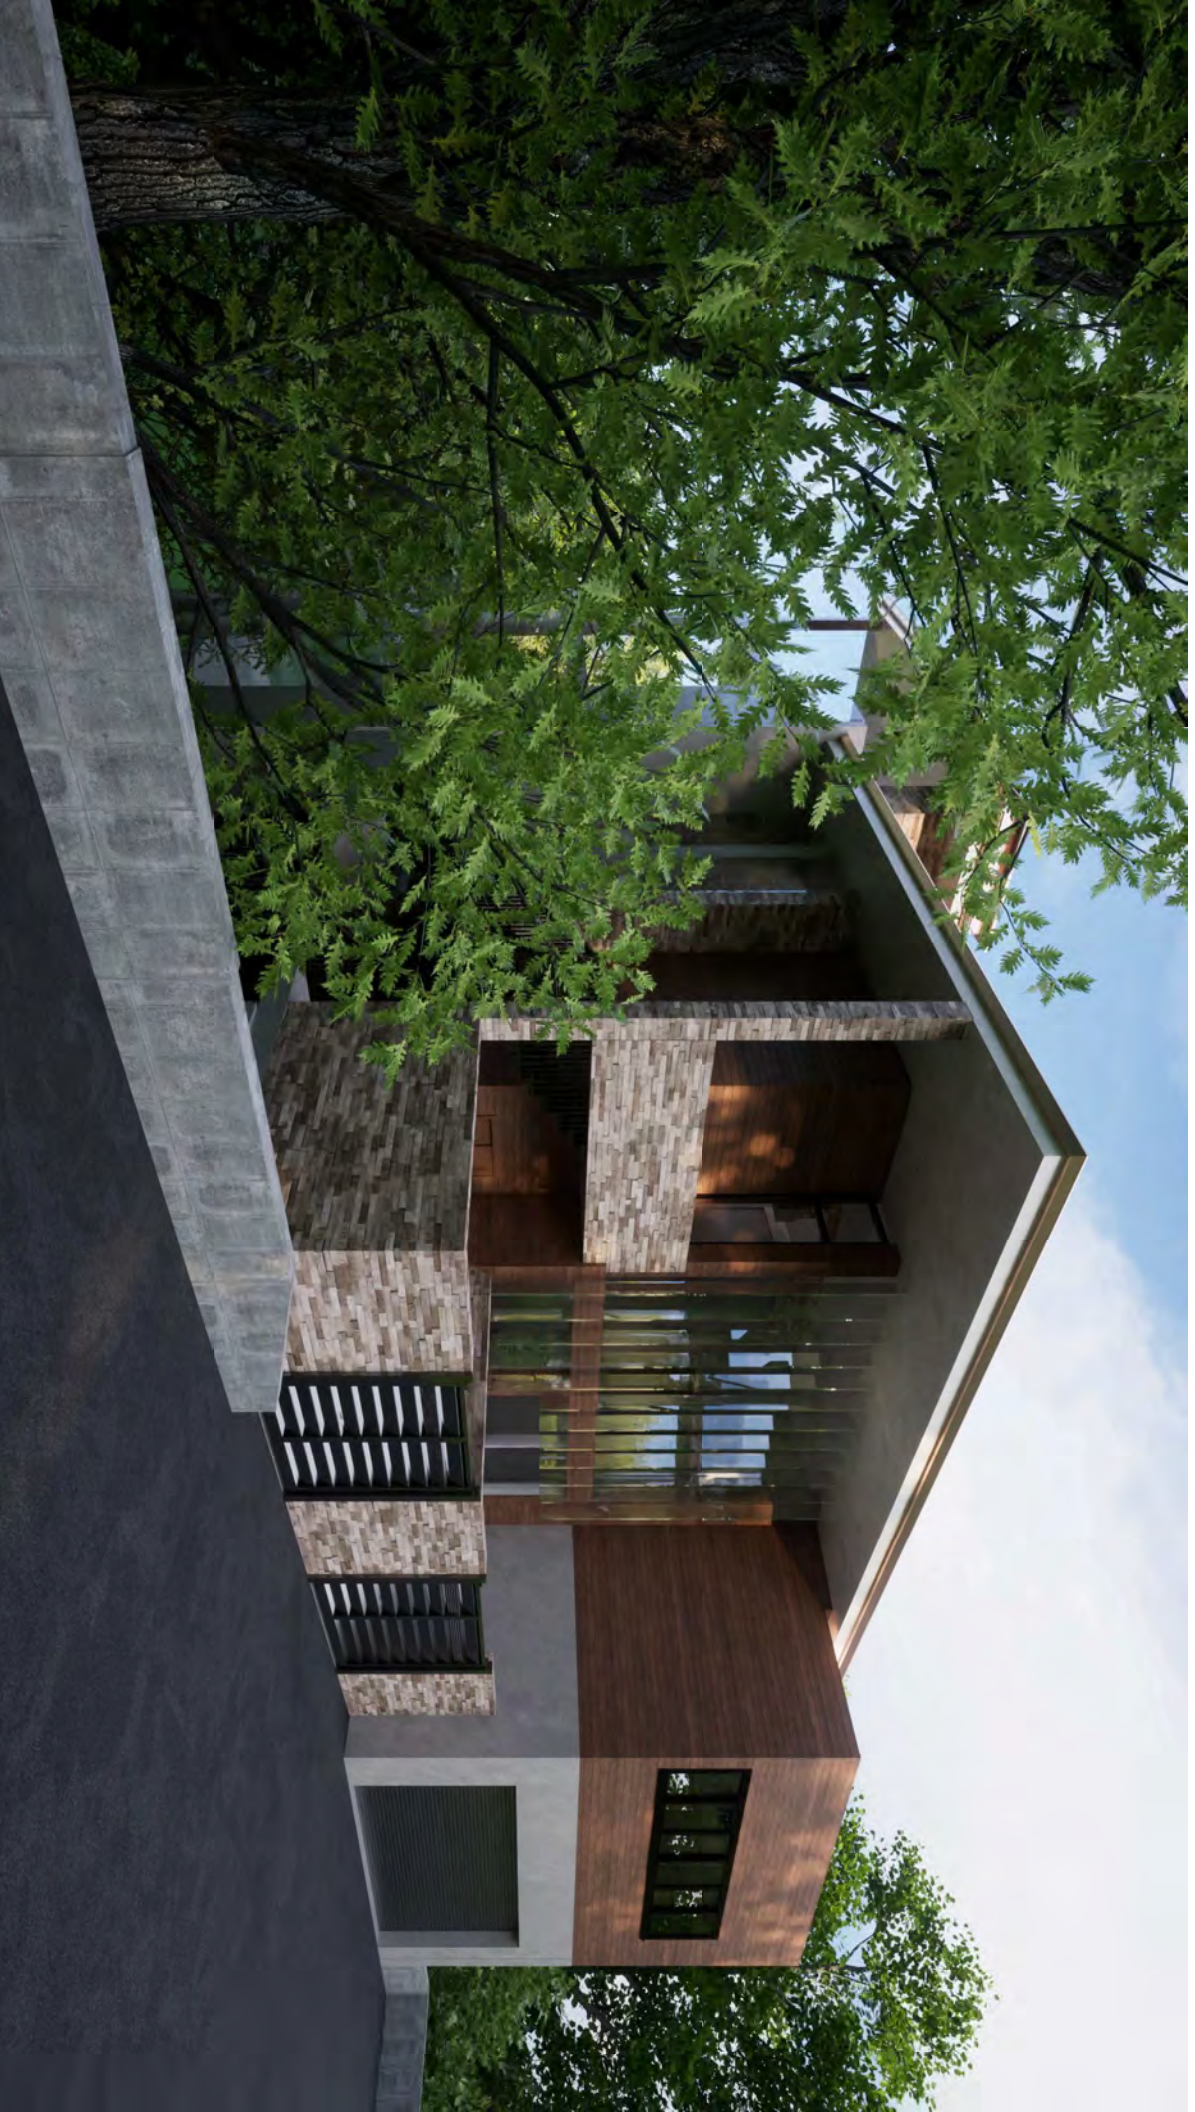
VIEW FROM CARMEL VALLEY RD WITH THE PROPOSED RESIDENCE

AVERAGE LINE OF THE TREE CANOPY ALONG THE
ROAD RETAINING WALL OF OAKWOOD CIRCLE

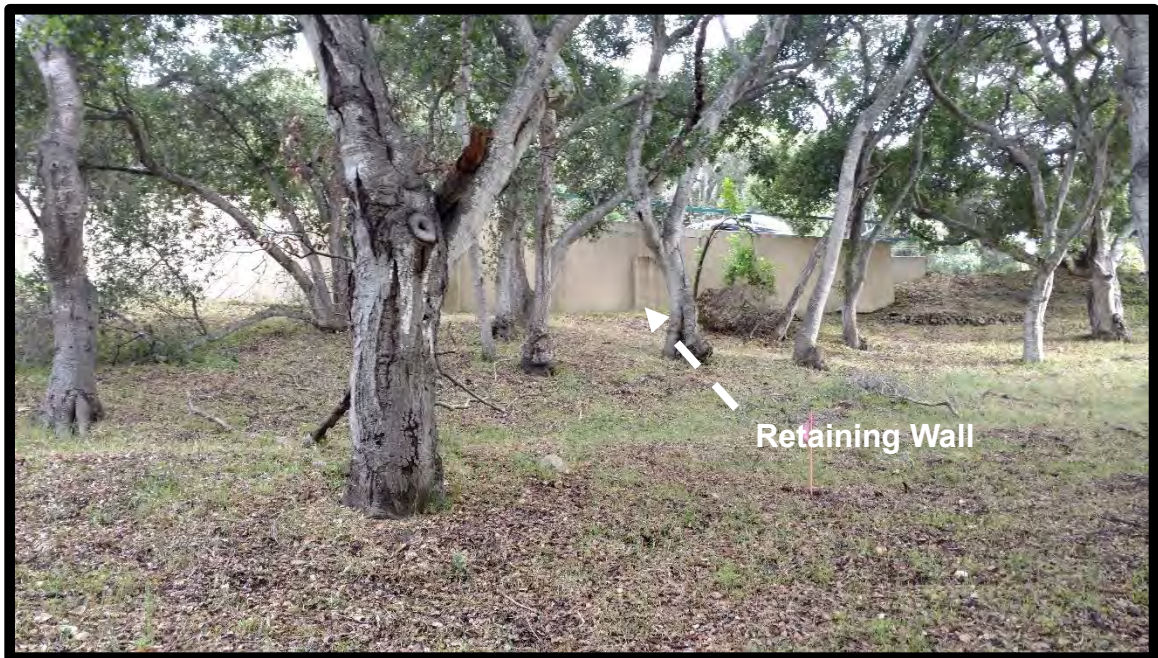
Figure 3 – Picture of Property with Retaining Wall.

Existing Conditions: The property is currently undeveloped, featuring oak woodland vegetation and exposed soil patches (Figures 1 through 4). The terrain gently slopes northward, with a concrete retaining wall separating the property from Oakwood Circle. No fault scarps, offset features, or ground cracks were observed on the property. The geotechnical investigation identified marine sandstone (siltstone) beneath the property, aligning with regional geological mapping. Two exploratory borings revealed very dense siltstone starting at 2 ft below the surface, with no groundwater encountered. There are no permanent water bodies or active streams on the property, and seasonal surface runoff follows the natural topographic slope toward lower elevations. Groundwater was not encountered in borings up to 7.5 ft deep, indicating deep groundwater levels (Appendix E).

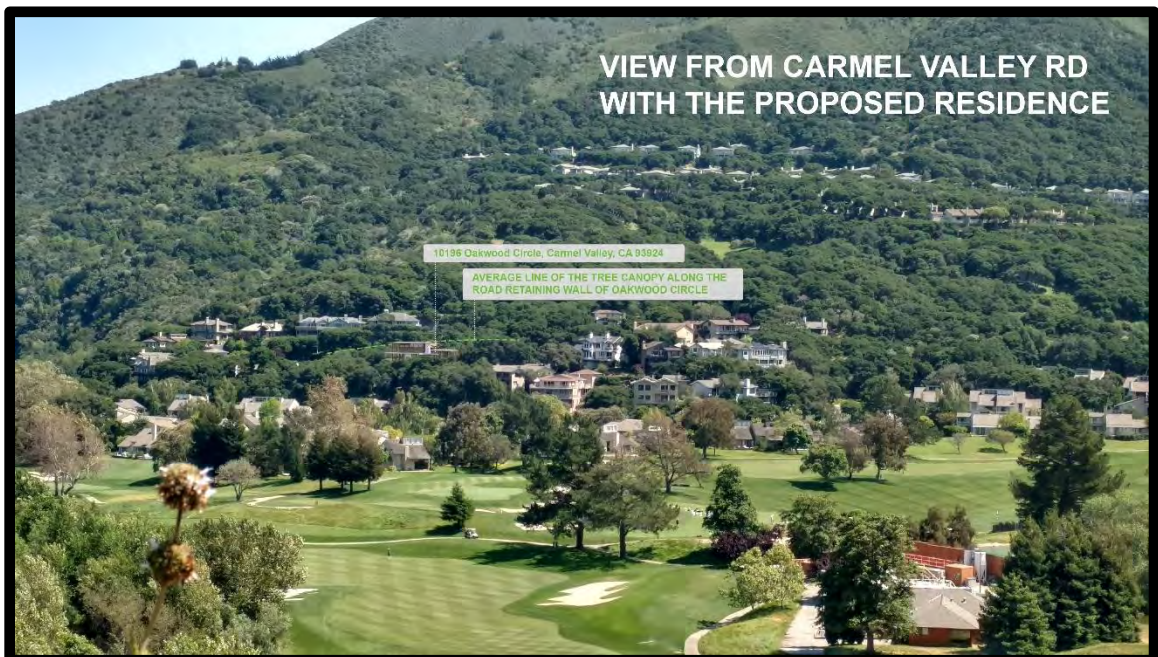
Figure 4 – View of property from Carmel Valley Road.

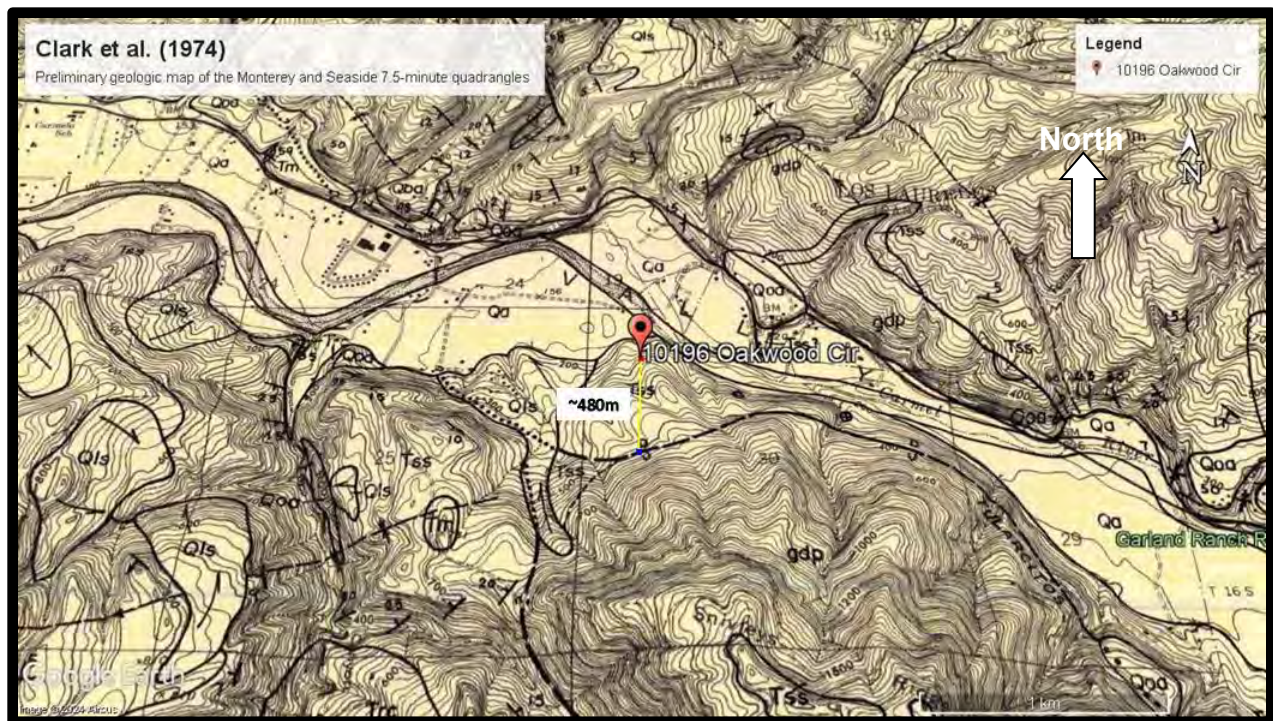
Figure 5 – Geological map by Clark et al. (1974).

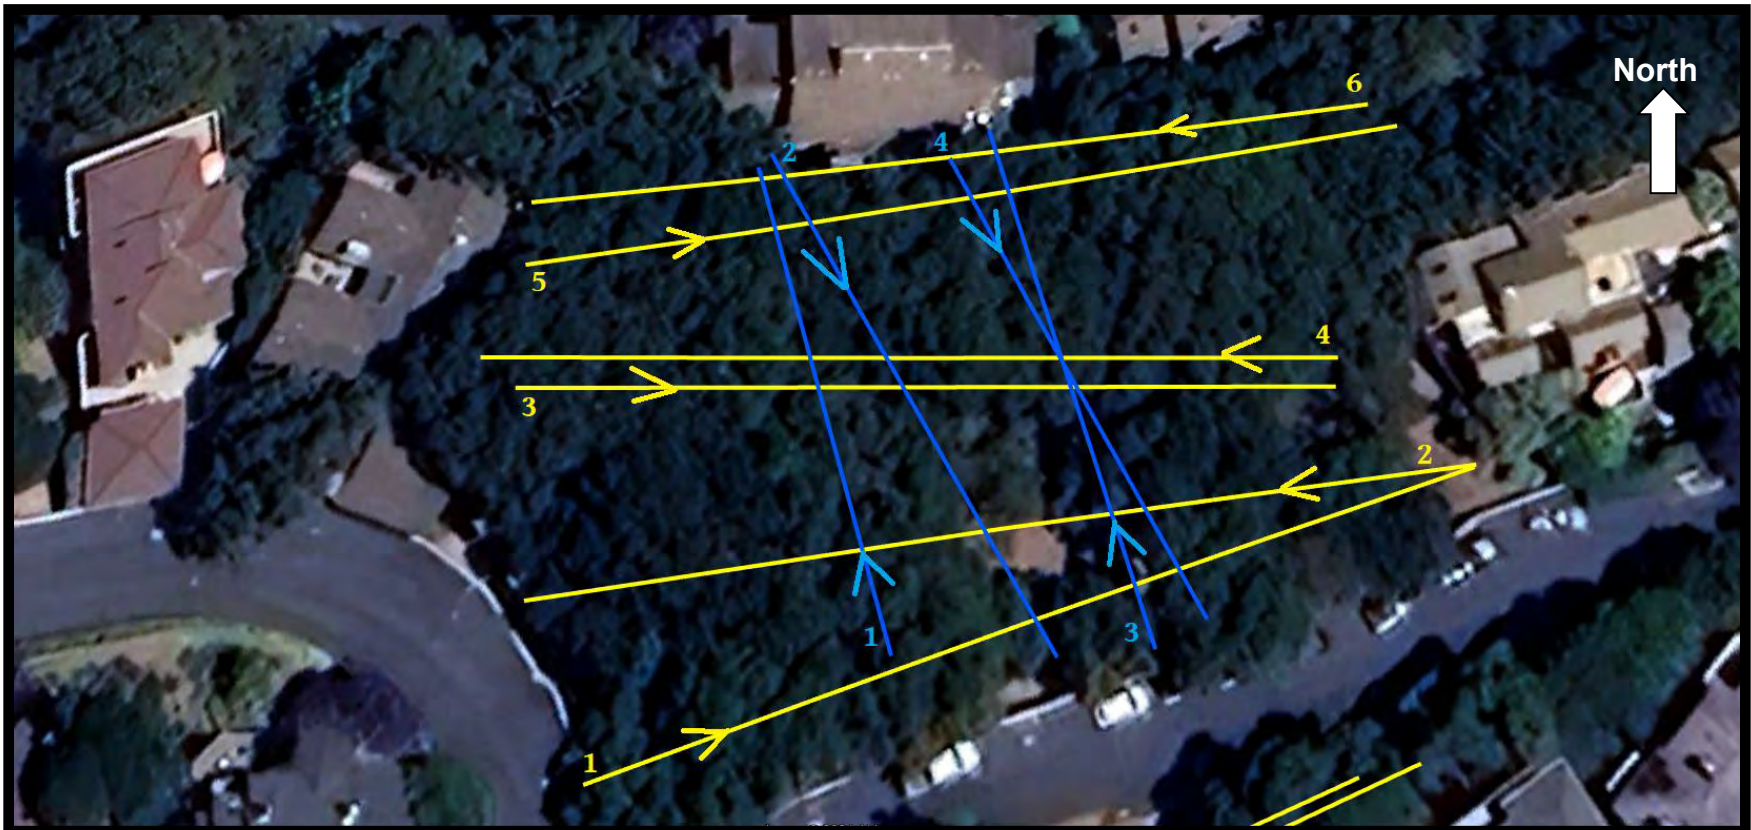
Figure 9b – Property traverses. All odd numbered transverses have an “E” after them and all even numbered transverses have a “W” after them; i.e. P01E or P02W, etc. The “E” is the direction of the traverse – East and the “W” denotes West while P01N (north) and P02S (south), etc.

- *Property:* The ten traverses on the property include four north-south traverses in blue on Fig. 9b totaling 195 m (640 ft) averaging 49 m (160 ft) long and six east-west traverses in yellow on Fig. 9b totaling 430 m (1,410 ft) averaging 72 m (235 ft) long. There were no identifiable fault/fracture zone anomalies shown on these paired p-sections; P03E and P04W anomalies are likely from an unknown interference from local cultural features.

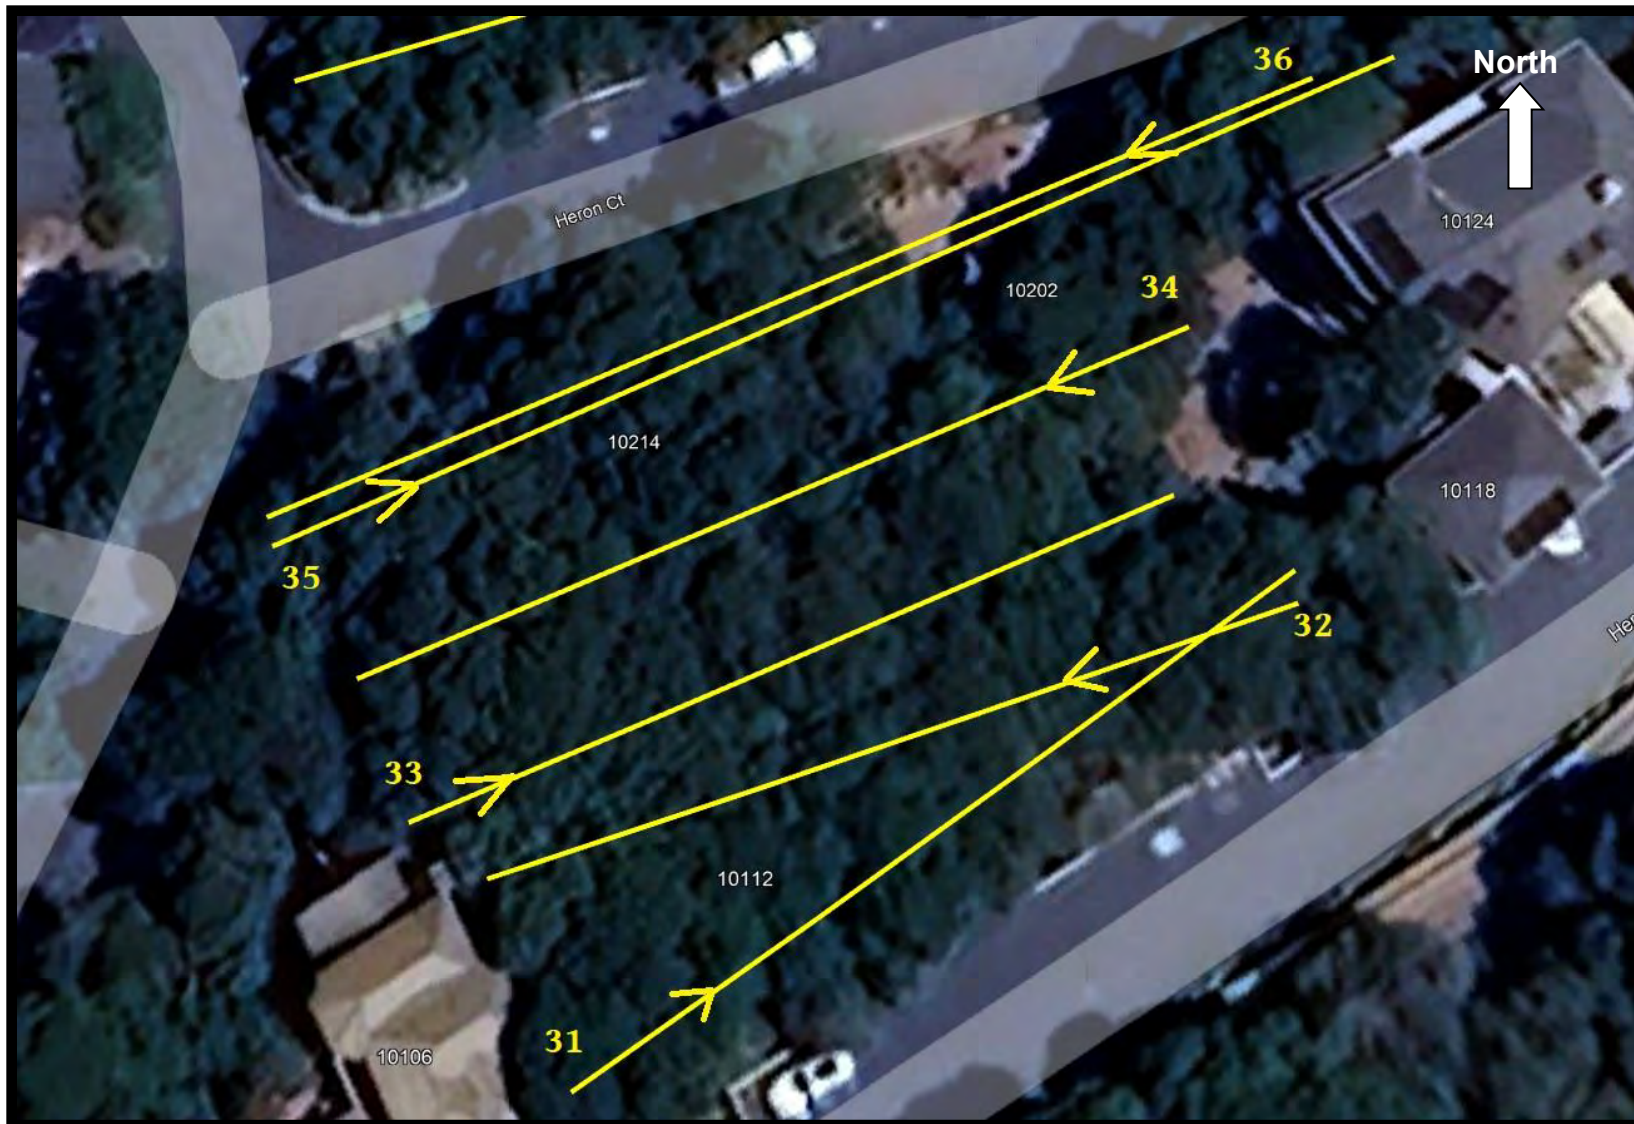
Figure 9c – Middle traverses. All odd numbered transverse have an “E” after them and all even numbered traverses have a “W” after them; i.e. P31E or P32W, etc. The “E” is the direction of the traverse – East and the “W” denotes West.

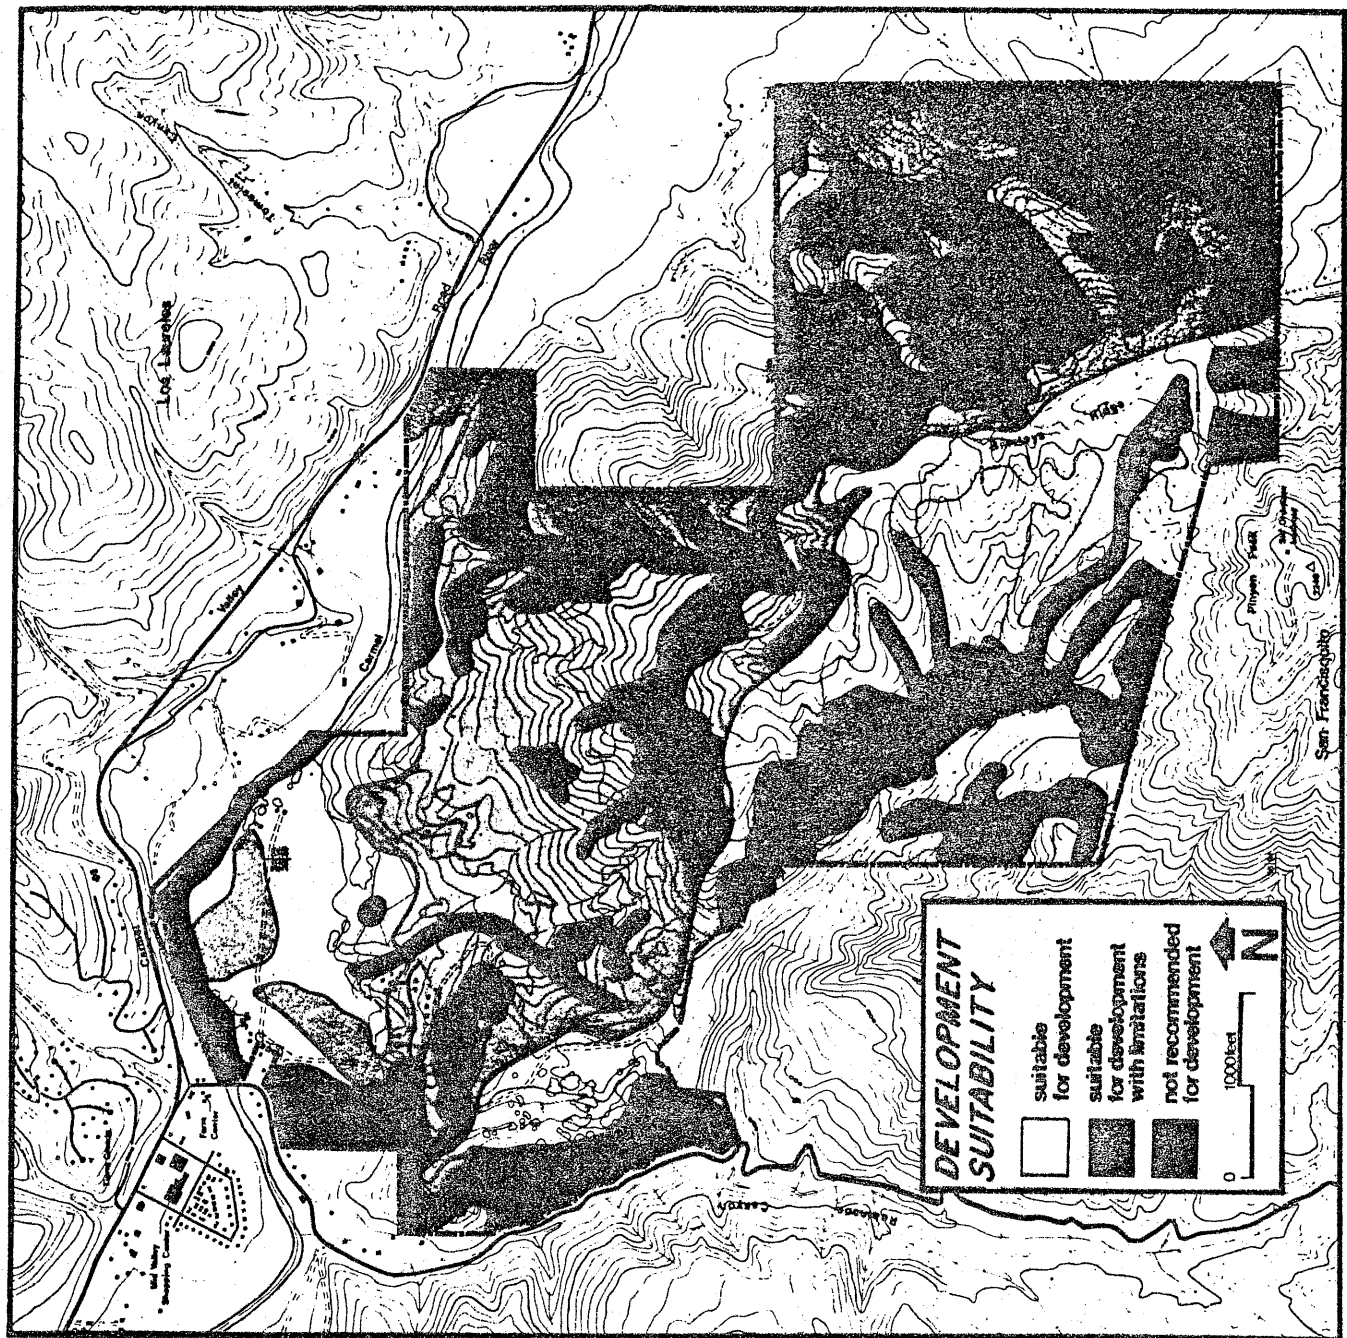
FIGURE 2.3

The physical characteristics of the site offer constraints to development. A development suitability map was prepared by Unique Golf Concepts, combining the available environmental data on the site. Although the use of this map does not preclude there being environmental impacts, the information is valuable as a planning guide. The Specific Plan appears to be flexible enough to avoid definite problem areas except for an area within the 100-year flood plain of the Carmel River. This data was obtained after the Specific Plan was prepared. (See Figure 2.3 for development suitability map)

Not recommended for development:

- slopes over 50%
- active landslide areas
- 100-year flood plain
- major drainageways
- unique natural area
