**PACIFIC GAS & ELECTRIC (PLN160131)**

**RESOLUTION NO. 21-320**

## Moss Landing-Metcalf 500kV

**MOSS LANDING-METCALF 500KV  
EROSION AND SEDIMENT CONTROL PLAN**

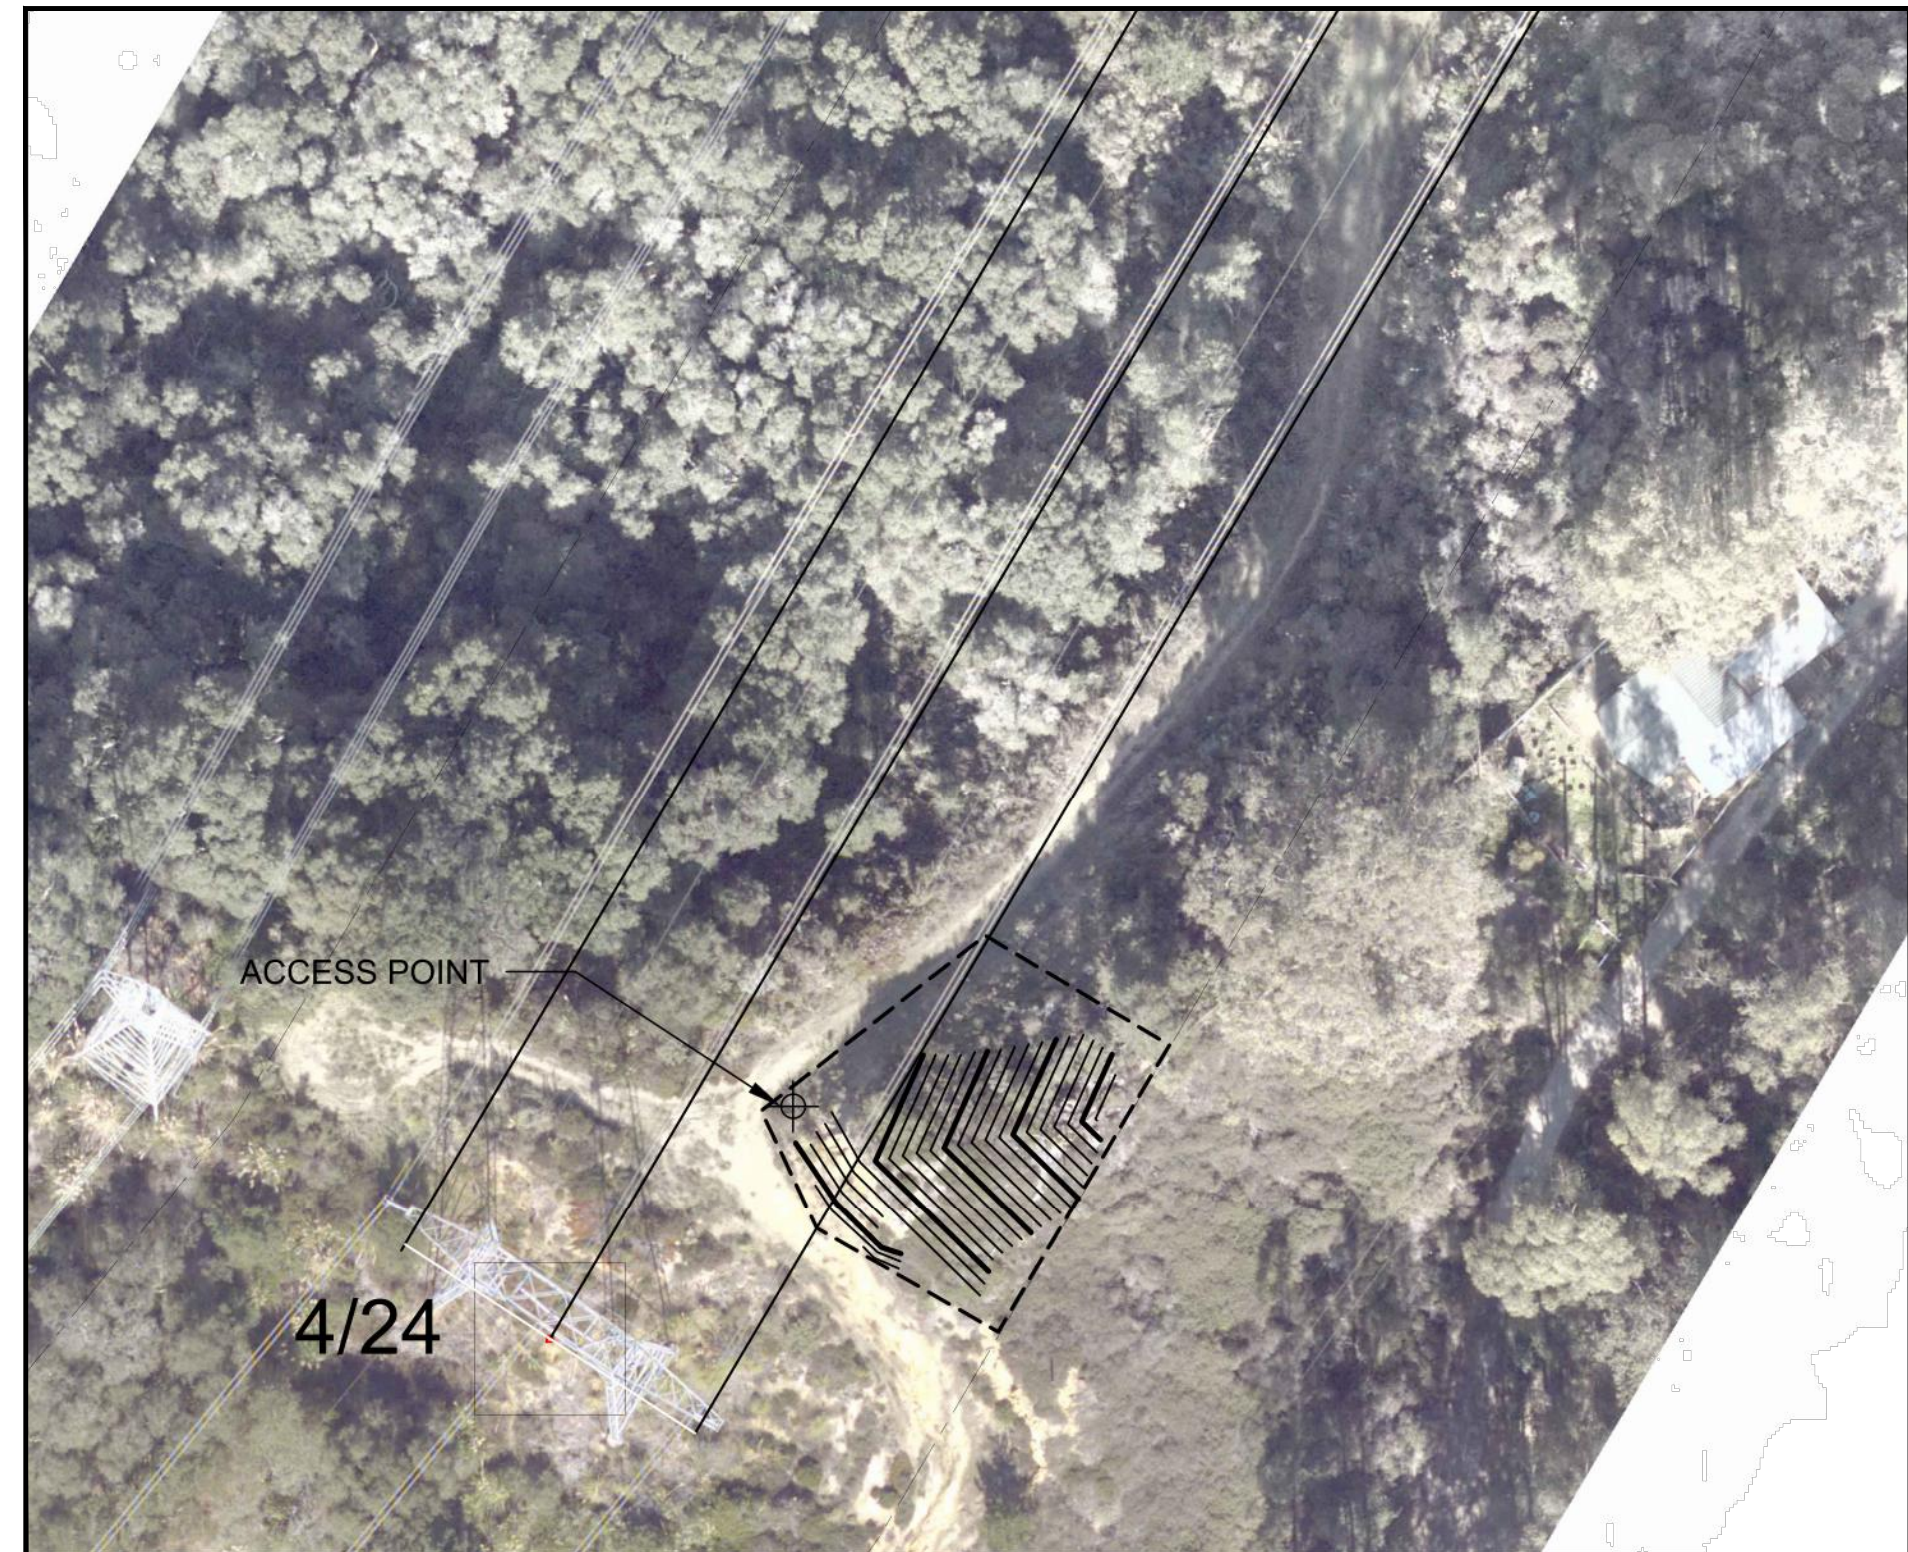
**EC1**

REFERENCE PLAN -					
BOURNS AND MCDONNELL					
MOSS LANDING-METCALF 500KV (MONTEREY COUNTY)					
FINAL GRADING PLAN SPAN 4/24-4/25					
No.	Date	Revisions	By	Ckd

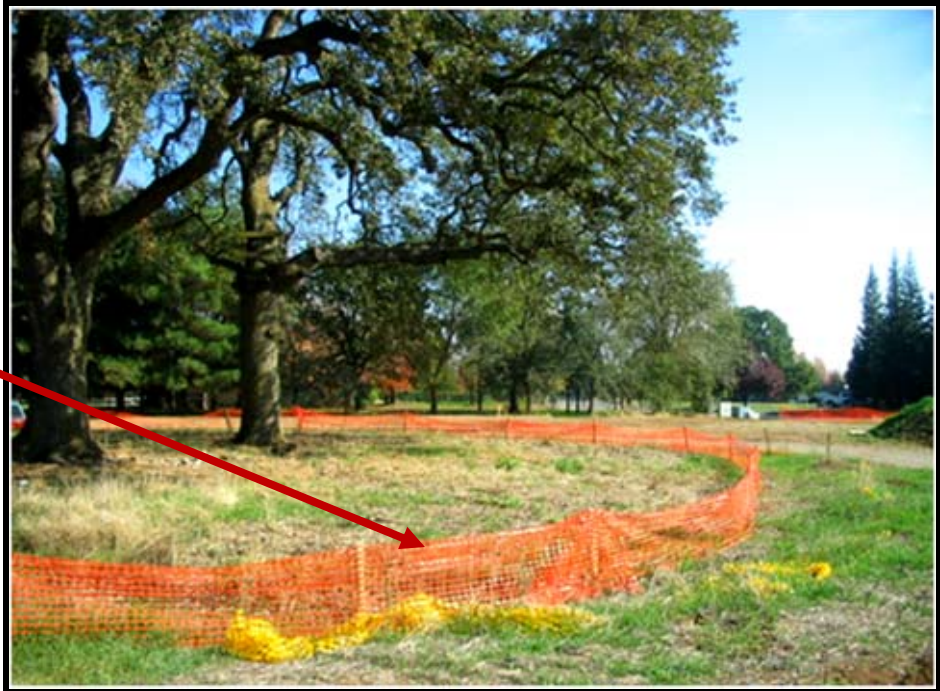
This slope should have been protected and will now be susceptible to erosion.

Ensure that vegetation protection barriers are adequate in length and delineation.

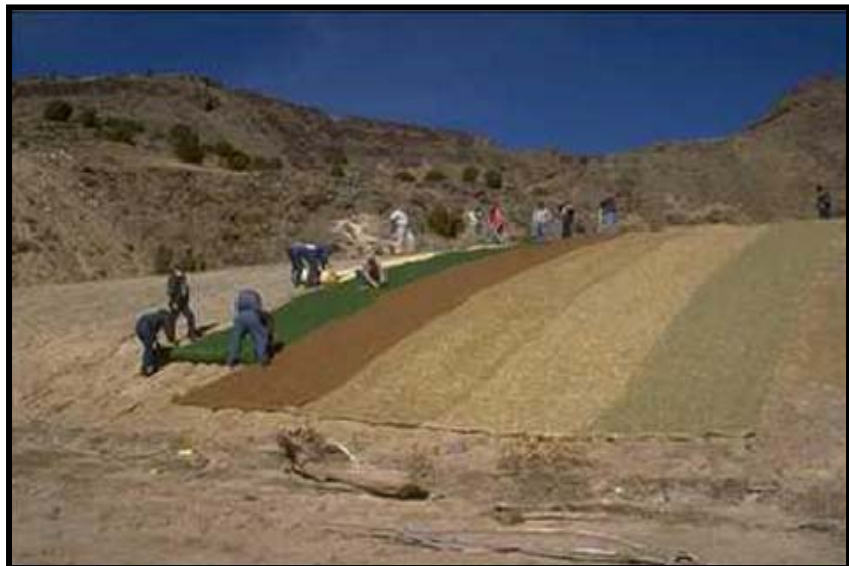
Several types of Erosion Control Blankets.

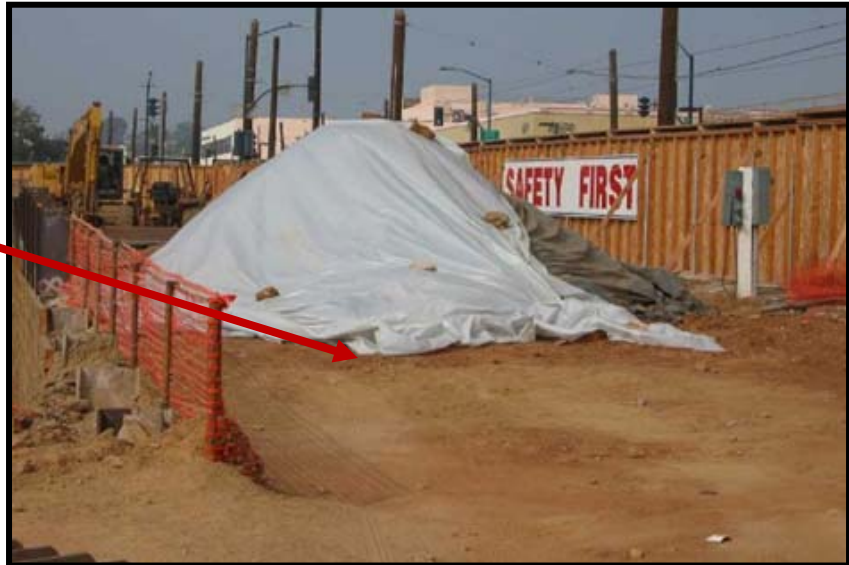
**This stockpile should have perimeter control around it. Such as, fiber rolls, a gravel bag berm, or silt fencing**

Stockpile covered with plastic and secured with large rocks. Where more than one sheet of covering is required, overlap sheets and secure at seam.

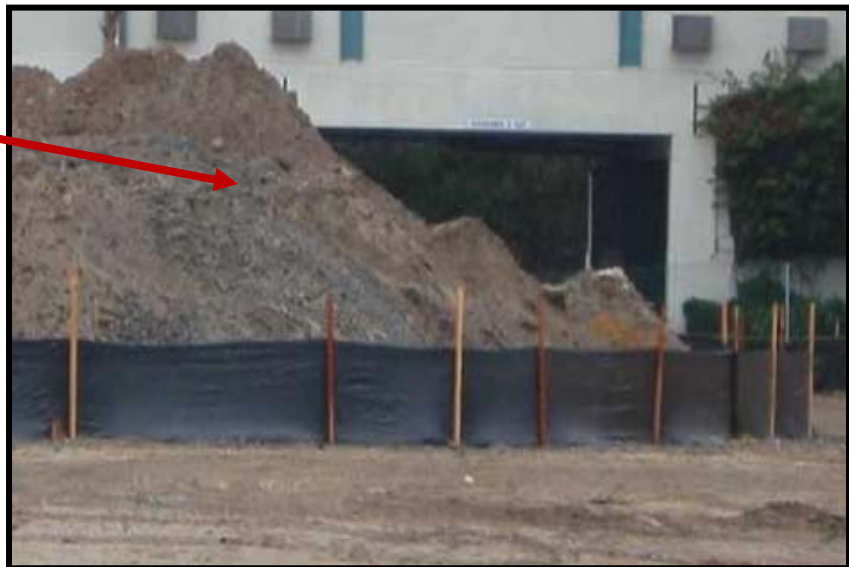
**This stockpile should be covered even though it has perimeter control.**

Silt fence as stockpile perimeter control.

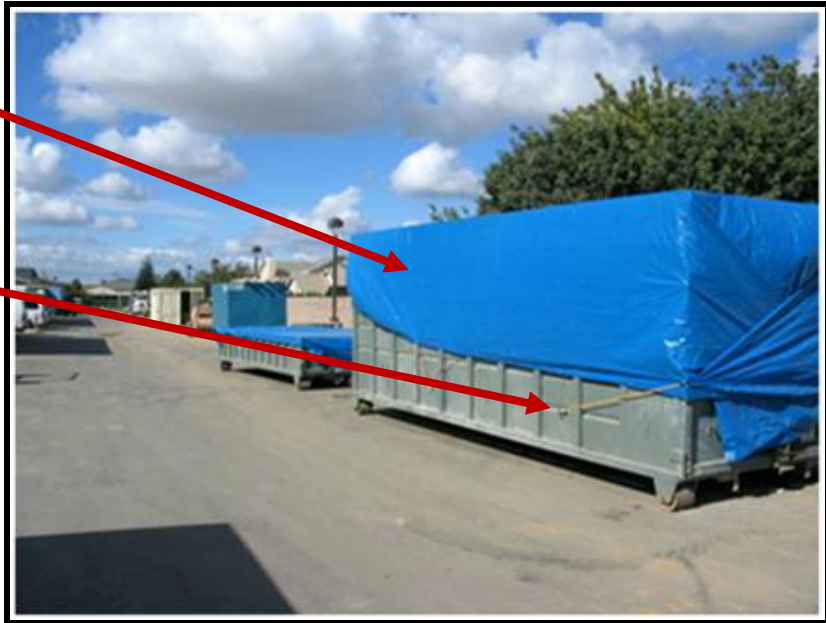
Waste bin with a tarp cover.

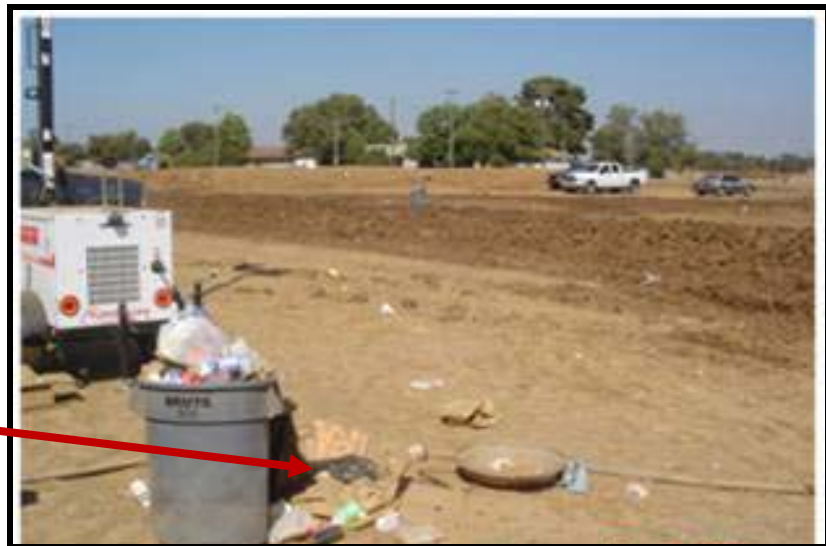
Improperly managed waste receptacle.

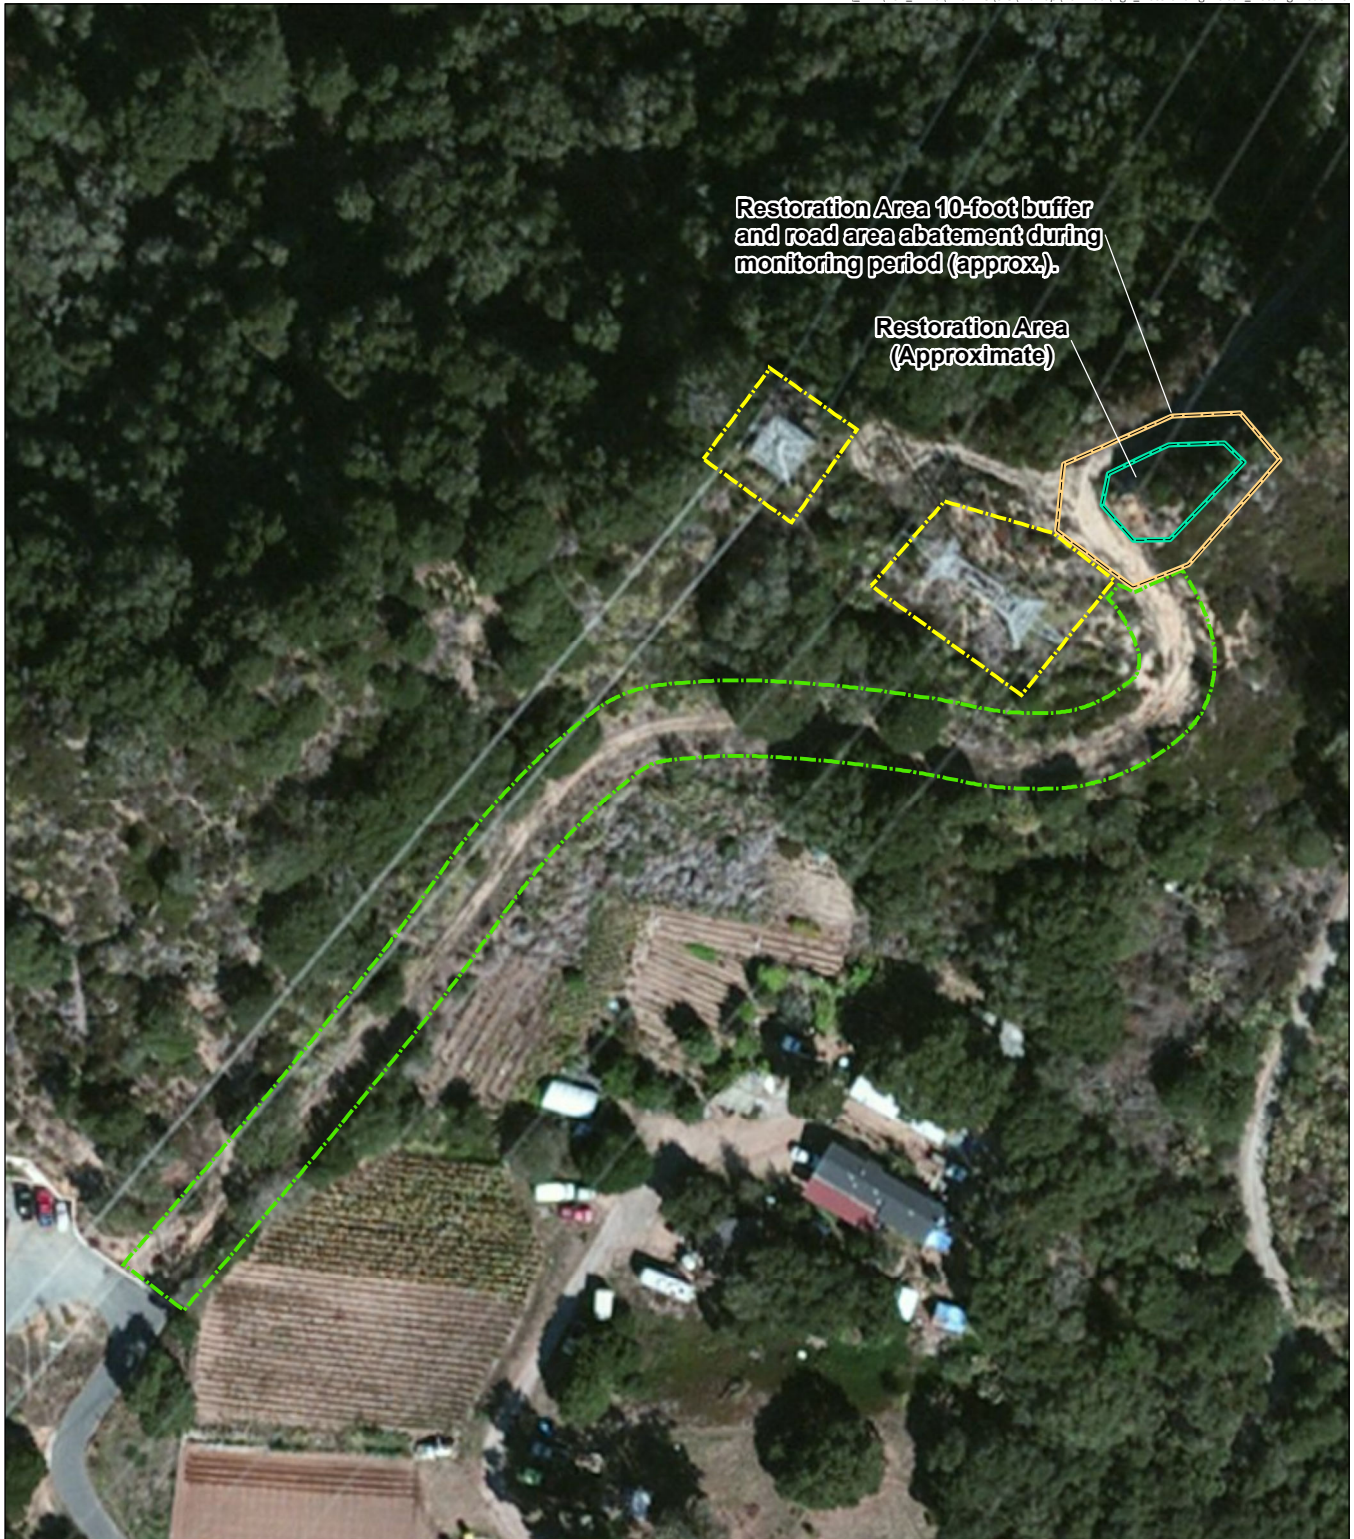
Restoration Area 10-foot buffer and road area abatement during monitoring period (approx).

Restoration Area (Approximate)
