## ATTACHMENT A DISCUSSION

### I. INTRODUCTION:

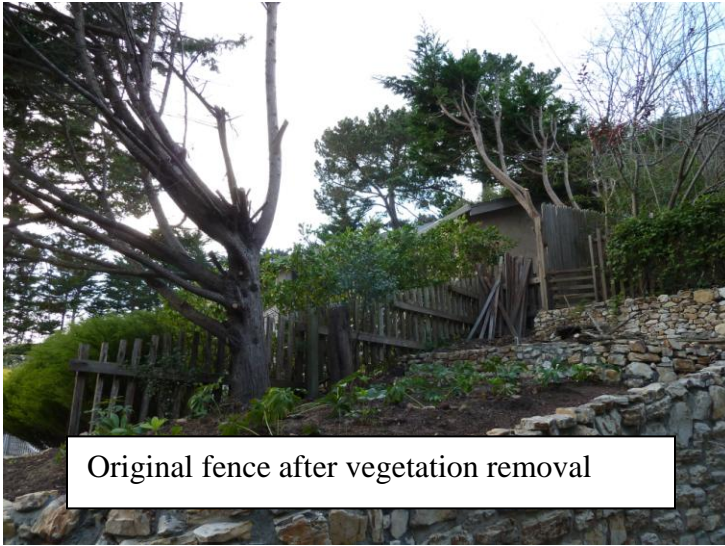
Original fence after vegetation removal

- c) Photographic evidence in the file shows that the original fence was not wire but wood. The height appears to be approximately 3 feet.
- d) The existing fence is made of weathered “grapestake” type wood and the proposed fence is redwood boards with horizontal wood members at the top and bottom, with an approximately 4-foot long section of 3-foot tall “grapestake” section at the southern (street) end. The proposed fence will eventually weather to be the same color as the existing fence. The proposed fence does not match the connecting fence on either end but does match the fence on the applicant’s western side property line. Materials for the proposed fence are subject to Board approval.

- b) The original fence was approximately 3 feet tall, made of wood and was located a few feet to the west as noted above in Staff’s Response No. 2. The age of the original fence is unknown but photographic evidence in the file shows that it was not new. The original fence was barely noticeable prior to the removal of the original terrace landscaping which included mature Monterey cypress trees, shrubbery and a hedge. After removal of the landscaping, the original fence was in full view.
