Signal Hill, LLC  
PLN100418

**ATTACHMENT B  
DRAFT RESOLUTION**

**SIGNAL HILL LLC (PLN100418)**

[PLN100418, Signal Hill LLC, 1170 Signal Hill Road, )  
Pebble Beach, Del Monte Forest Area Land Use Plan )  
(APN: 008-261-007-000)] )

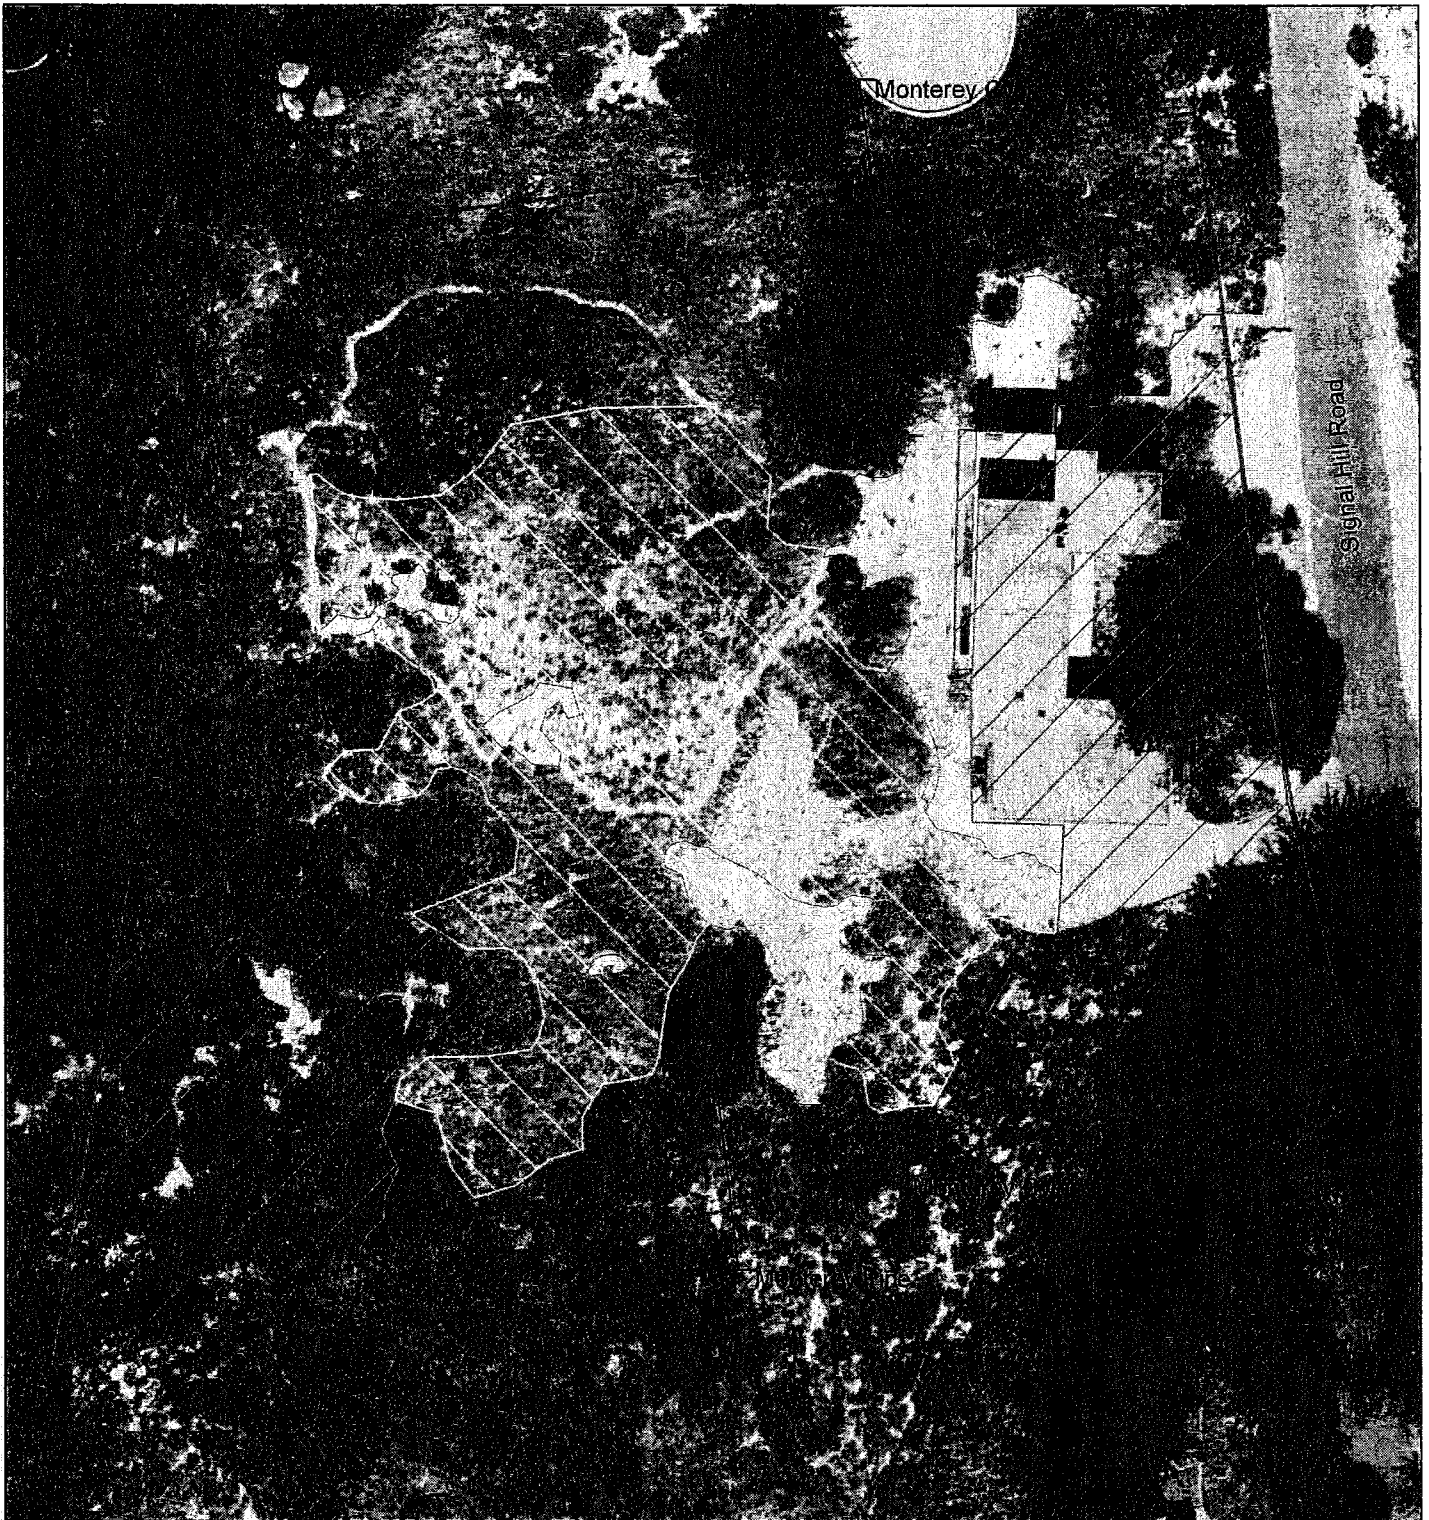
Figure  
 1

This dune restoration plan has been prepared to address restoration of remnant dune areas on an approximately 2.17-acre parcel located at 1170 Signal Hill Drive, Pebble Beach, California, known as the Mehdipour property (Figure 1). The property is situated in an older (ca 1950's) residential subdivision on sandy dune substrates between two existing golf courses: Spyglass Hill & Cypress Point. The property also sits near the base of Signal Hill Dune, a protected remnant of a once more extensive dune system that historically occurred along the Monterey Peninsula shoreline. The historic dune system has been fragmented by sand mining, the construction of roads, golf courses, houses and other development over the years.
