DRAFT RESOLUTION

WIND & SEA PROPERTY (PLN200097)

Resolution by the Monterey County Zoning Administrator:

[PLN200097, WIND & SEA PROPERTY LLC,
54722 HIGHWAY 1, BIG SUR, BIG SUR LAND
USE PLAN (APN: 421-011-010-000)]

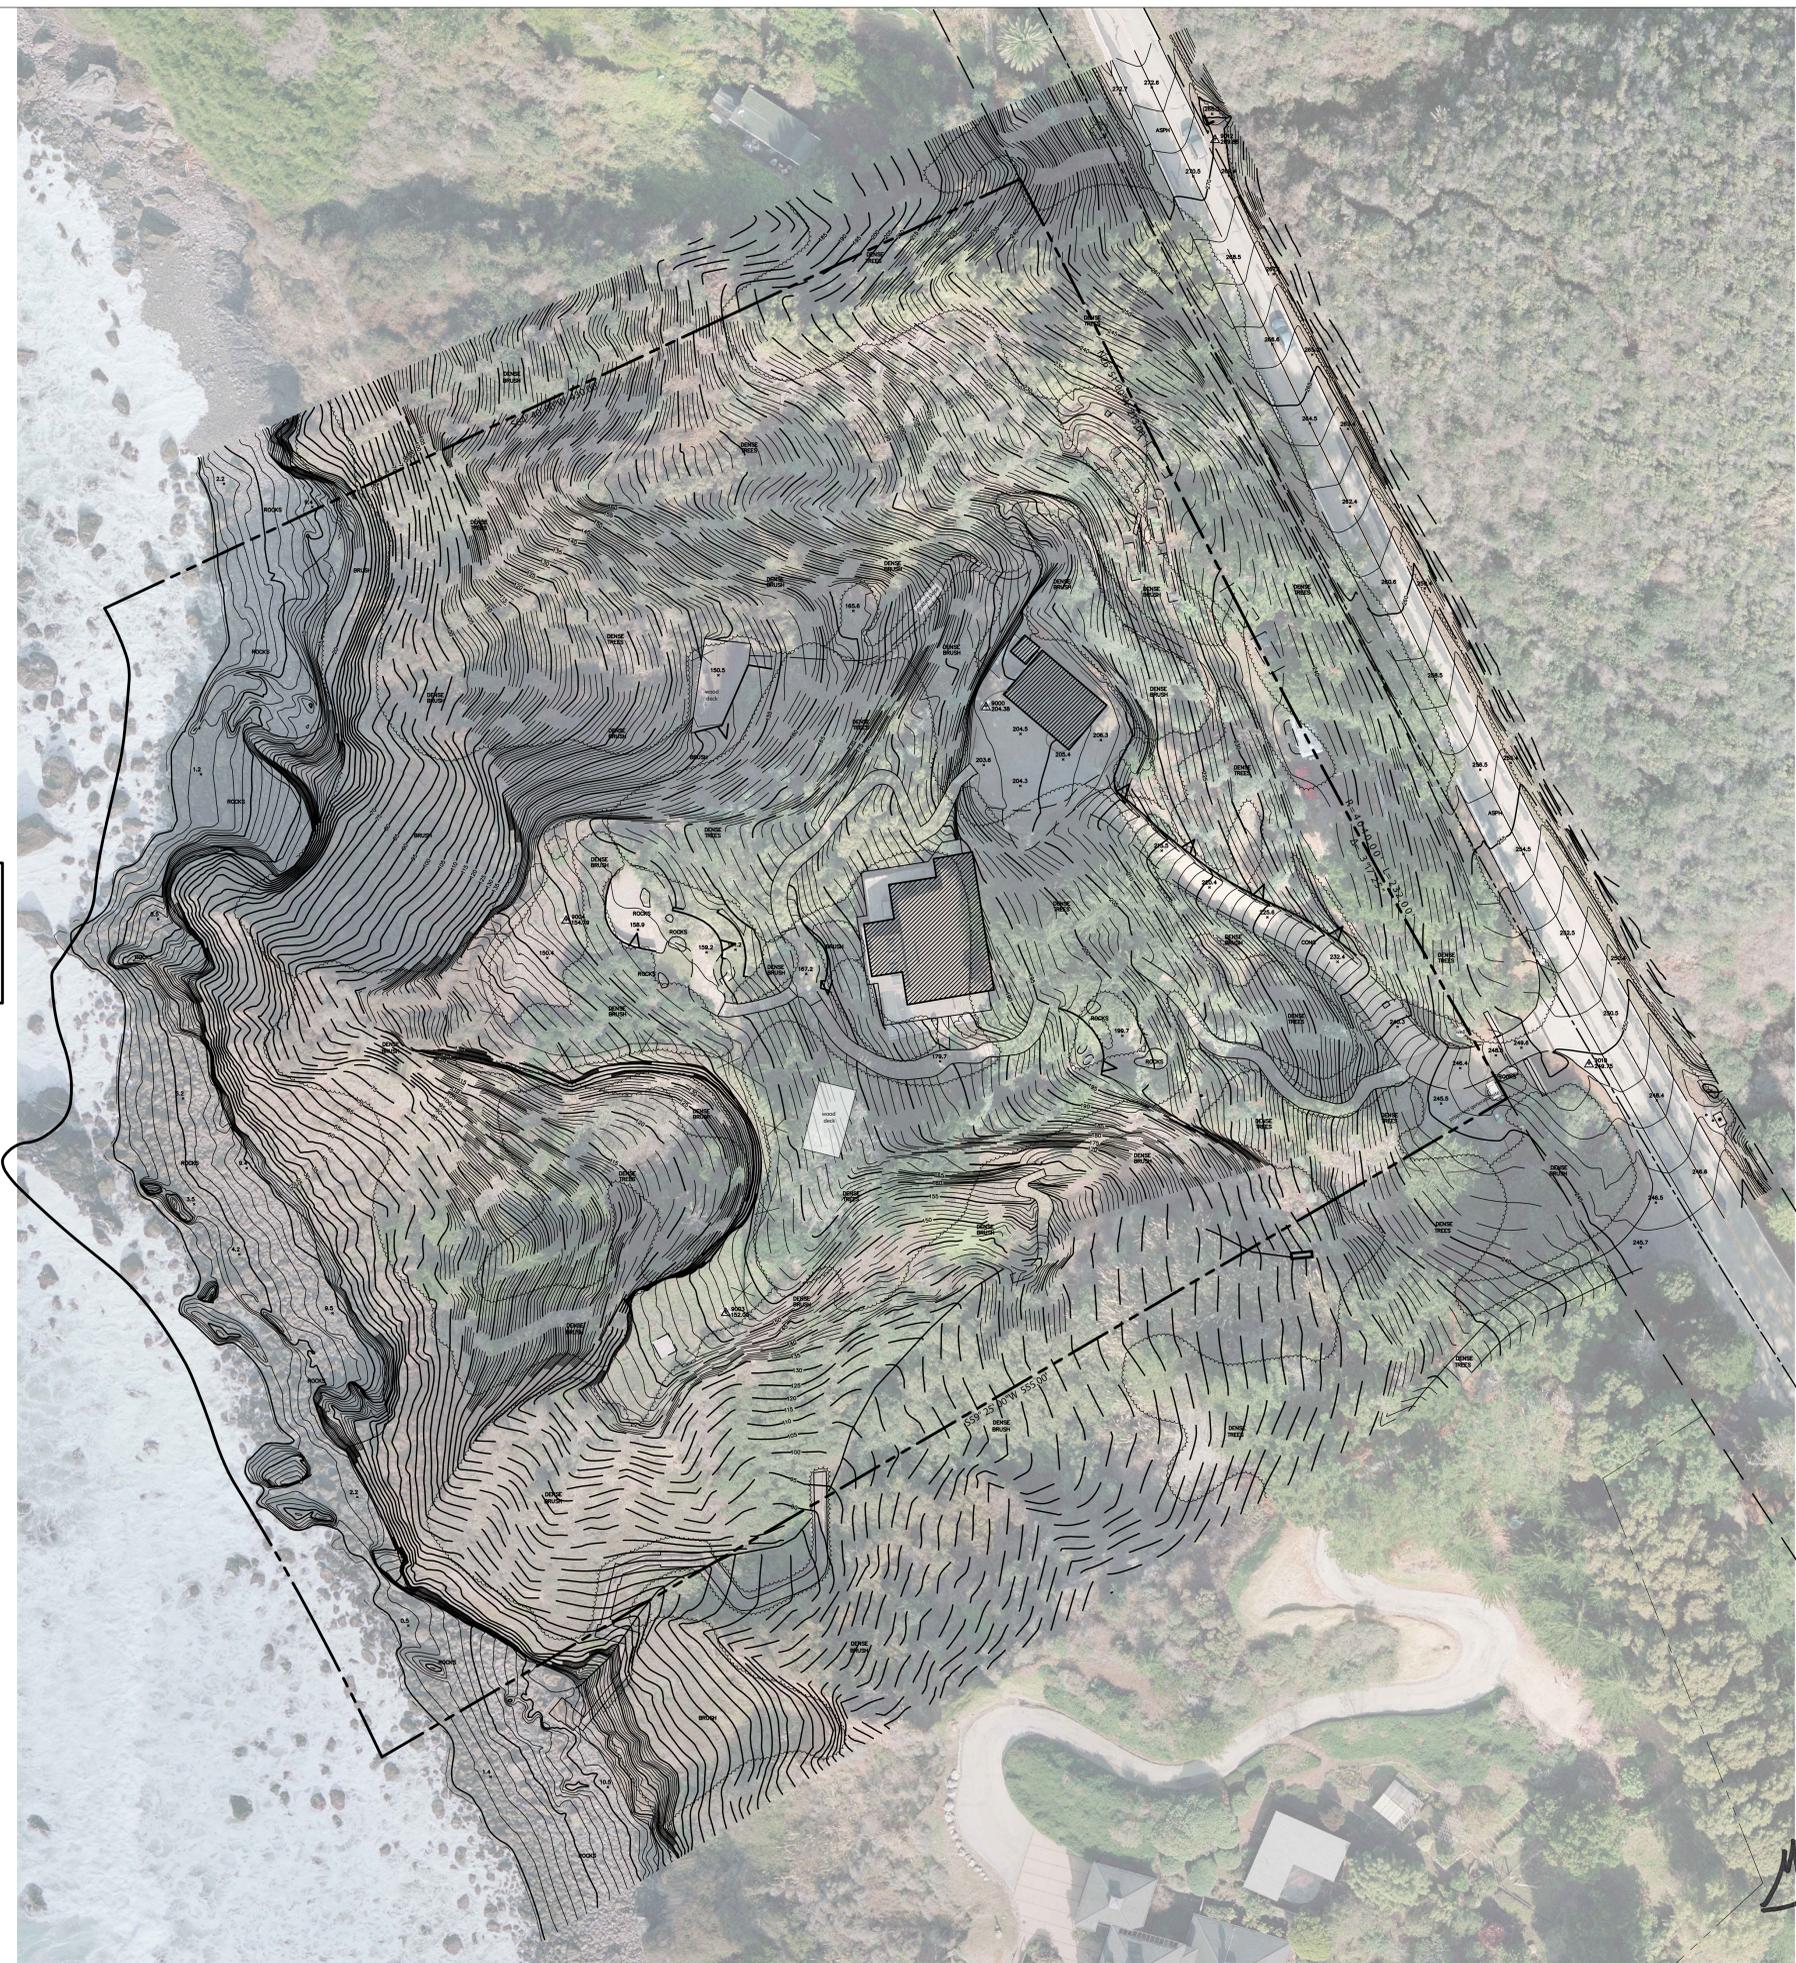
We comply with map accuracy standards from ASPRS and American Congress on Surveying and Mapping printed by U.S. Department of the Interior, except where ground is not visible. Use areas of heavy trees, clear areas in-between trees with no stems visible, heavy brush, heavy shadow, or blind areas in the back of some structures.

This map portrays the site at the time of the survey and does not show soils or geology information, underground conditions, easements, zoning or regulatory information or any other items not specifically requested by the property owner. There may be easements or other rights, recorded or unrecorded, affecting the subject property which are not shown hereon.

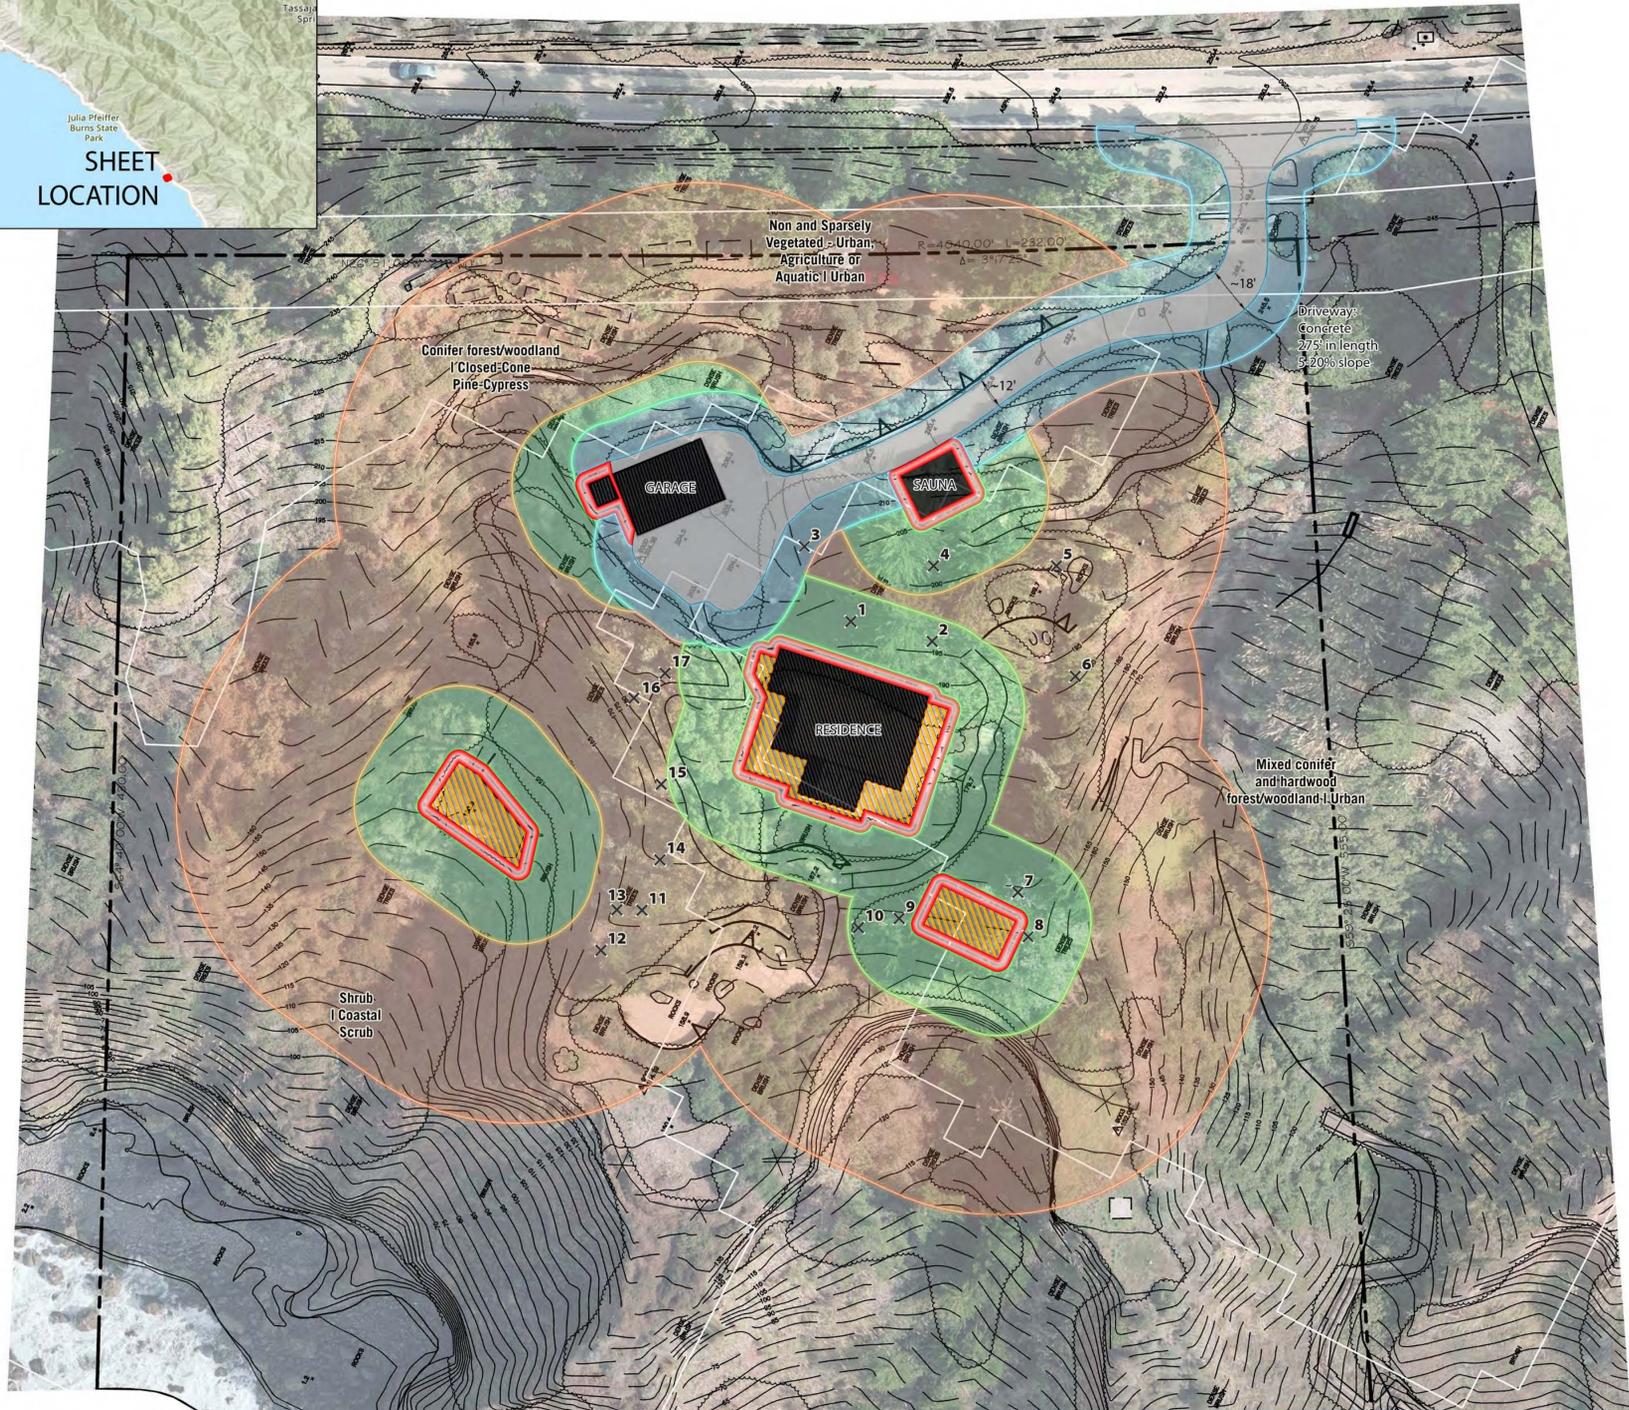
- Legend**
- x Trees
 - Vegetation
- House and Driveway Footprints**
- Home
 - Garage
 - Sauna
 - Deck
 - Driveway
- Zones**
- Non-combustible Zone (0 - 5')
 - Driveway Zone (0 - 15')
 - Green Zone (30')
 - Management Zone (100')

Observations: Dense vegetative fuels (shrubs) were observed along both sides of the driveway.

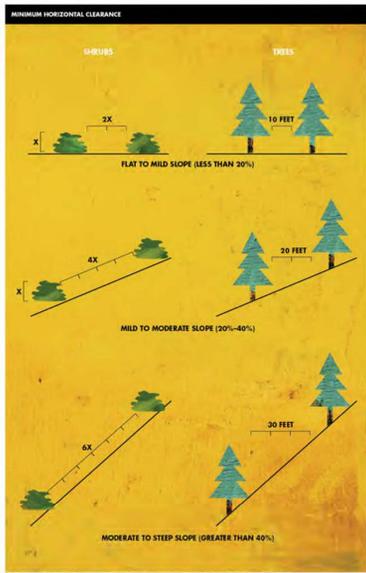
Example: A 5-foot shrub is growing near a tree. 15 feet of clearance is needed between the top of the shrub and the lowest tree branch.

How much space should you leave between trees or shrubs?
 Horizontal space depends on the slope of the land and the height of the shrubs or trees. Leave more space between vegetation on bigger slopes. Refer to the chart below to determine spacing distance.

Space between shrubs:
 Flat or mild slope (less than 20%): Two times the height of the shrub.
 Mild to moderate slope (20-40%): Four times the height of the shrub
 Moderate to steep slope (greater than 40%): Six times the height of the shrub
