PRIMARY RECORD

Resource Name or #: (Assigned by recorder) *Hatton Dairy Barn (Upper Hatton Ranch)*

BUILDING, STRUCTURE, AND OBJECT RECORD

CONTINUATION SHEET

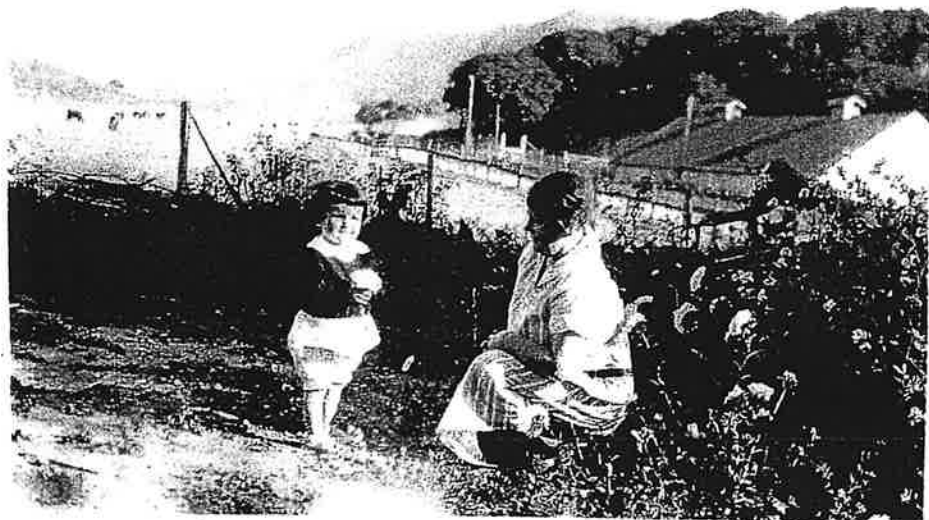
Supplemental Photograph or Drawing

Looking SE at the north side-elev., and west gable end of the Hatton Upper Ranch Dairy barn, unknown photographer, c. 1925.
