# Elkhorn Battery Energy Storage System

Monterey County Board of Supervisors  
December 13, 2022

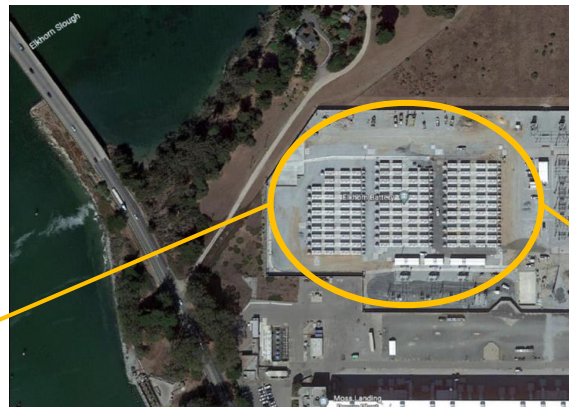
- Fire affected 1 Tesla Megapack (out of 256), which failed safely as designed.
- Local fire response operated as expected based on pre-operations collaboration.
- Elkhorn is fully de-energized and currently offline.
- PG&E and Tesla are conducting an investigation to determine the likely root cause of the incident.
  - PG&E is working to implement a complete set of corrective actions and is committed to mitigating the issue and improving its response
