Subject: CSA 34 – Rancho Rio Vista/Carmel Knolls & CSA 47 – Carmel Views  
Emergency Storm Drain Projects

**Emergency Storm Drain Repairs – Canada Drive**  
CSA 34 – Rancho Rio Vista/Carmel Knolls and CSA 47 – Carmel Views

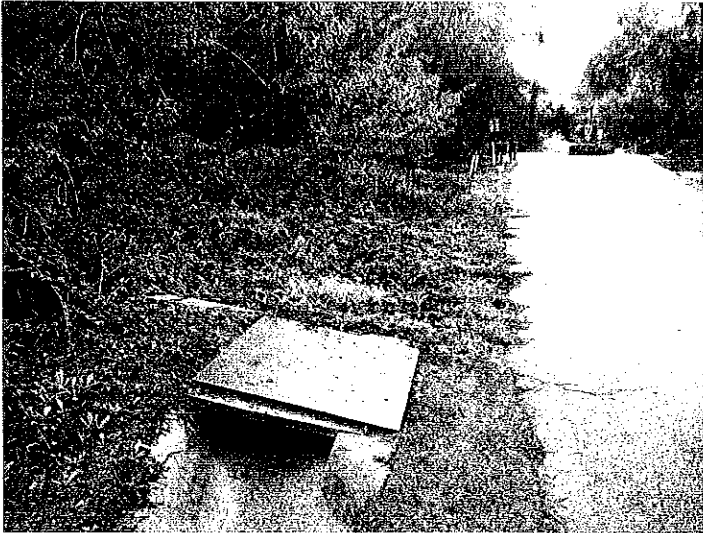
**Location 1**

On January 7, 2016, Resource Management Agency – Public Works (RMA – PW) maintenance staff discovered erosion in two locations adjacent to stormdrain and along open culverts on Canada Drive. The culvert is located in County Service Area (CSA) 34 – Rancho Rio Vista/Carmel Knolls and collects storm water runoff from CSA 34 on the west side of Canada Dr., as well as CSA 47 – Carmel Views, along the east side of Canada.

Before (looking downhill)

Upon investigation, it was determined that the Job Order Contract (JOC) process would be the best process to complete the repairs necessary to avoid further erosion and potential roadside shoulder and pavement collapse. Granite Construction was selected to do the work, which will be completed on January 27, 2016. The work involves removing excess debris at the existing ditch, placing riprap along the edge of the road and extending the 18" culvert approximately 20 (twenty) linear feet. It was determined appropriate to charge the cost estimated at \$22,600, for the repairs equally between CSA 34 and 47 since the erosion was due to storm water from both CSAs.

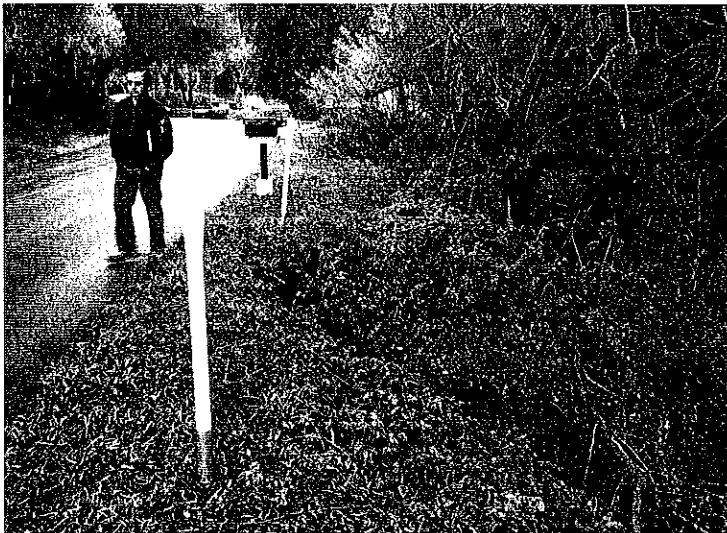
**Location 2**

Before
