### Options 4A and 4B - Rip Rap Sections

Repair Alternatives Analysis  
Laguna Seca Recreation Area - Turn 6  
Monterey County, California

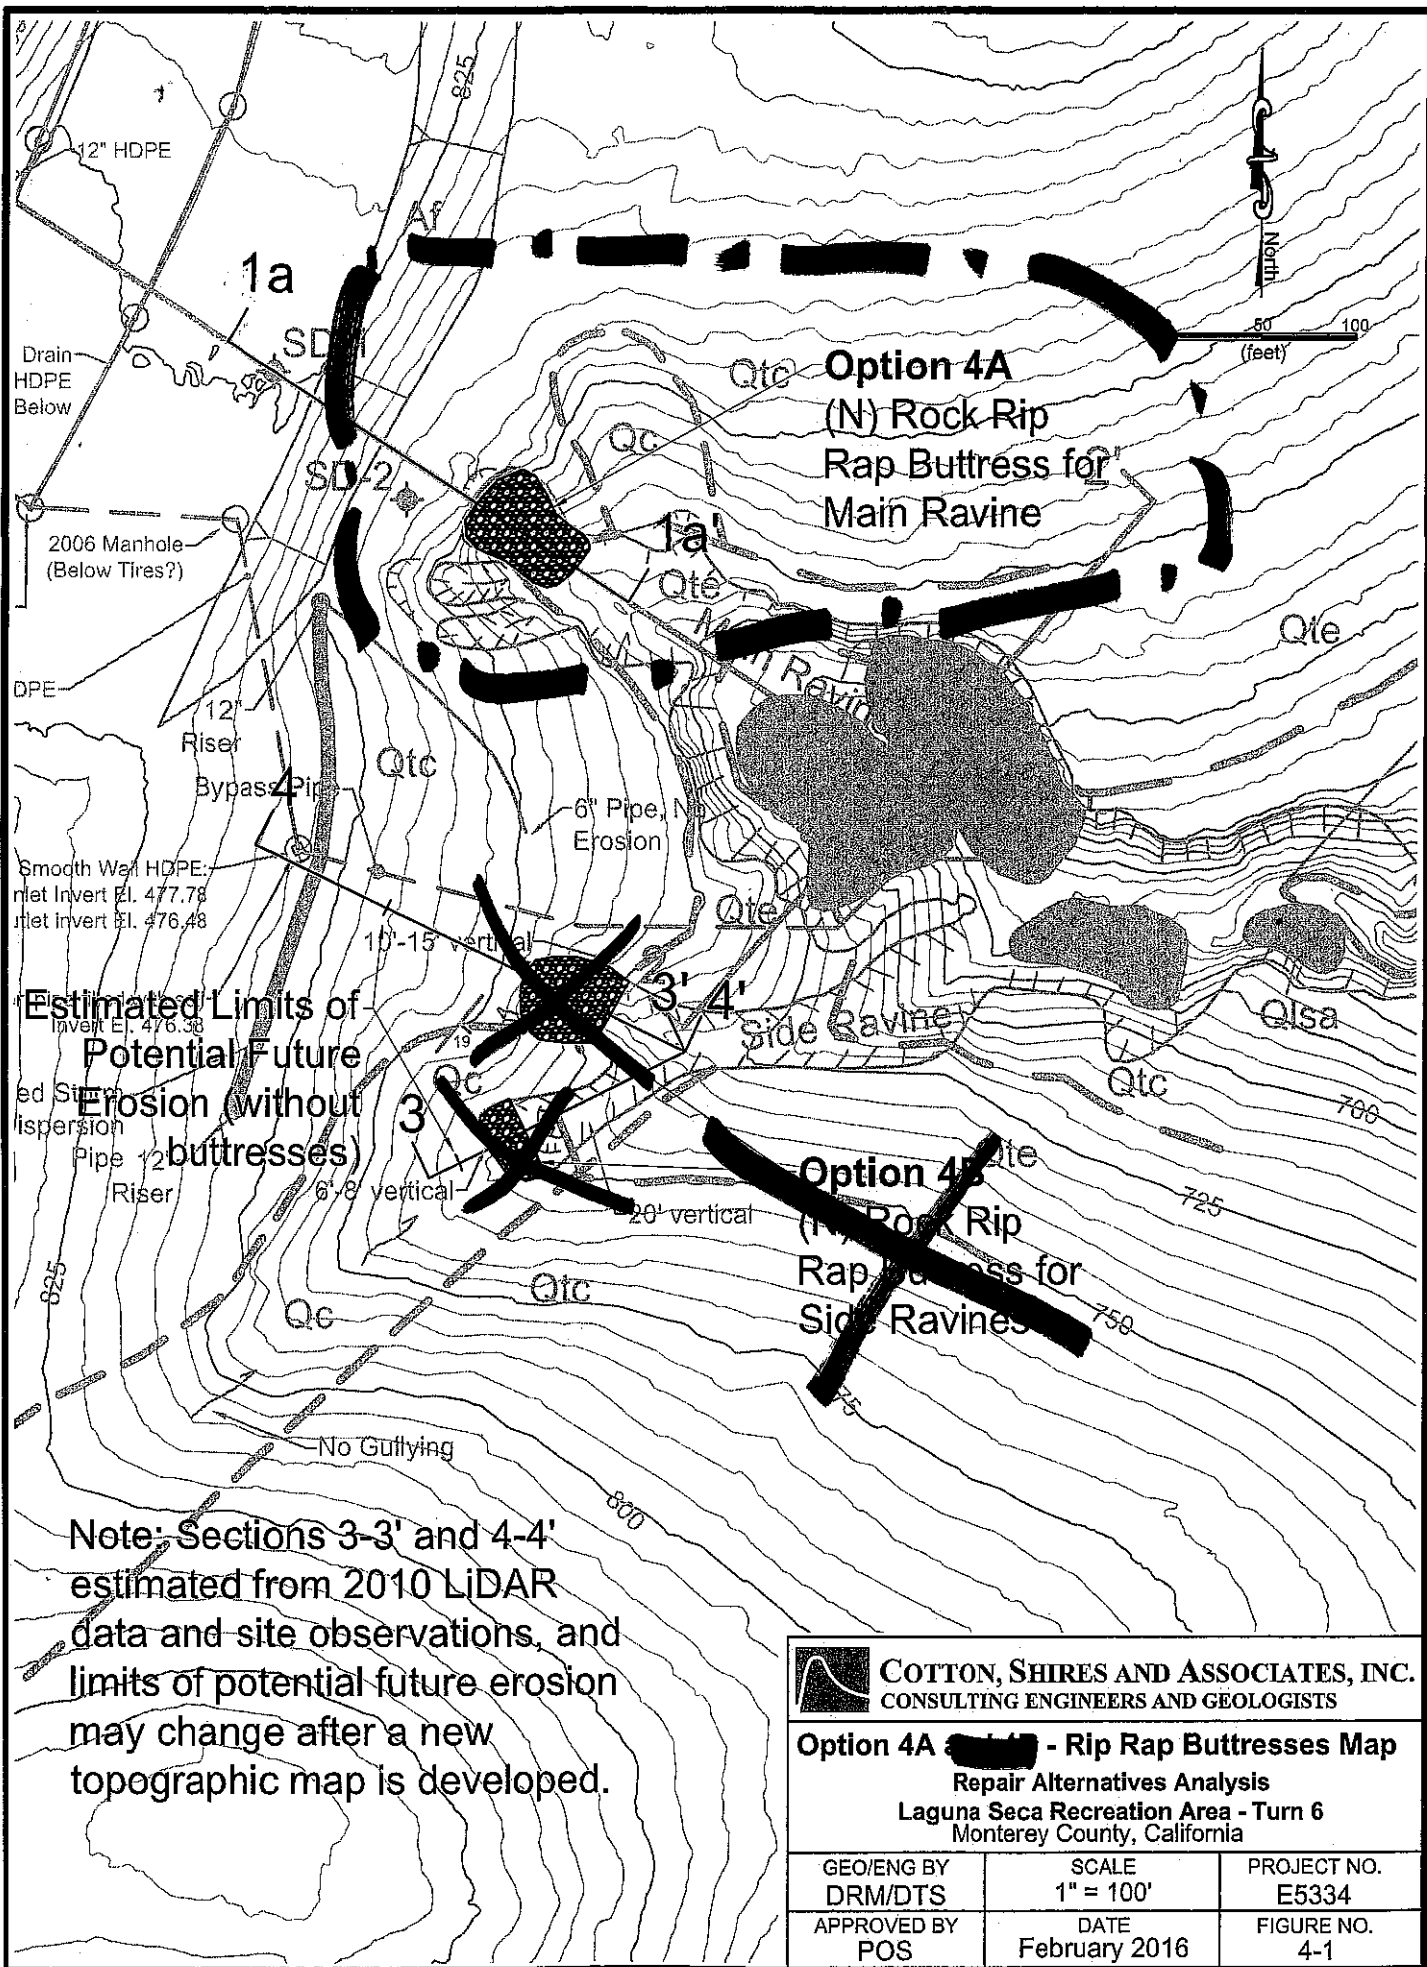
FIGURE NO.  
4-2

Note: Section 1a-1a' surveyed by CSA in Sept. 2015. Sections 3-3' and 4-4' estimated from 2010 LIDAR data and site observations, and limits of potential future erosion may change after a new topographic map is developed.
