This page intentionally left blank.

PAST
CONSULTANTS LLC

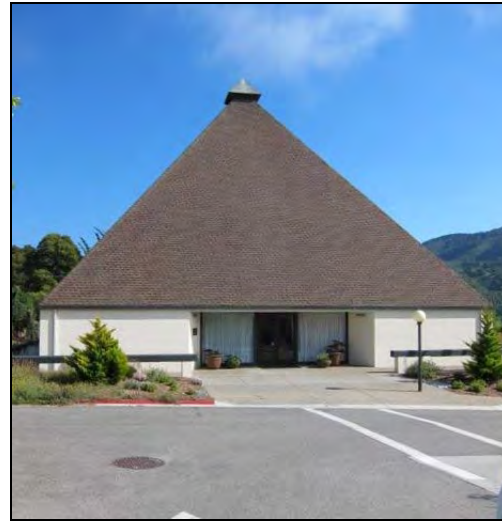
Figure 22. Front (north) elevation of Meeting House.

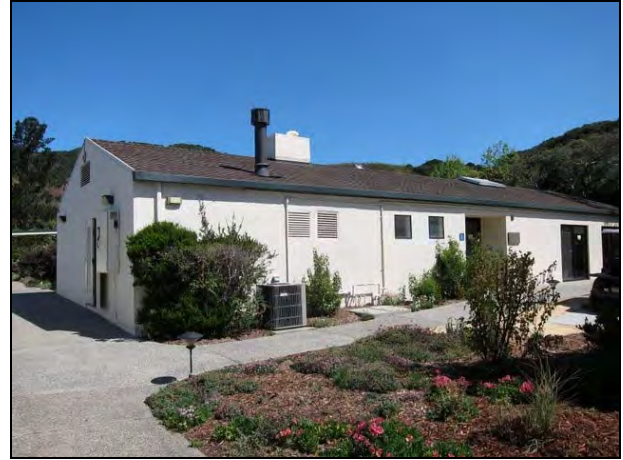
Figure 24. Rear (south) elevation of the Fitness Center.

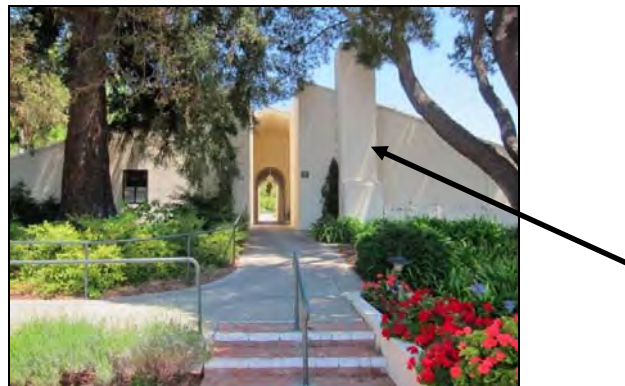
Figure 31. Front (west) elevation of Bldg. 2. Note chimney (arrow) and window in left shed end.

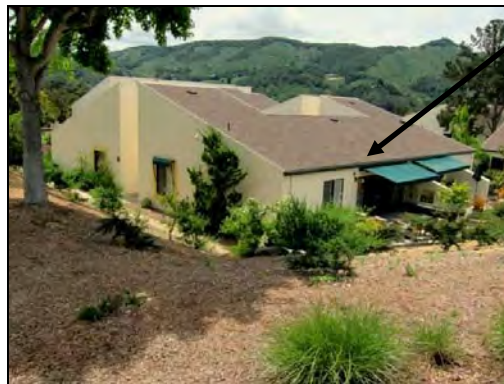
Figure 34. Overall view of Bldg. 18 with full outer wall extension (arrow).

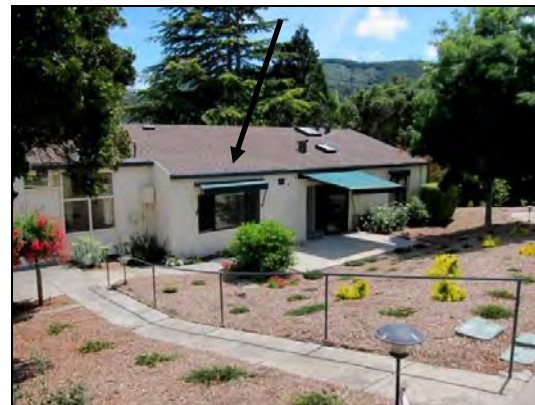
Figure 38. Rear of Bldg. 29 showing garage conversion.

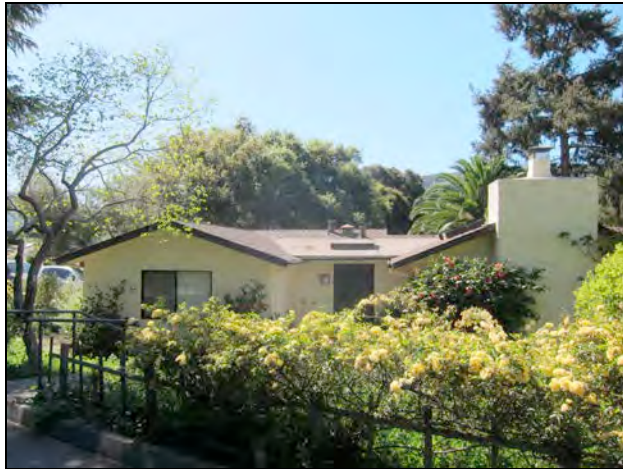
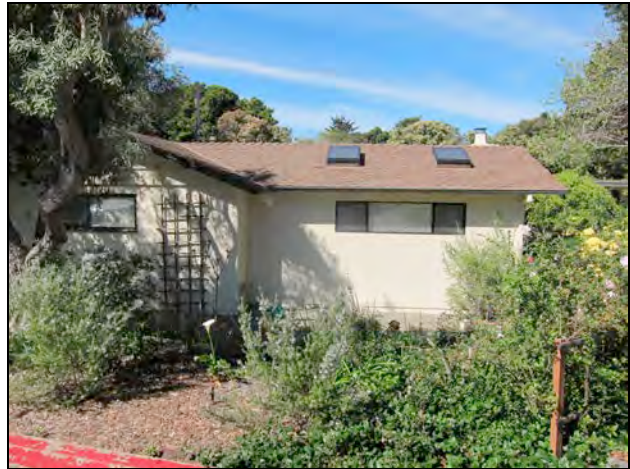
Unit #34; APN 169-041-023

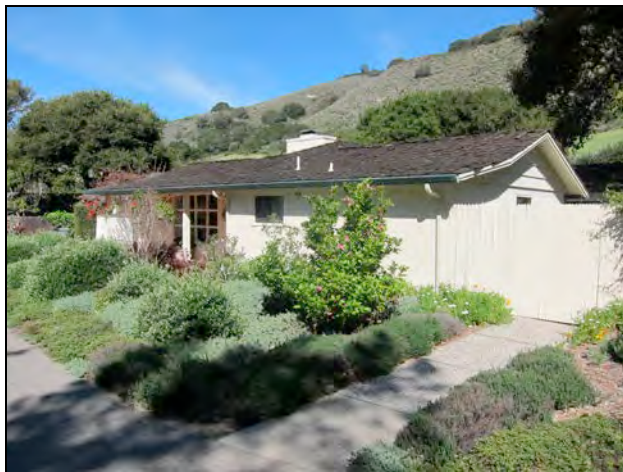
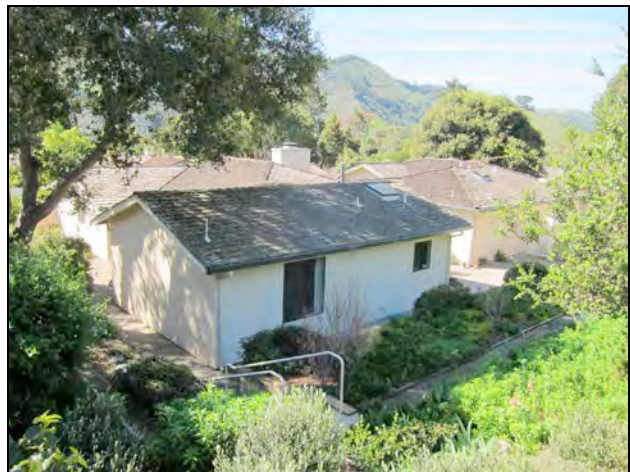
Unit #35; APN 169-041-024

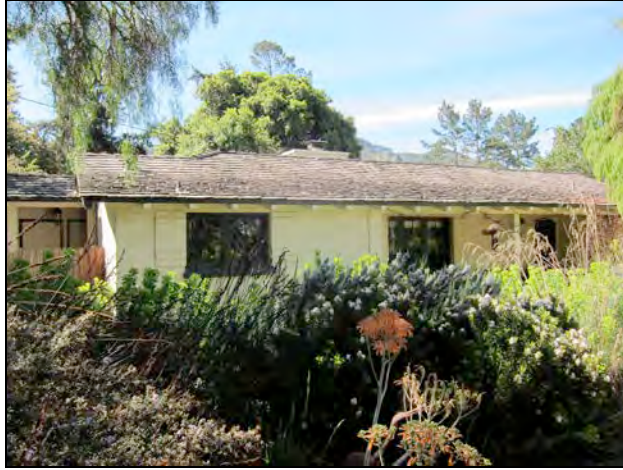
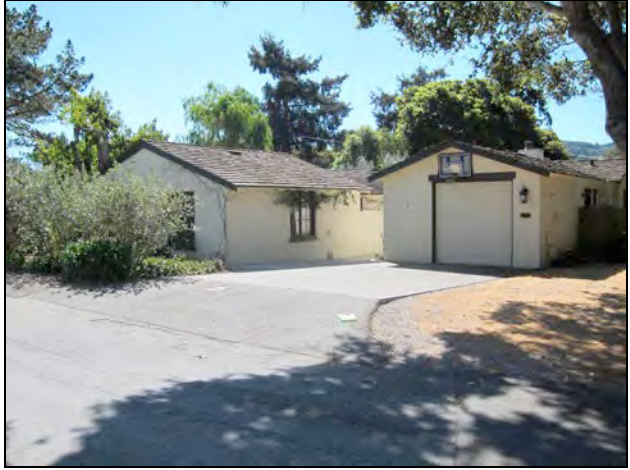
Unit #36; APN 169-041-003

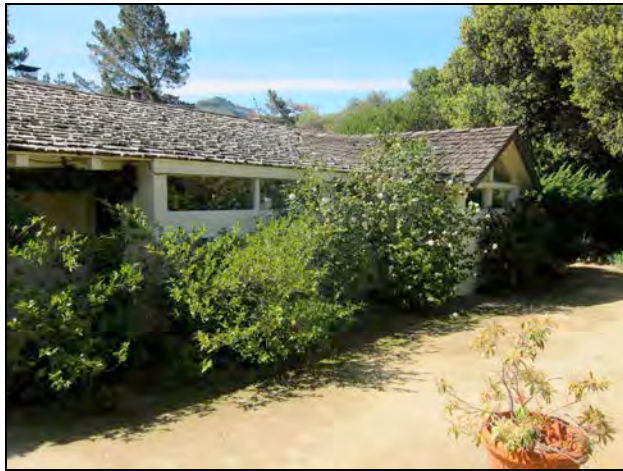
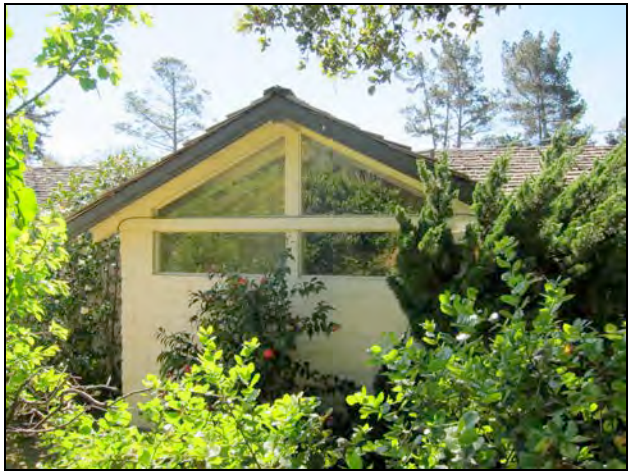
Unit #38; APN 169-041-018
