Natividad Medical Center Facility Assessment Report

*Prepared by Kitchell
For*

County of Monterey, California

December 9, 2015
Job No. 4983A3

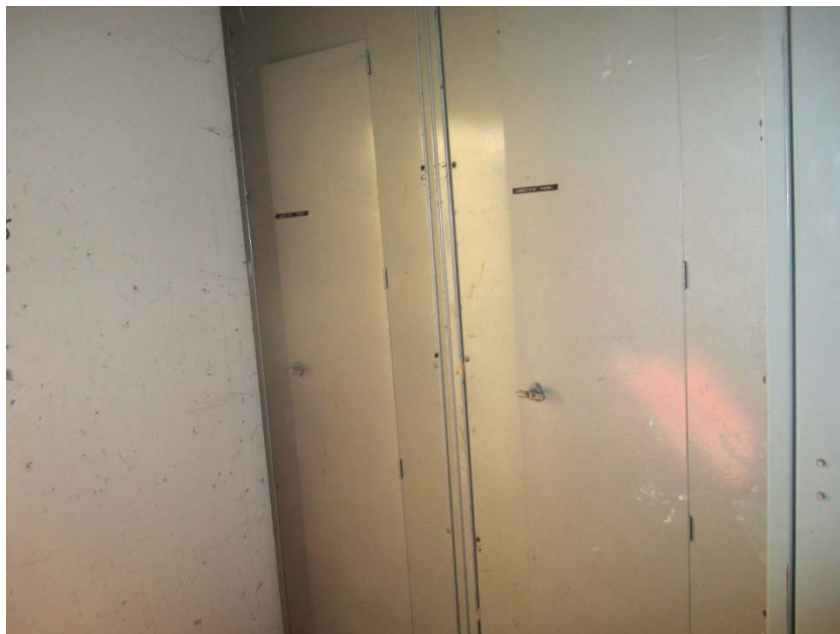
The fire alarm panel is past its expected useful life.

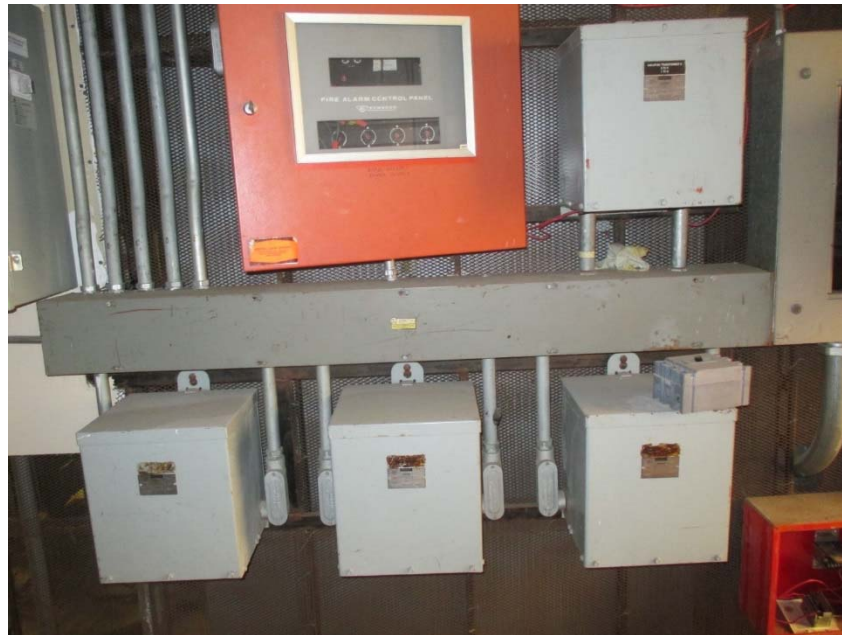
All panels are past their expected useful lives.

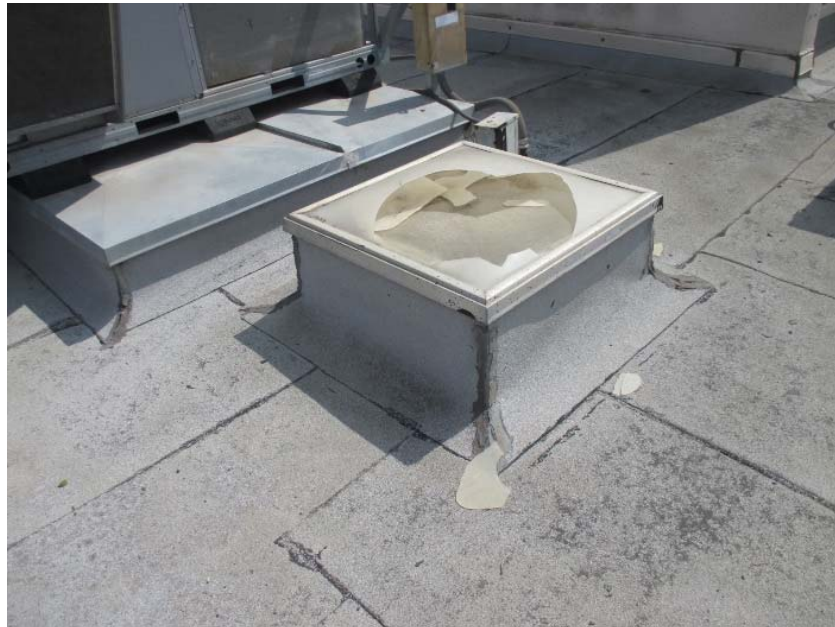
The roof consists of built-up roofing. Overall, it is in fair condition but is at the end of its useful life and should be considered for replacement. The metal screen wall that hides the mechanical units is of similar construction to the metal screen at ground level and is in the same condition, requiring paint. One skylight is severely damaged.

Damaged skylight

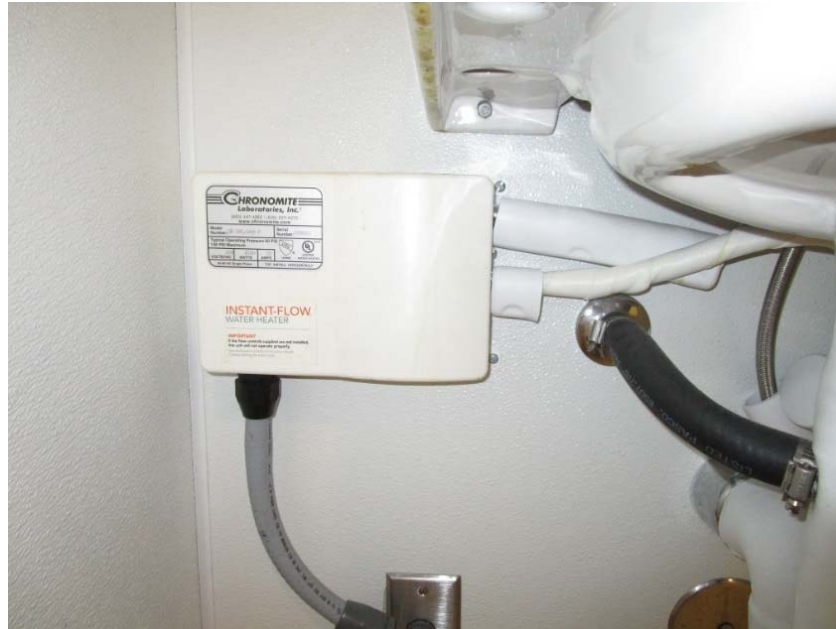
Buildings 820 and 840 under-sink electric instantaneous water heaters are at the end of their expected useful lives.

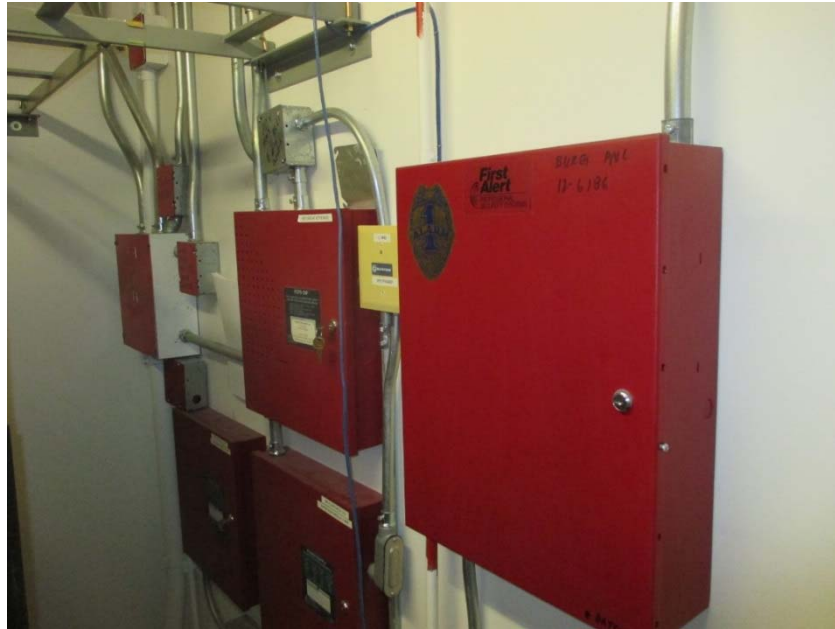
The fire alarm panel is past its expected useful life.

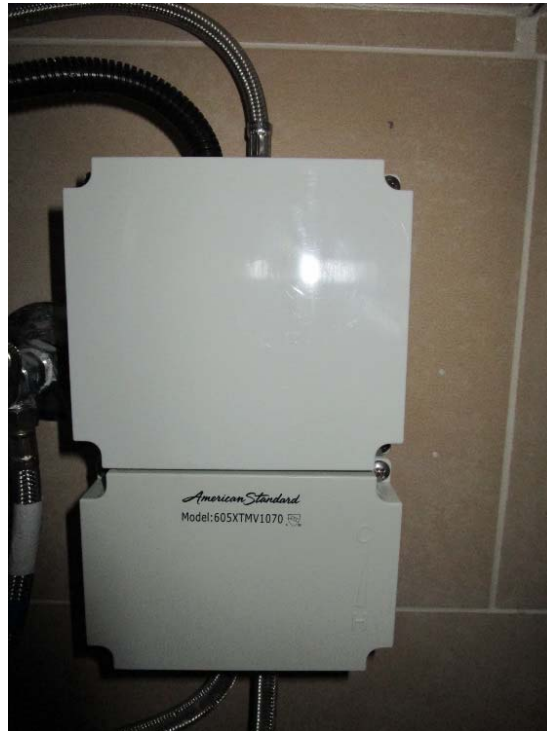
Electric instantaneous water heaters are at the end of their expected useful lives.

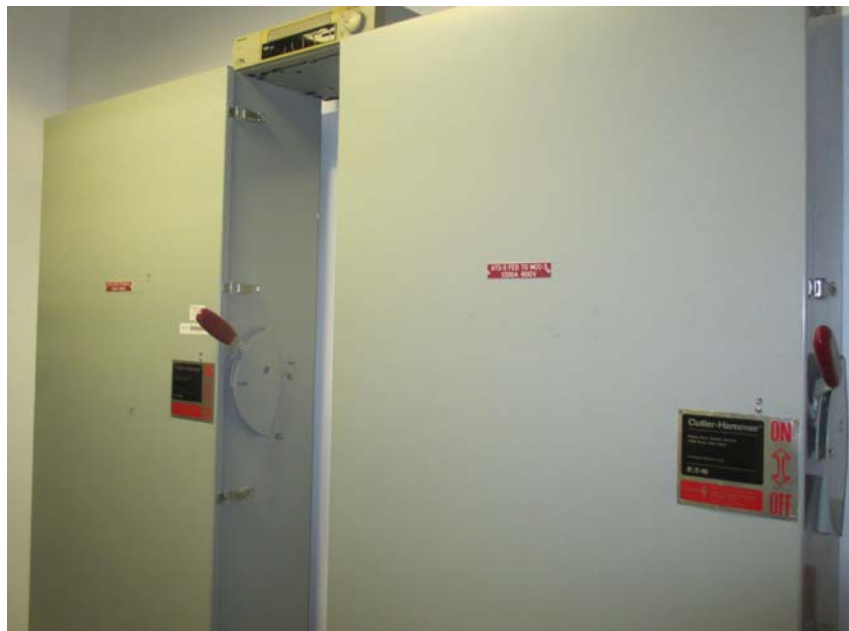
Two 1200A ATS are past their expected useful lives.

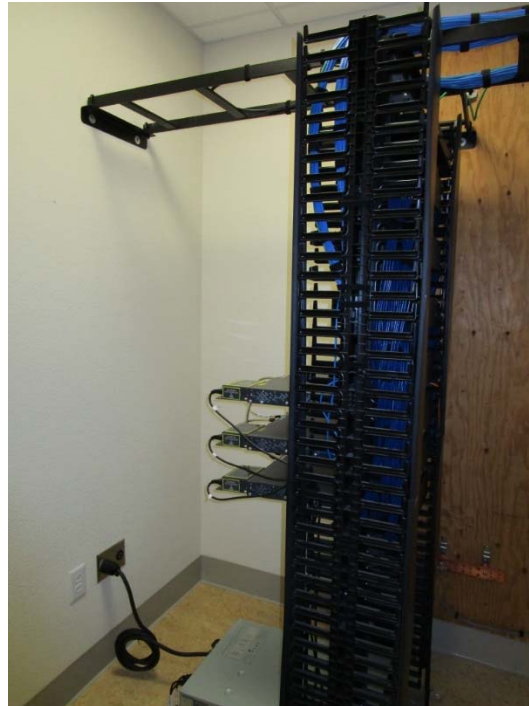
The FACP Room contains data equipment and gets very warm. Recommend installing a new split ductless HVAC system in this room to maintain proper room temperature.

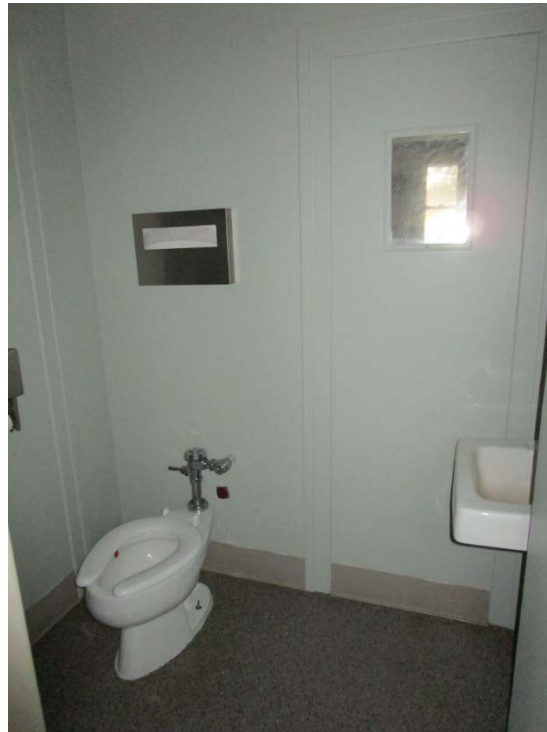
There is currently no means of ventilation in the restroom. A ceiling exhaust fan will need to be installed to maintain proper ventilation.

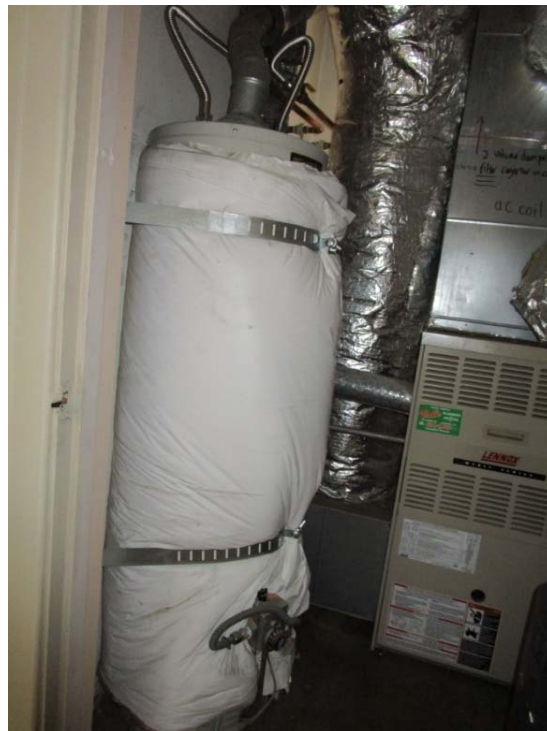
Gas water heater is at the end of its expected useful life.
