# Exhibit E

Submitted herewith is the report of our Geotechnical Investigation for the proposed new single family residence with garage and guest house to be constructed within Parcel 1, on Rinconada Drive, APN 416-361-043, in Carmel Valley, California. One boring was drilled on February 28, 2017 and an additional boring was drilled on March 28, 2017 for geotechnical investigation purposes. Laboratory tests were subsequently made on driven soil core samples taken from the borings to determine the near surface and subsurface soil conditions and suitability for the construction of the proposed single family residence and detached guesthouse. We find that the project site is suitable for the proposed use with the recommendations made herein.

TREE RESOURCE EVALUATION  
PROJECT IMPACT ANALYSIS  
TREE PROTECTION PLAN

# Clifton and Wolske Residence Tree Assessment/Forest Management Plan

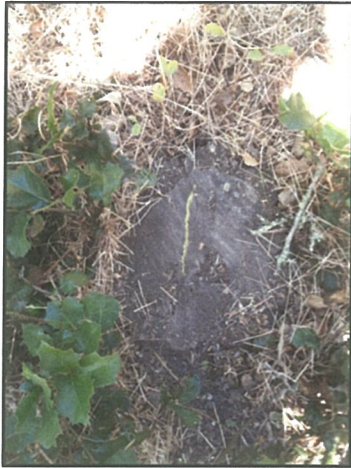
Tree 1 – hole in center

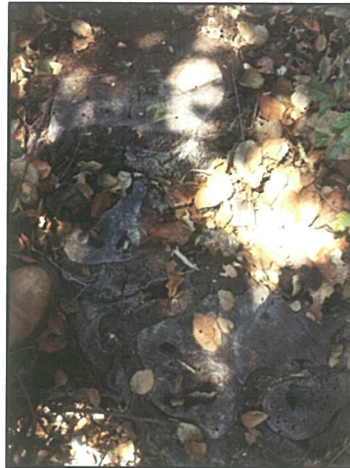
Tree 2 - multiple holes & stems

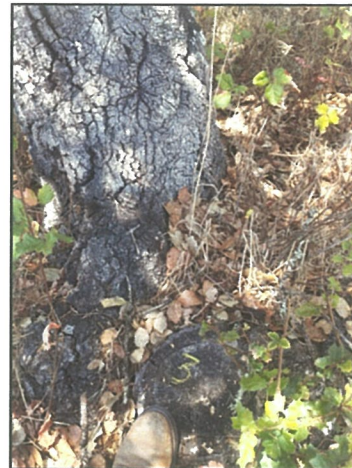
Tree 3 – adjacent to living tree

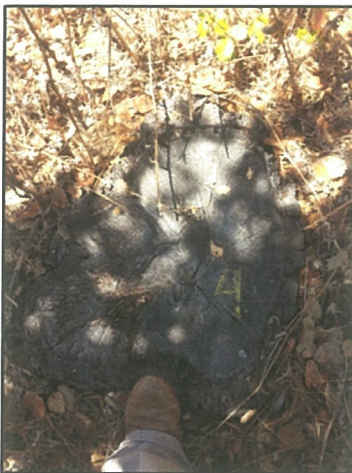
Tree 4 – big diameter

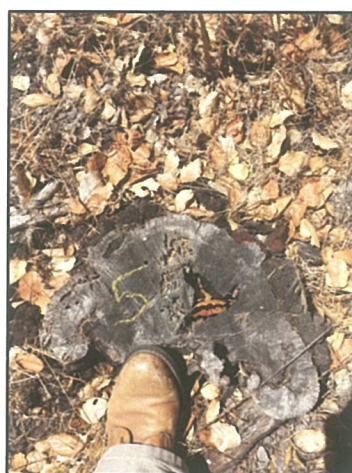
Tree 5 – multiple holes

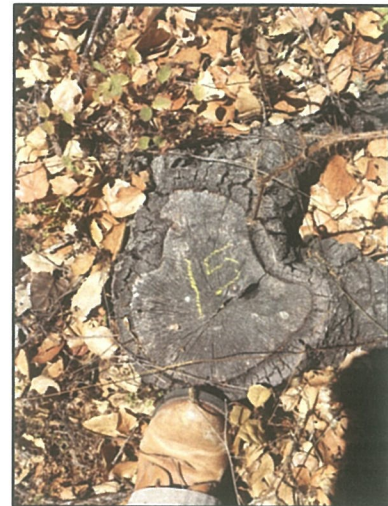
Tree 15

Figure 2 – Callous on limb cut more than 15 years ago on Tree #15 (photo July 25, 2017).

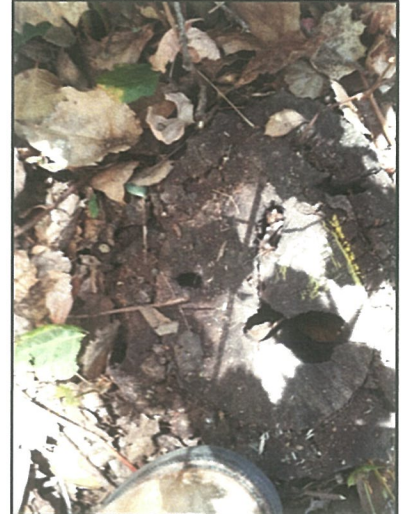
Tree 21 – holes

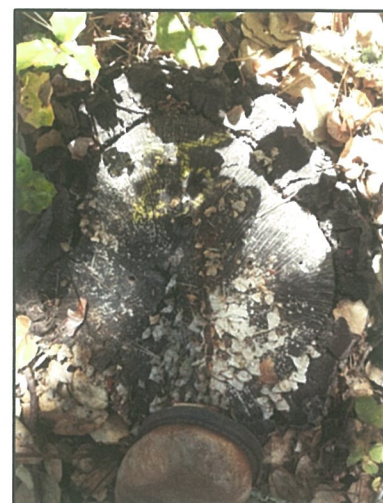
Tree 24 – multiple stems

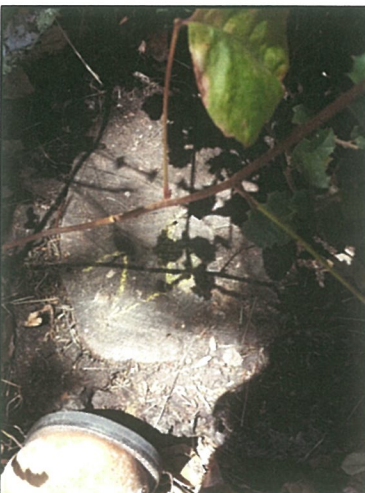
Tree 25 – decay fungus

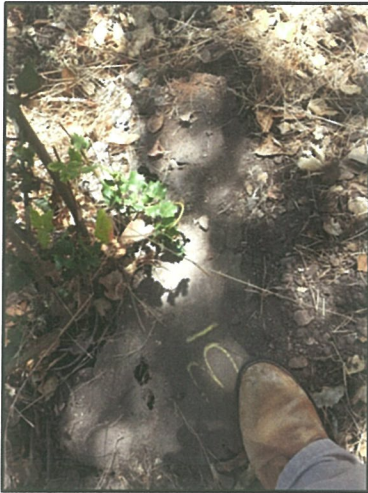
Tree 30 – holes

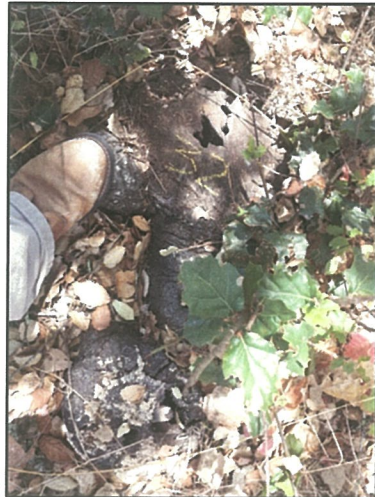
Tree 31 – wide, irregular base

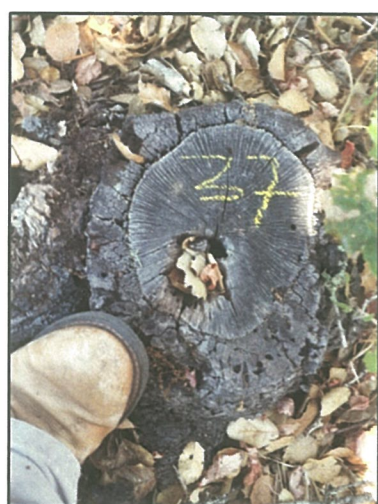
Tree 36 – decay fungus

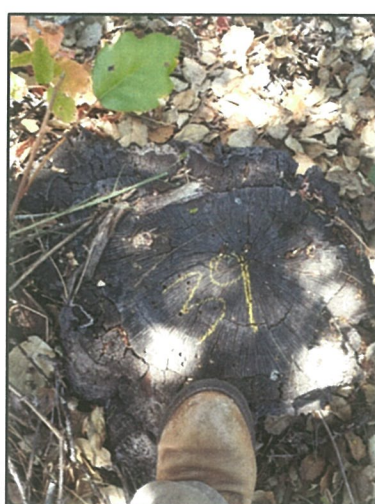
Tree 38 – merged stems

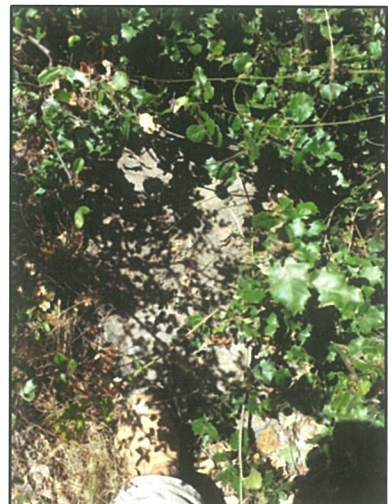
Tree 39 – termite damage

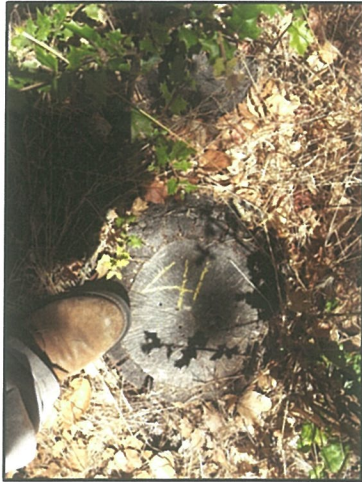
Tree 40 – big base

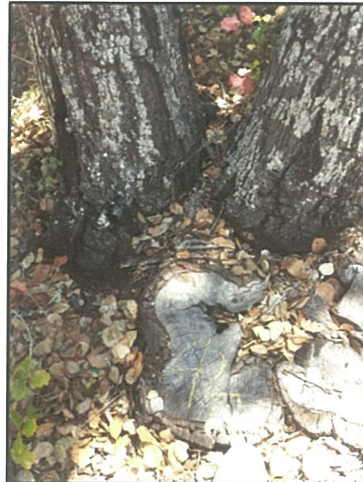
Tree 41 – multiple trunks

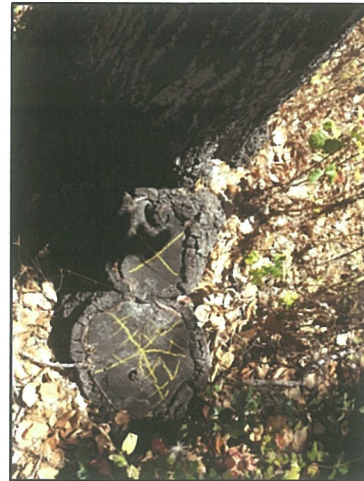
Tree 42 – merged stems
