ARBORIST REPORT

PORTOFINO

10 Country Club Way
Carmel Valley, CA 93924

May 22, 2023

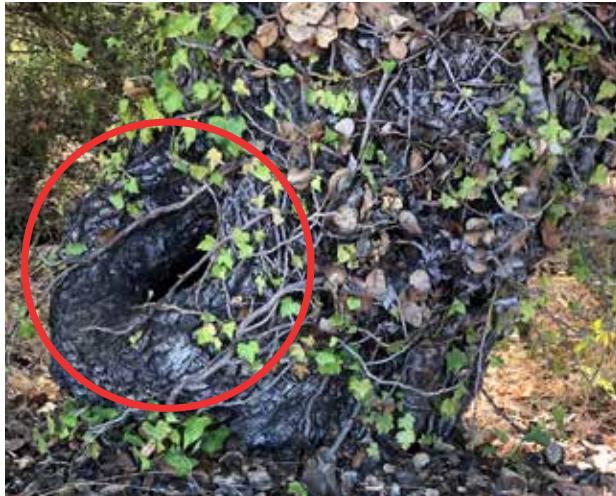
Tree 59: Location of the cavity near the root collar circled in red.

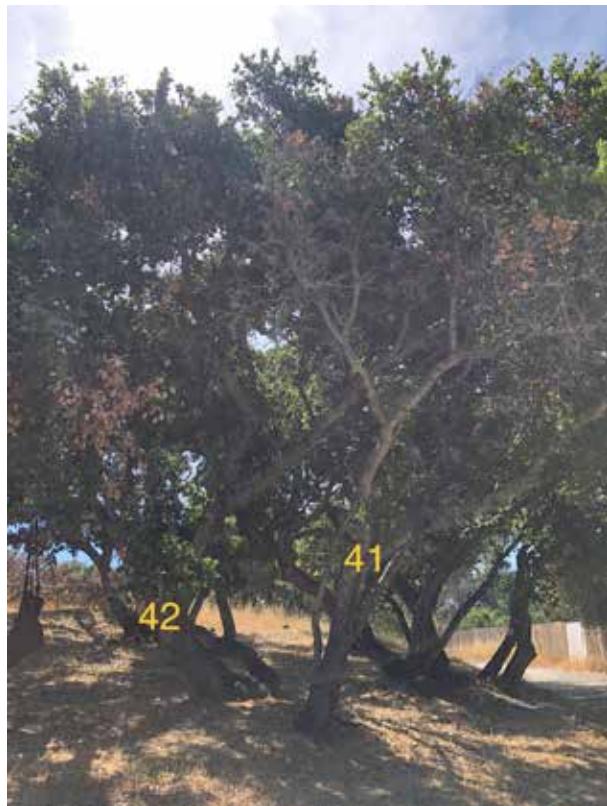
Large cavity in the root collar of tree 42

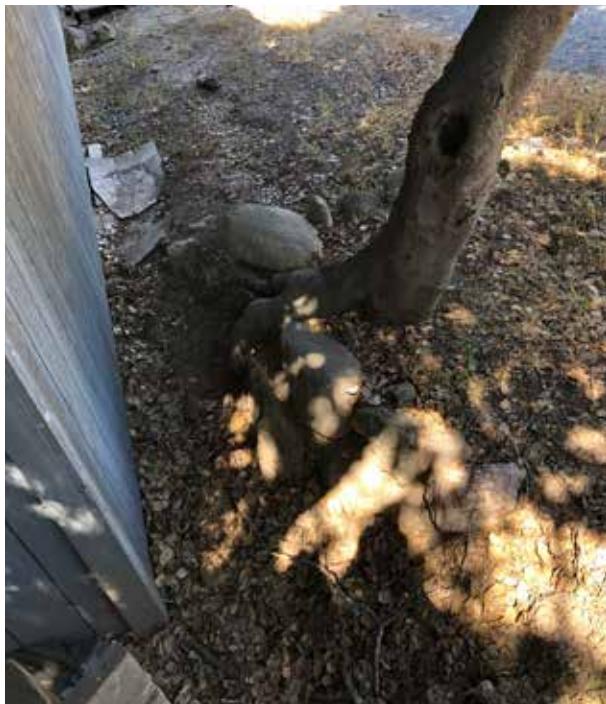
Severe impact to the critical root zone of tree 43 dating back to the original construction

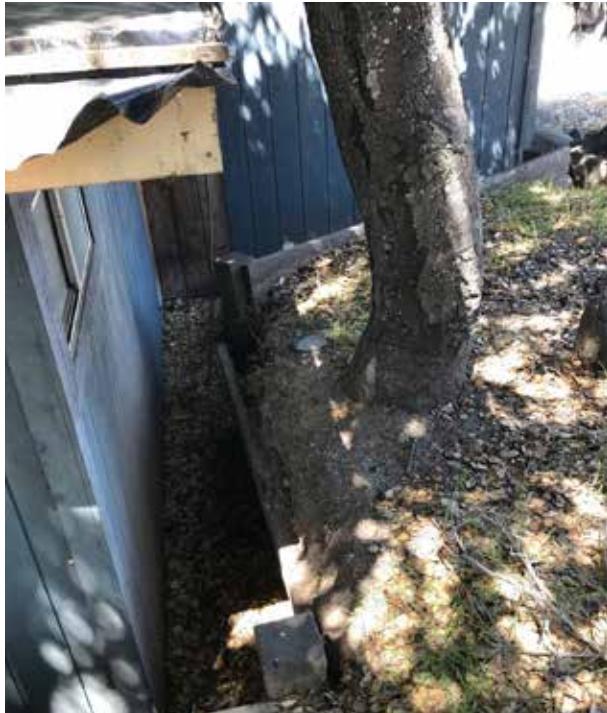
Severe impact to the critical root zone of tree
44 dating back to the original construction

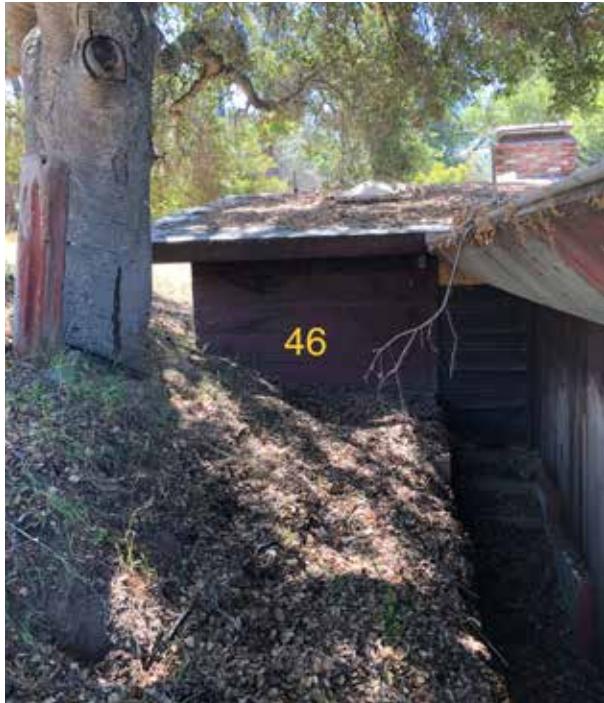
Severe impact to the critical root zone of tree 46 dating back to the original construction

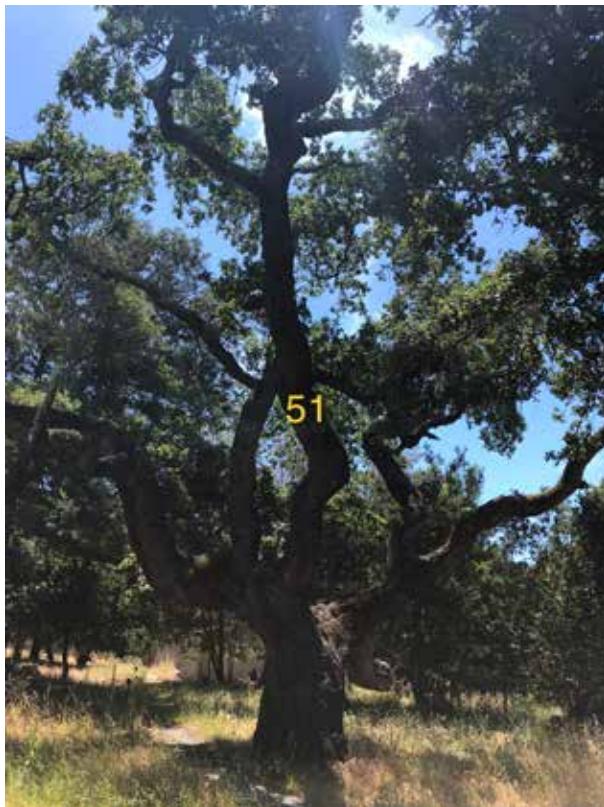
Large uncompartmentalized limb removal from many years ago is now a source of decay for tree 51

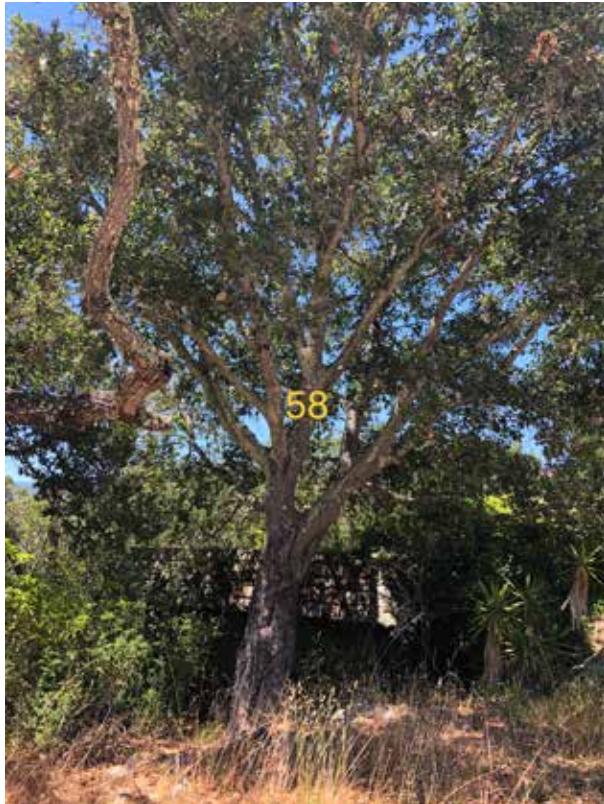
Large areas of decay on tree 58

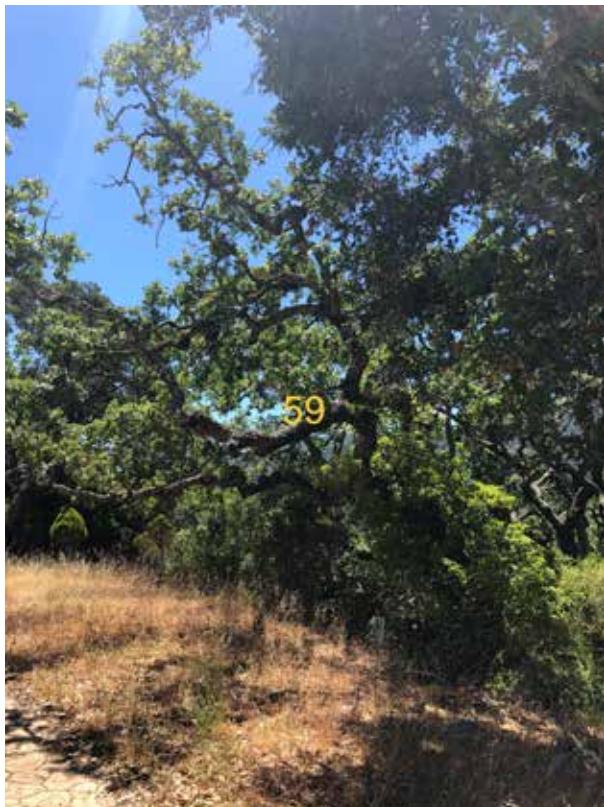
Large cavity on tree 59 filled with standing water

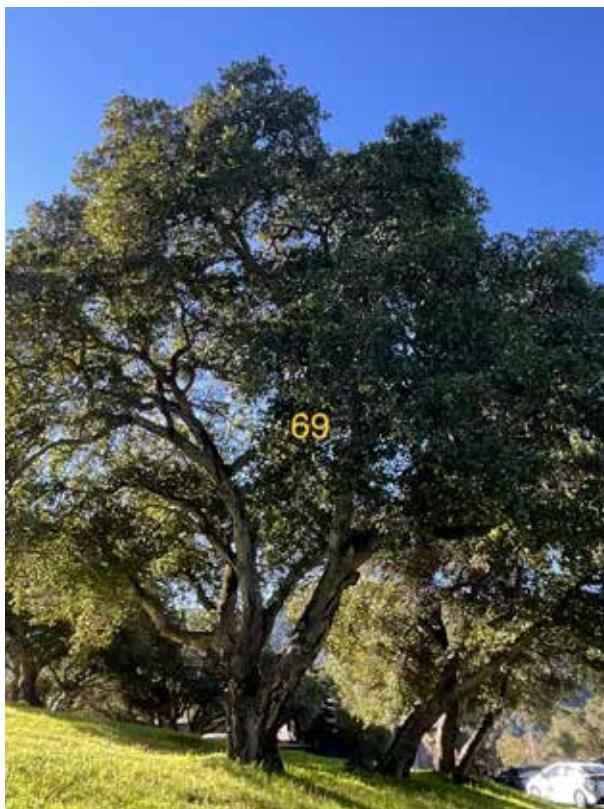
Tree 69 location of probable decay at codominant stem crotch

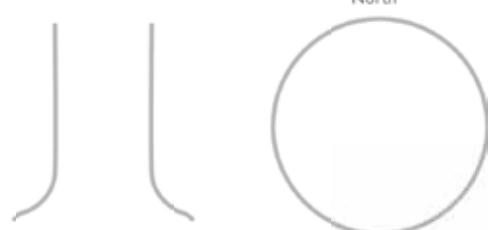
Overall tree risk rating Low Moderate High ExtremeOverall residual risk None Low Moderate High Extreme Recommended inspection interval AnnualData Final Preliminary Advanced assessment needed Yes-Type/Reason _____Inspection limitations None Visibility Access Vines Root collar buried Describe _____ Root collar excavation would expose extent of root collar burial and presence of response growth. Vines impact sounding.

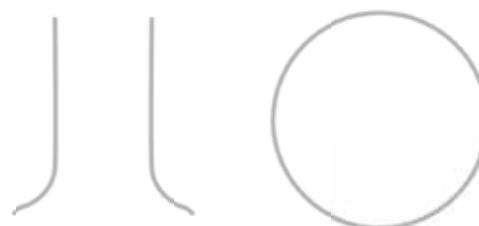
Inspection limitations None Visibility Access Vines Root collar buried Describe _____ Root collar excavation needed to determine depth of decay and depth of burial.
